INSPECTION PHOTOS

Well: MACHENZIE FEDERAL 23-2

INSPECTION DOC #: 716302342

Operator: EVERGREEN NATURAL RESOURCES LLC

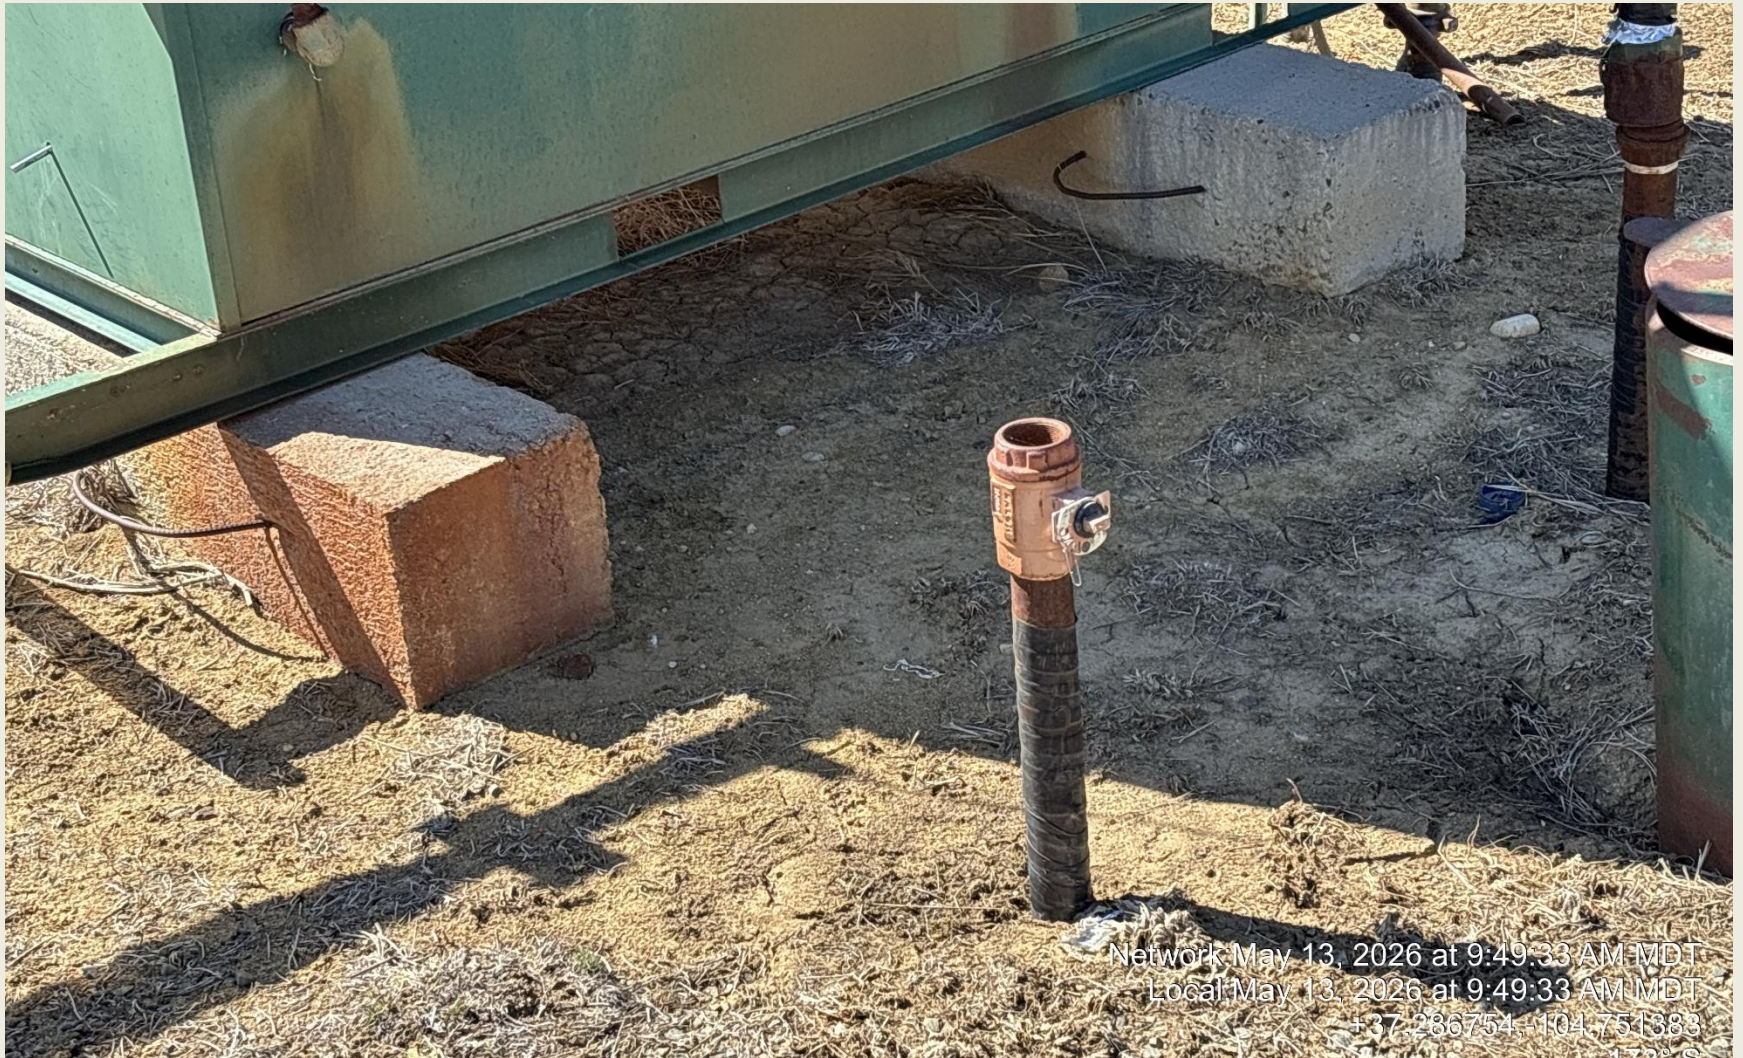
PHOTO 5: UNUSED EQUIPMENT (2" RISER NEAR METER HOUSE NOT LABELED). **REMOVE OR LABEL RISERS PER RULE 606. CA DATE 6/13/2026.**

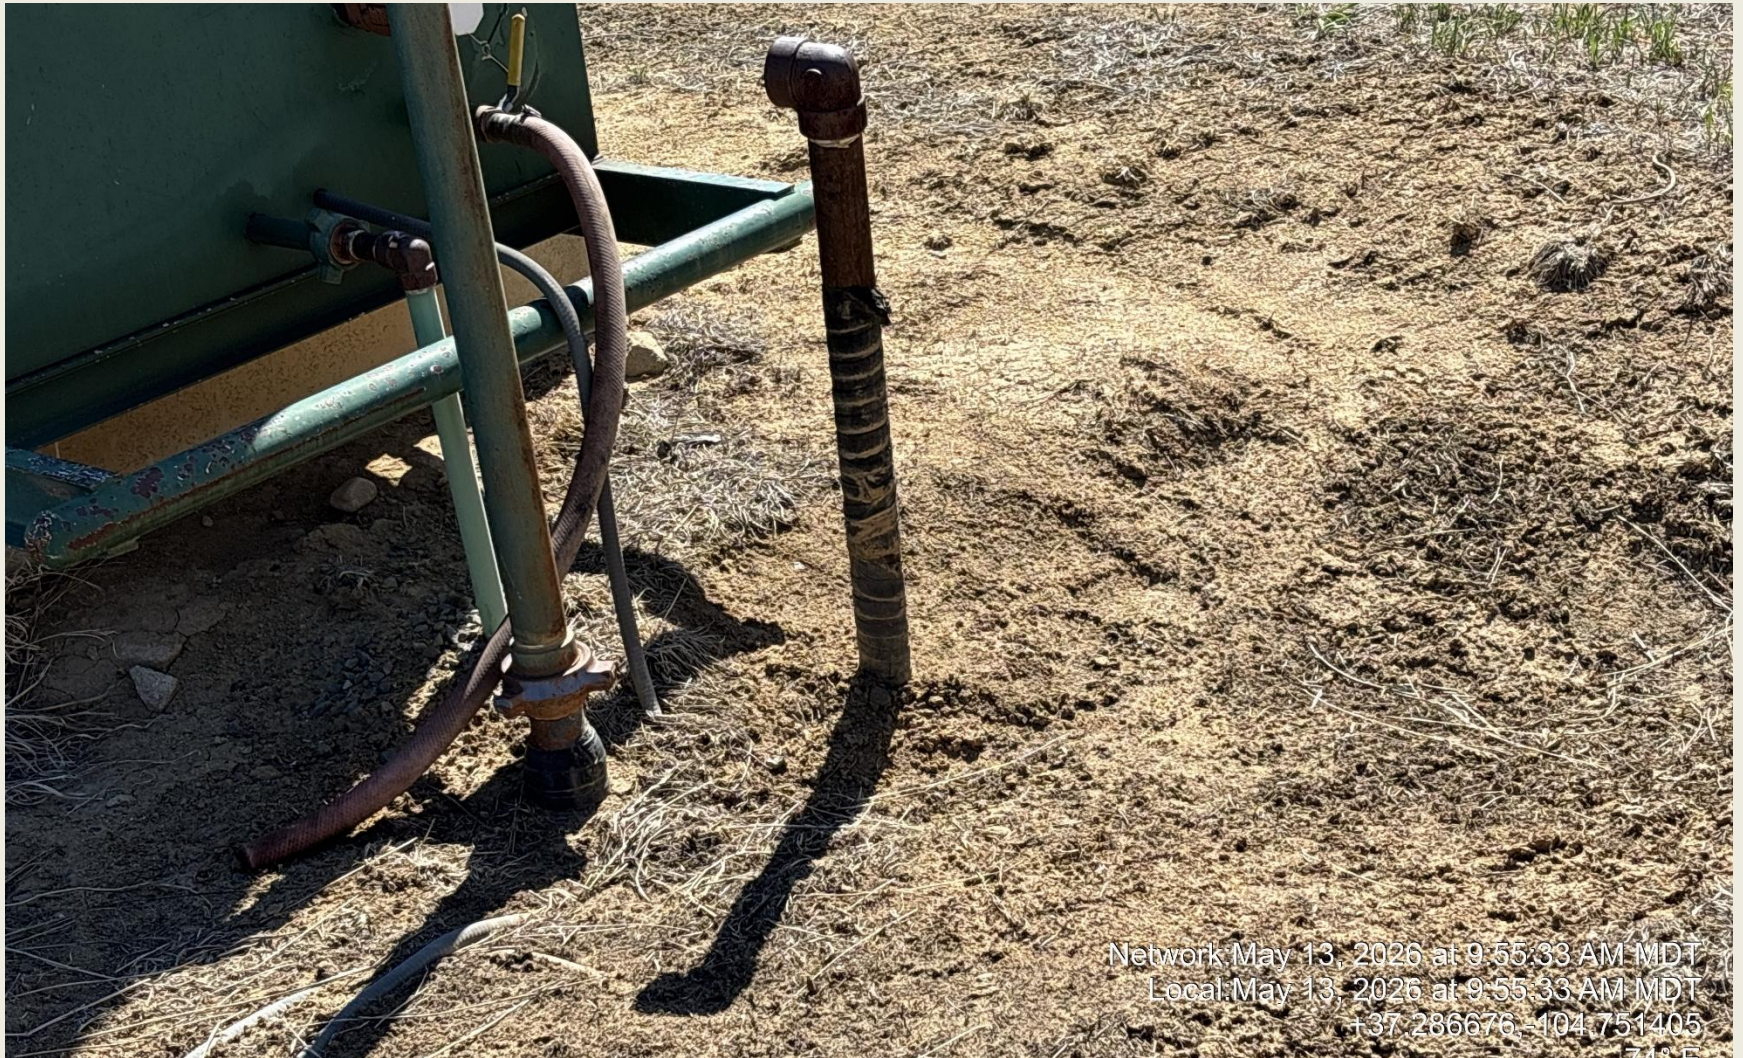
PHOTO 6: UNUSED EQUIPMENT (2" RISER NEAR METER HOUSE NOT LABELED). REMOVE OR LABEL RISERS PER RULE 606. CA DATE 6/13/2026.

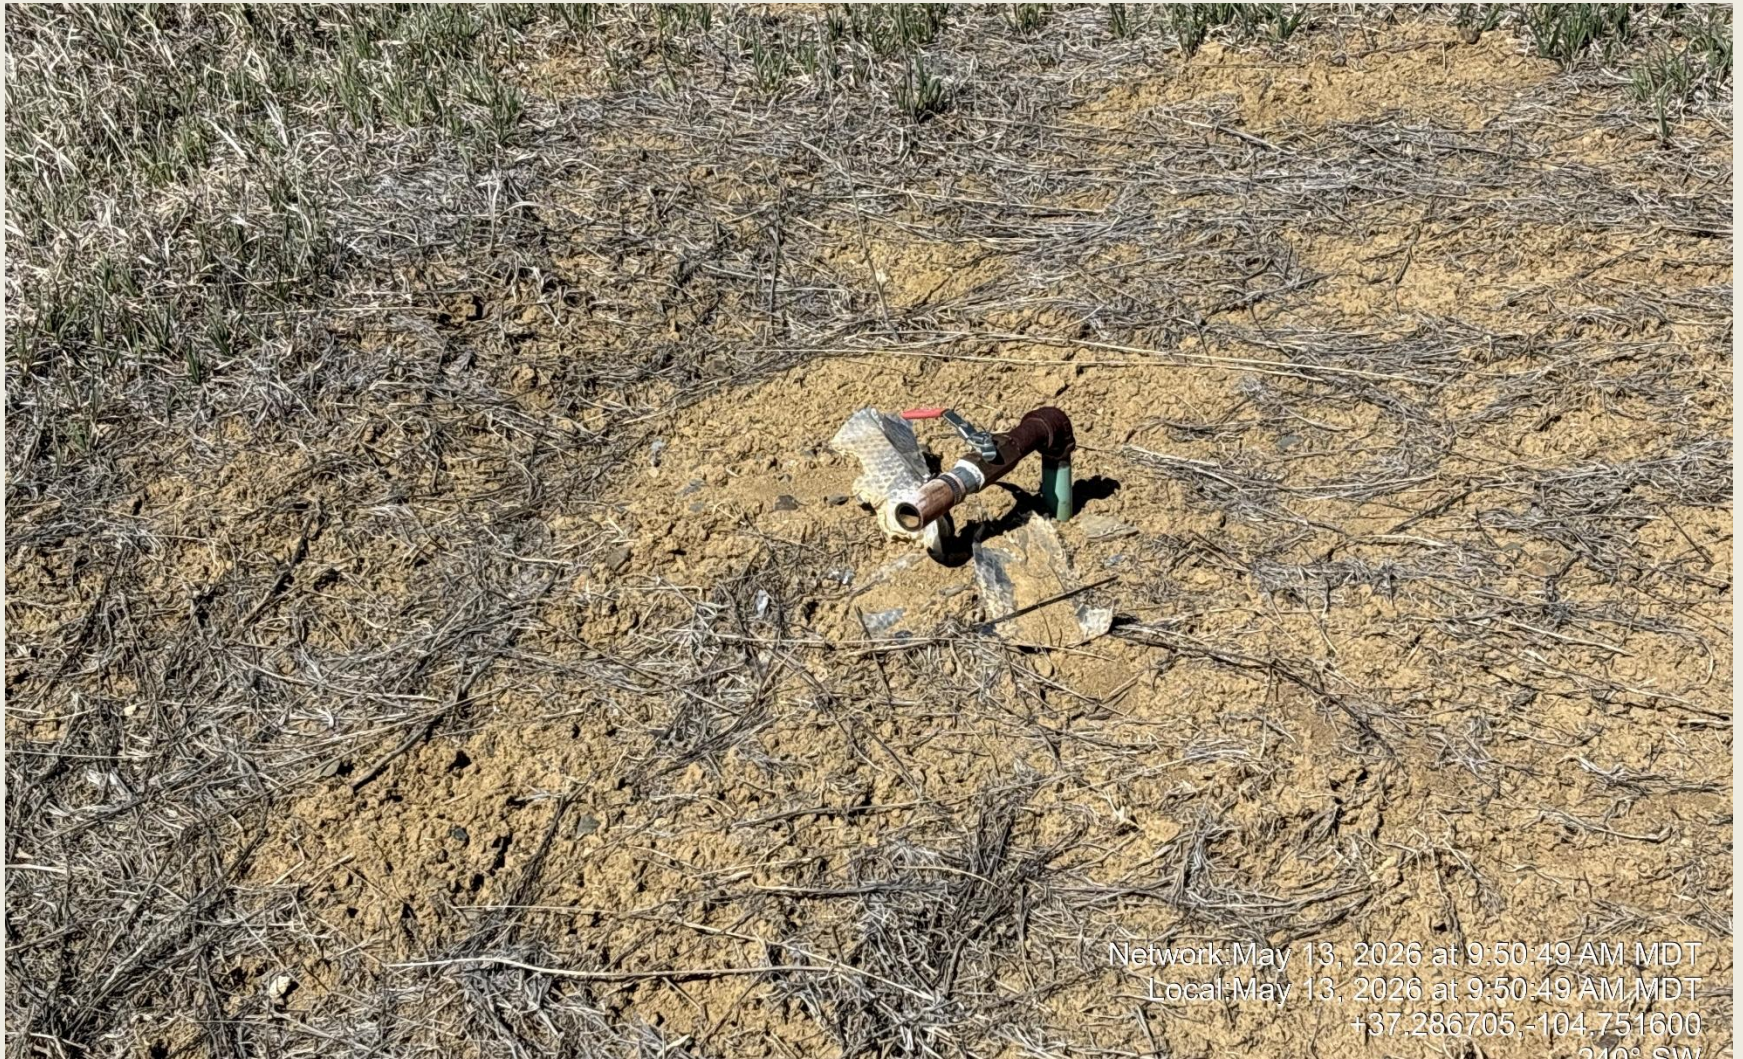
PHOTO 7: UNUSED EQUIPMENT (1" RISER NEAR WELLHEAD NOT LABELED). **REMOVE OR LABEL RISERS PER RULE 606. CA DATE 6/13/2026.**

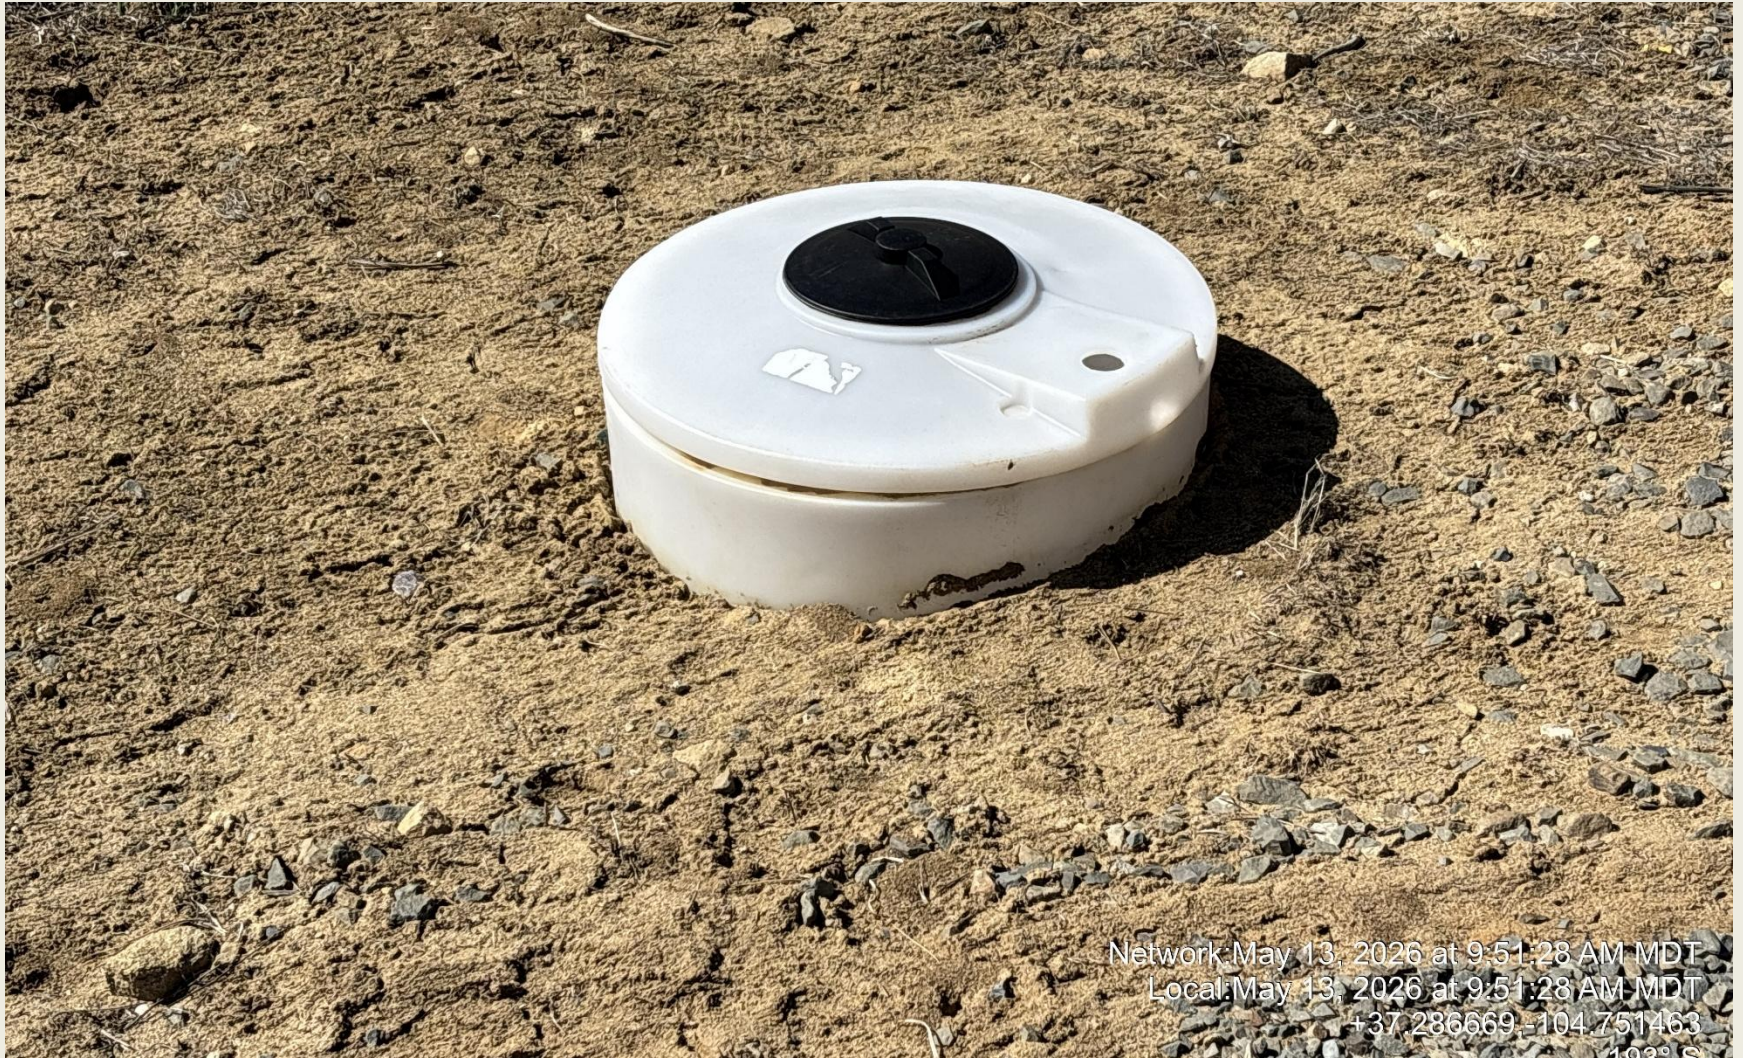
PHOTO 8: UNUSED EQUIPMENT (IN GROUND DRIP TANK NO LONGER IN USE). REMOVE UNUSED EQUIPMENT PER RULE 606. CA DATE 6/13/2026.

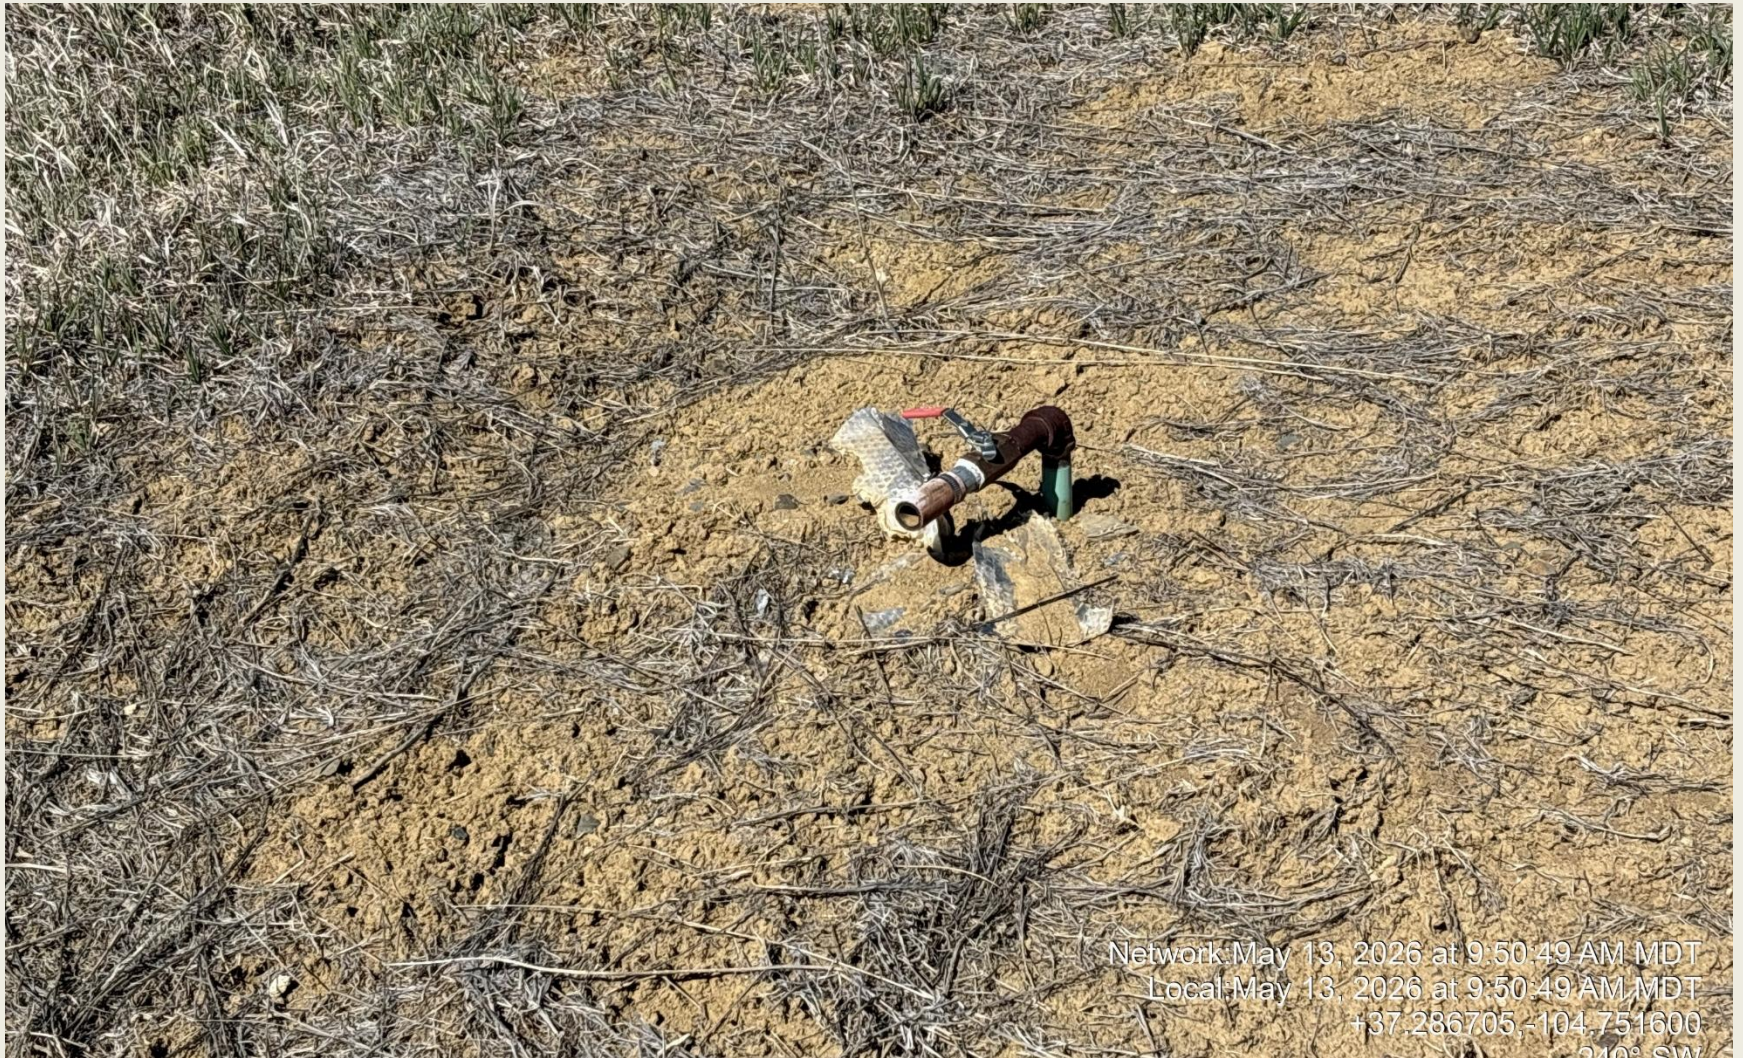
PHOTO 9: SMALL PEACES OF TRASH ALL AROUND WELLHEAD AREA AND SOME AROUND METER HOUSE AREA. POLICE ON AND AROUND LOCATION FOR TRASH PER RULE 606. CA DATE 6/13/2026.

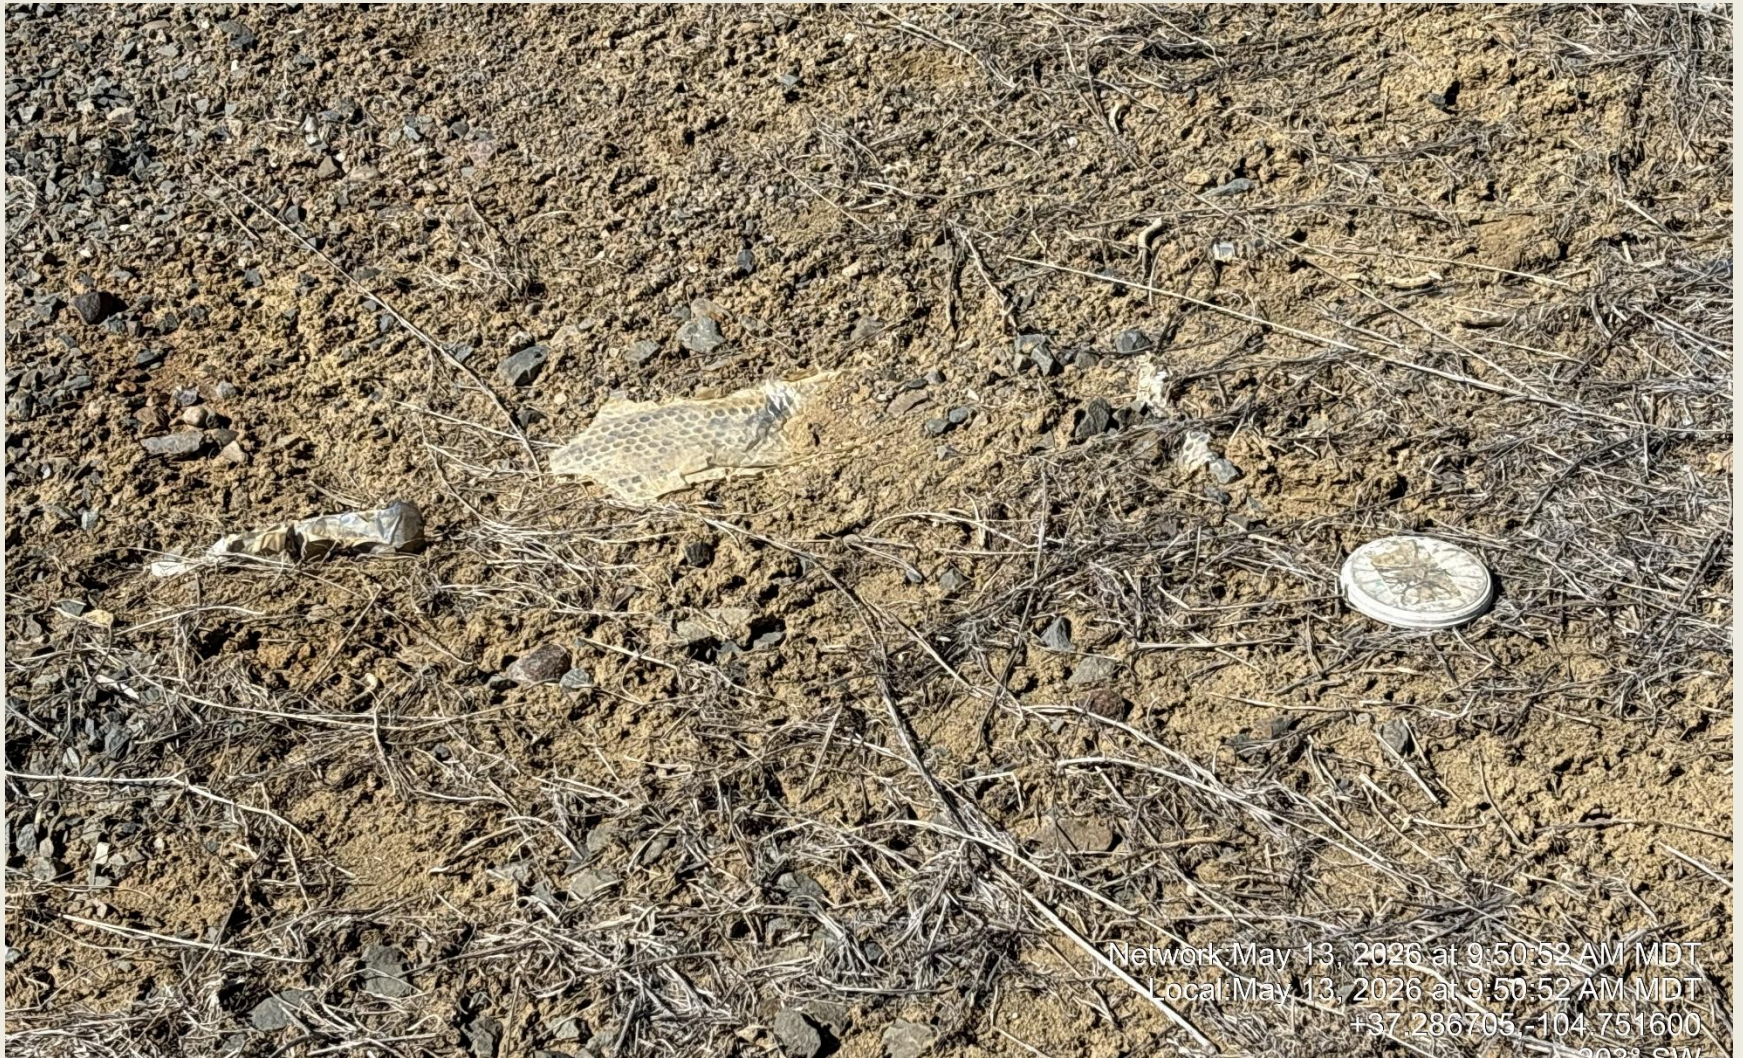
PHOTO 10: SMALL PEACES OF TRASH ALL AROUND WELLHEAD AREA AND SOME AROUND METER HOUSE AREA. POLICE ON AND AROUND LOCATION FOR TRASH PER RULE 606. CA DATE 6/13/2026.

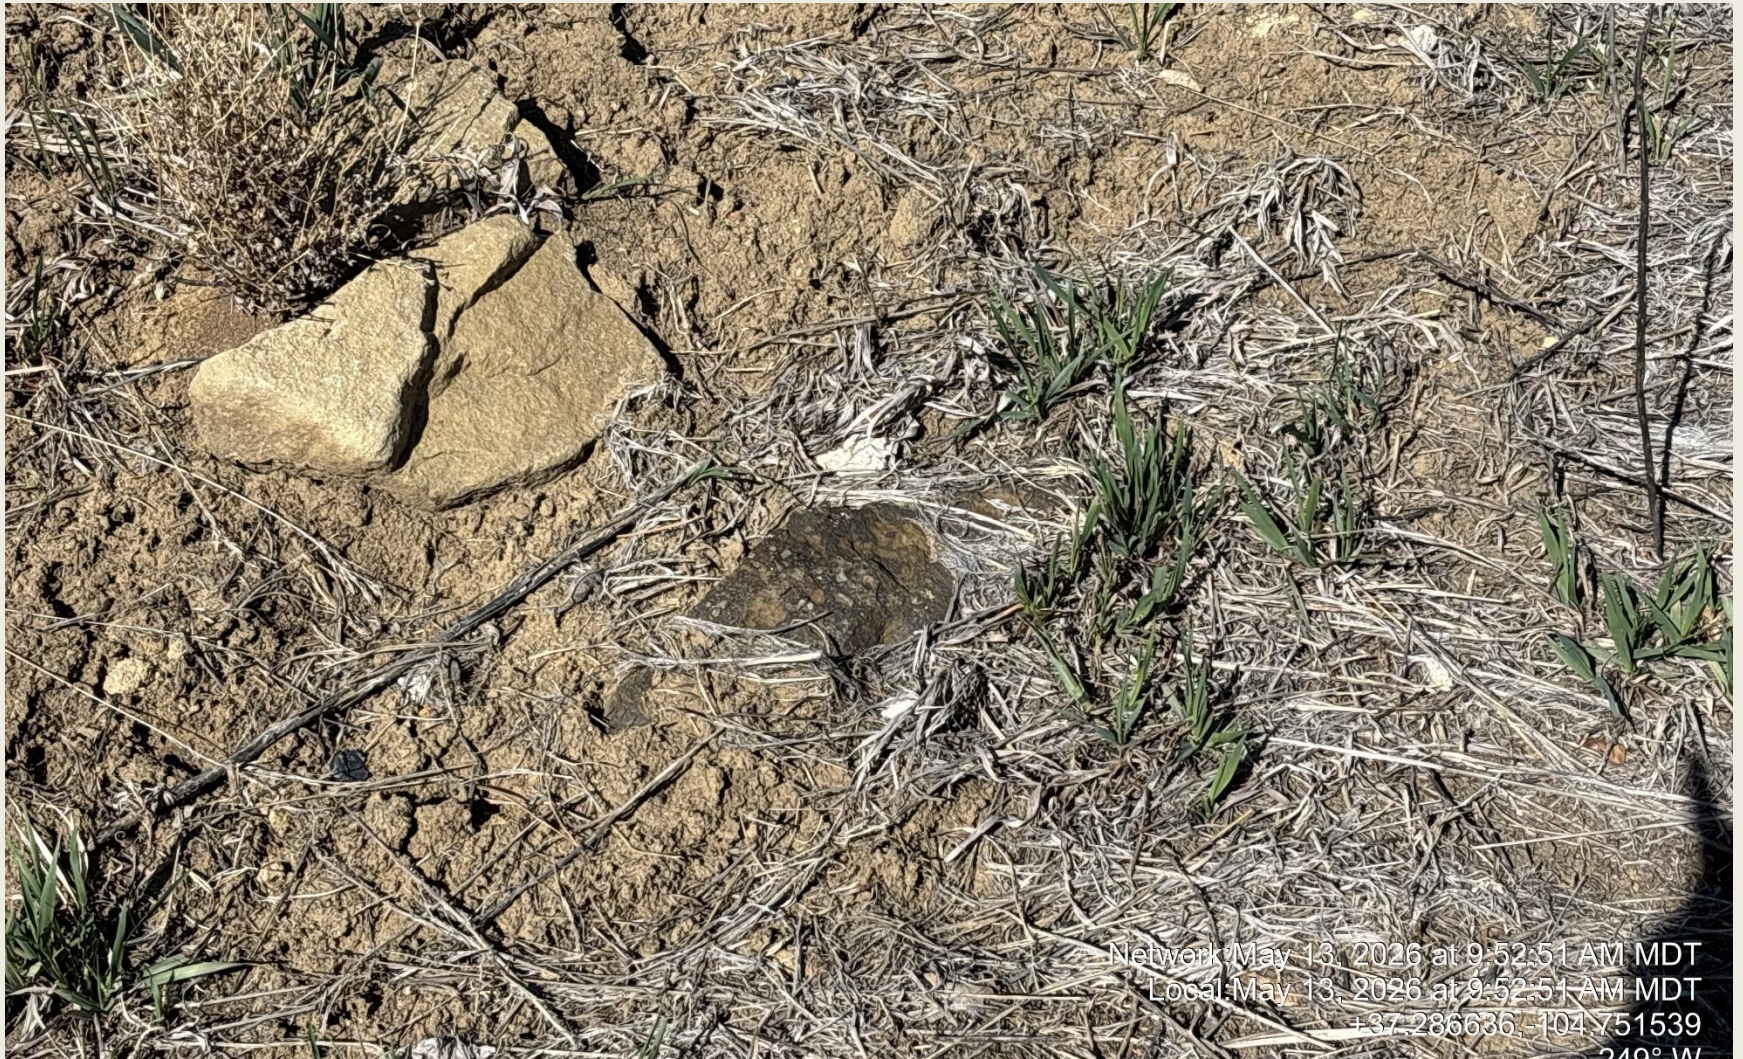
PHOTO 11: SMALL PEACES OF TRASH ALL AROUND WELLHEAD AREA AND SOME AROUND METER HOUSE AREA. **POLICE ON AND AROUND LOCATION FOR TRASH PER RULE 606. CA DATE 6/13/2026.**

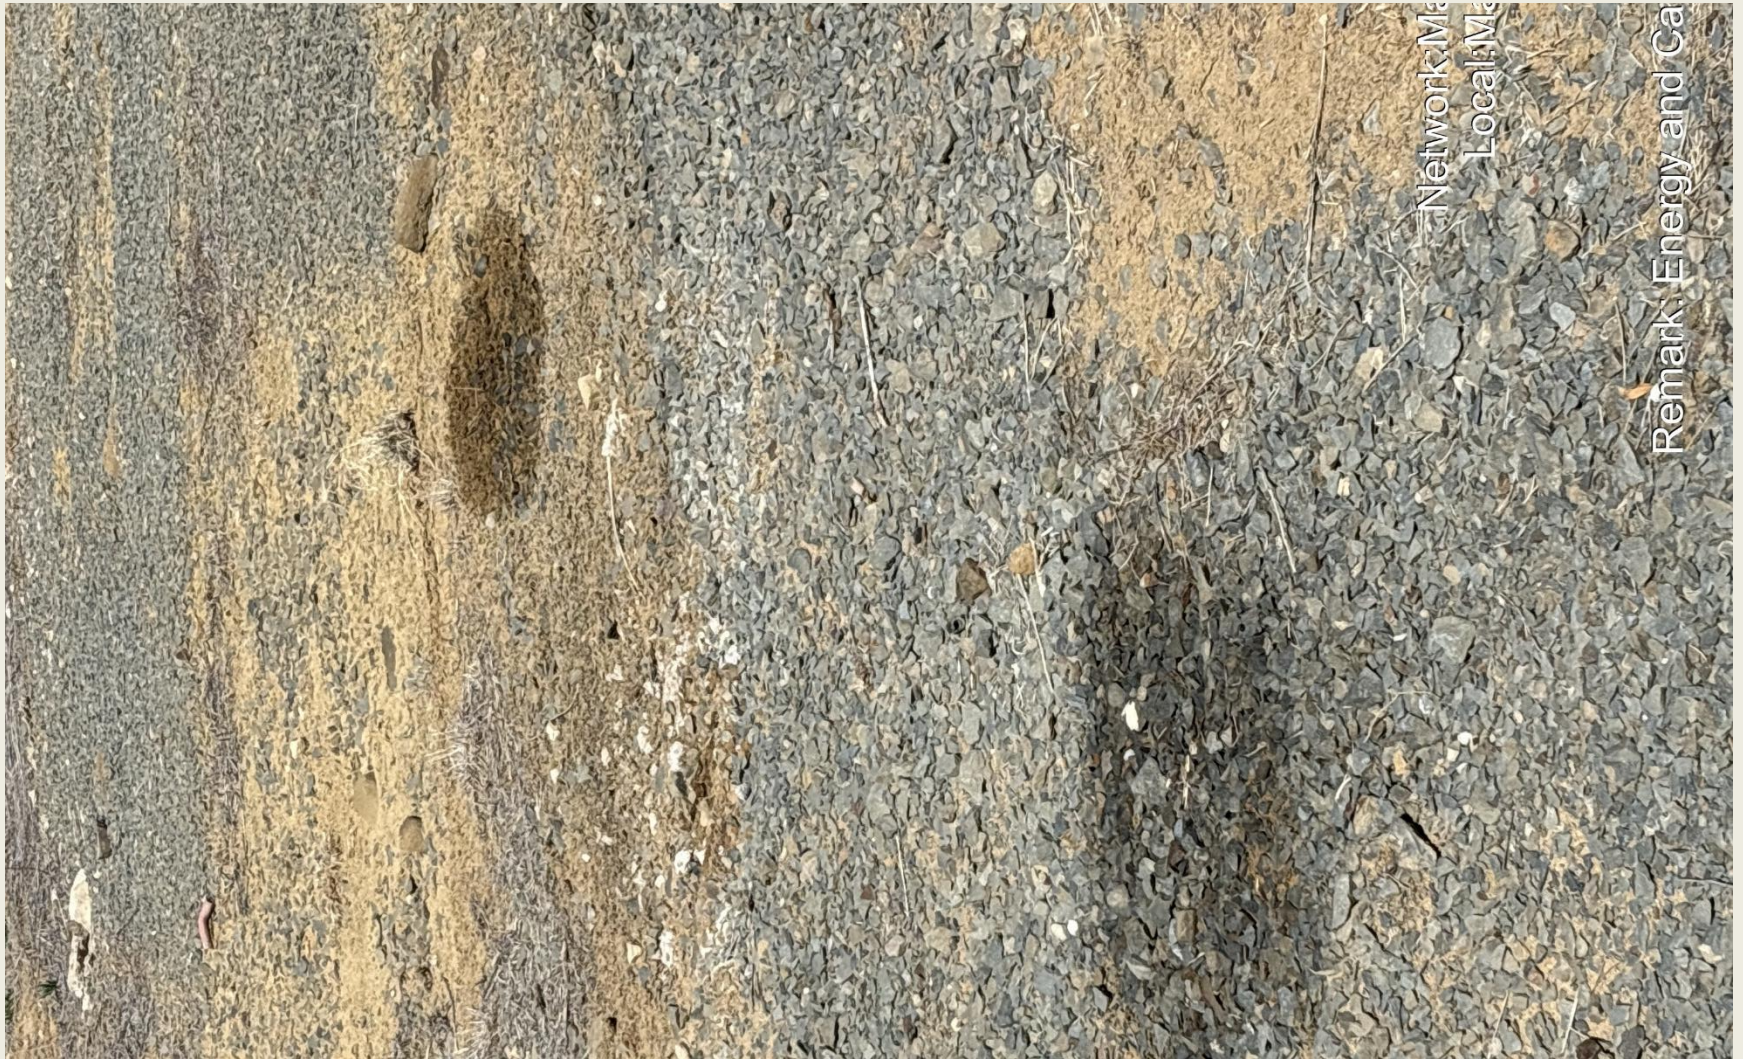
PHOTO 12: AREA OF IMPACTED SOIL NEAR WELLHEAD. Cleanup stained material and review self inspection processes. COMPLY WITH RULE 1002,.(2).D. CA DATE 6/13/2026.

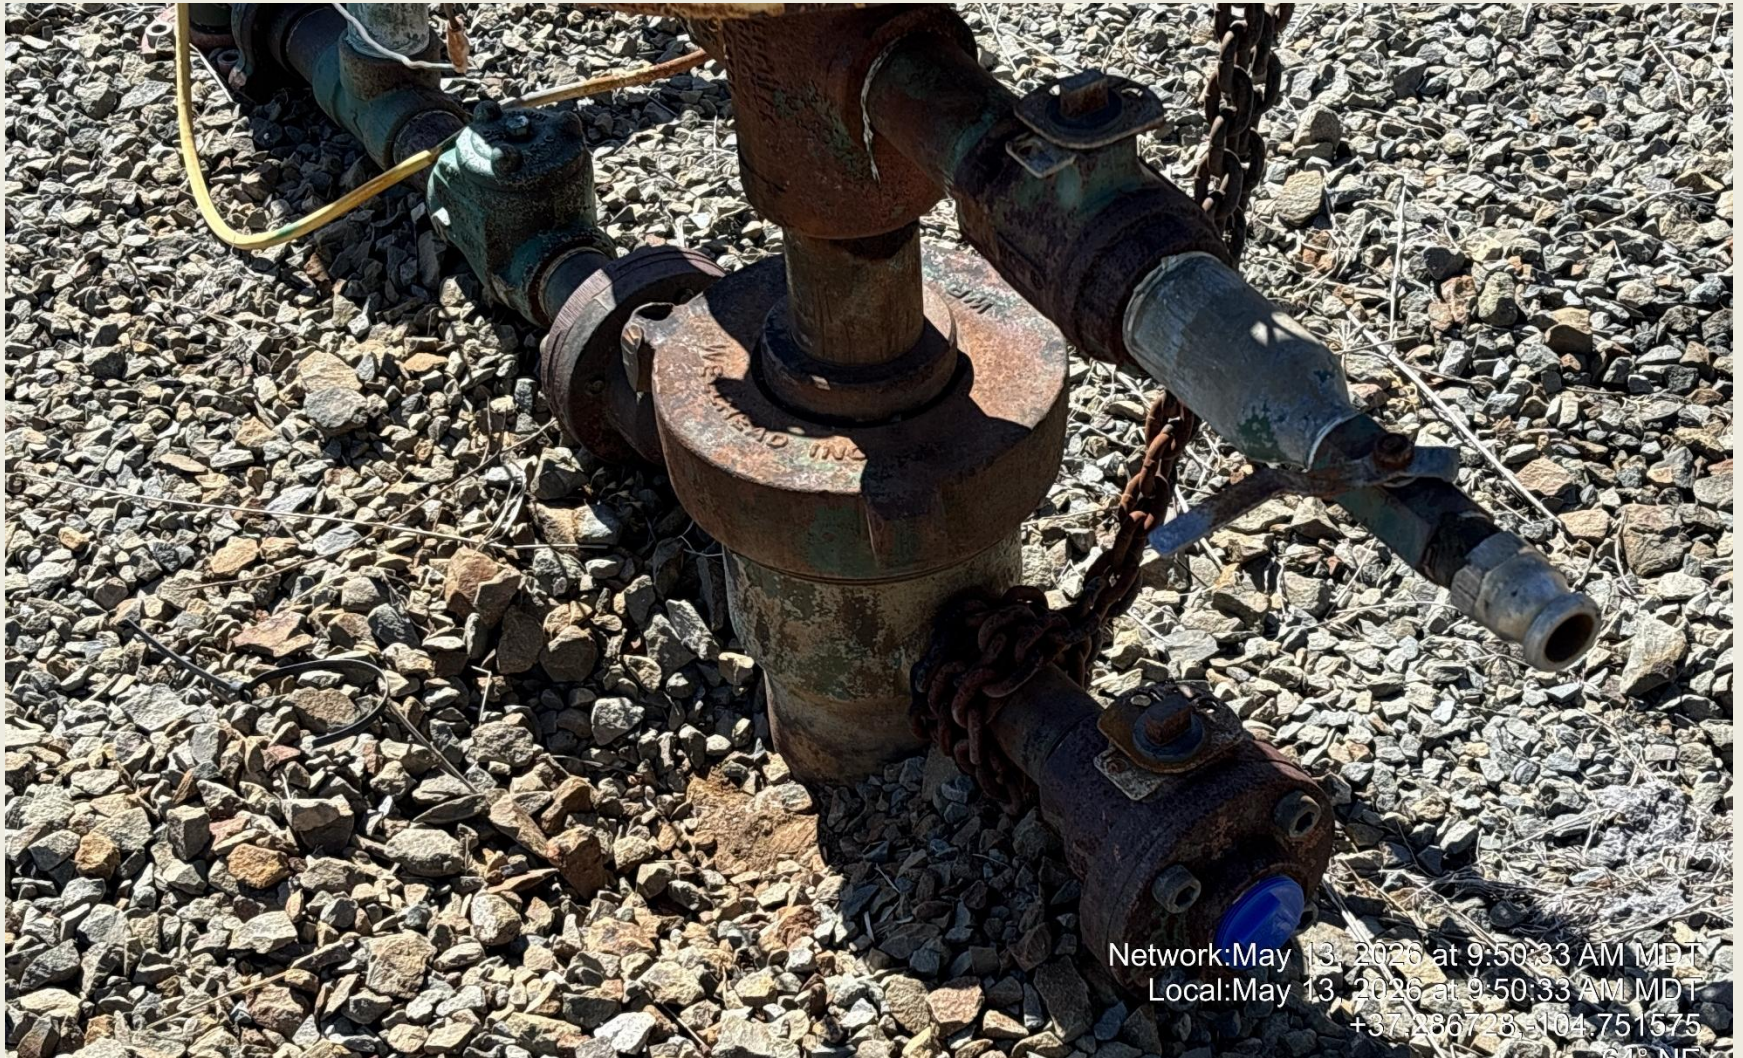
PHOTO 13: Bradenhead inaccessible or not visible. Install appropriate fittings to allow bradenhead visual inspection as per Rule 419.a.(1), (2). ALL WELLS SHOULD HAVE ACCESS TO BRHD BY NOW CA DATE 5/15/2026.
