# Inspection Photos

Operator: Chevron USA Inc #16700

Location ID: 314518

Inspection Doc: 719201169

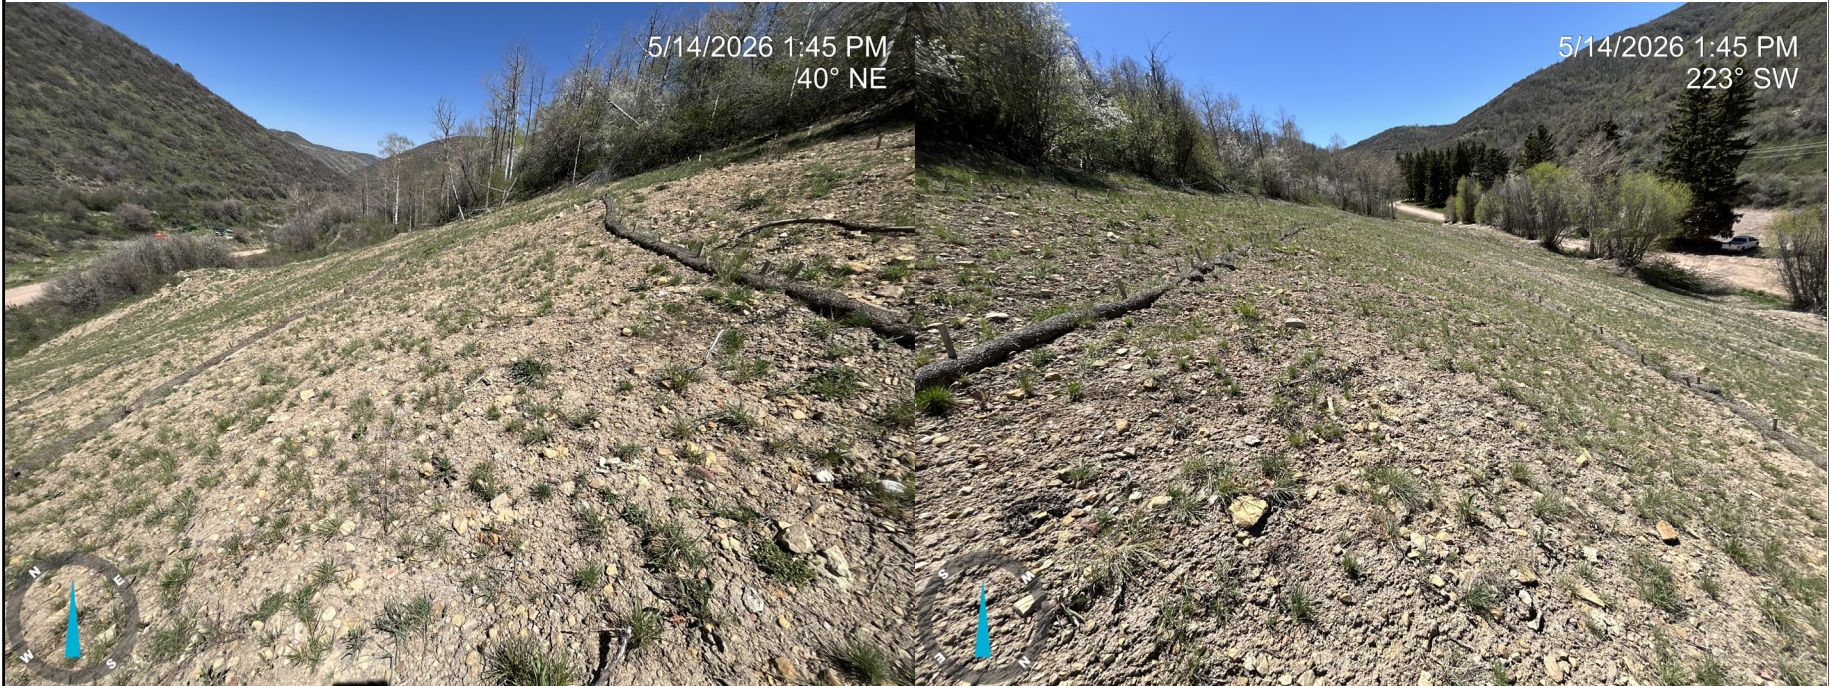
**Photo 1:** Photos showing an overview of the location looking northeast and southwest, respectively.

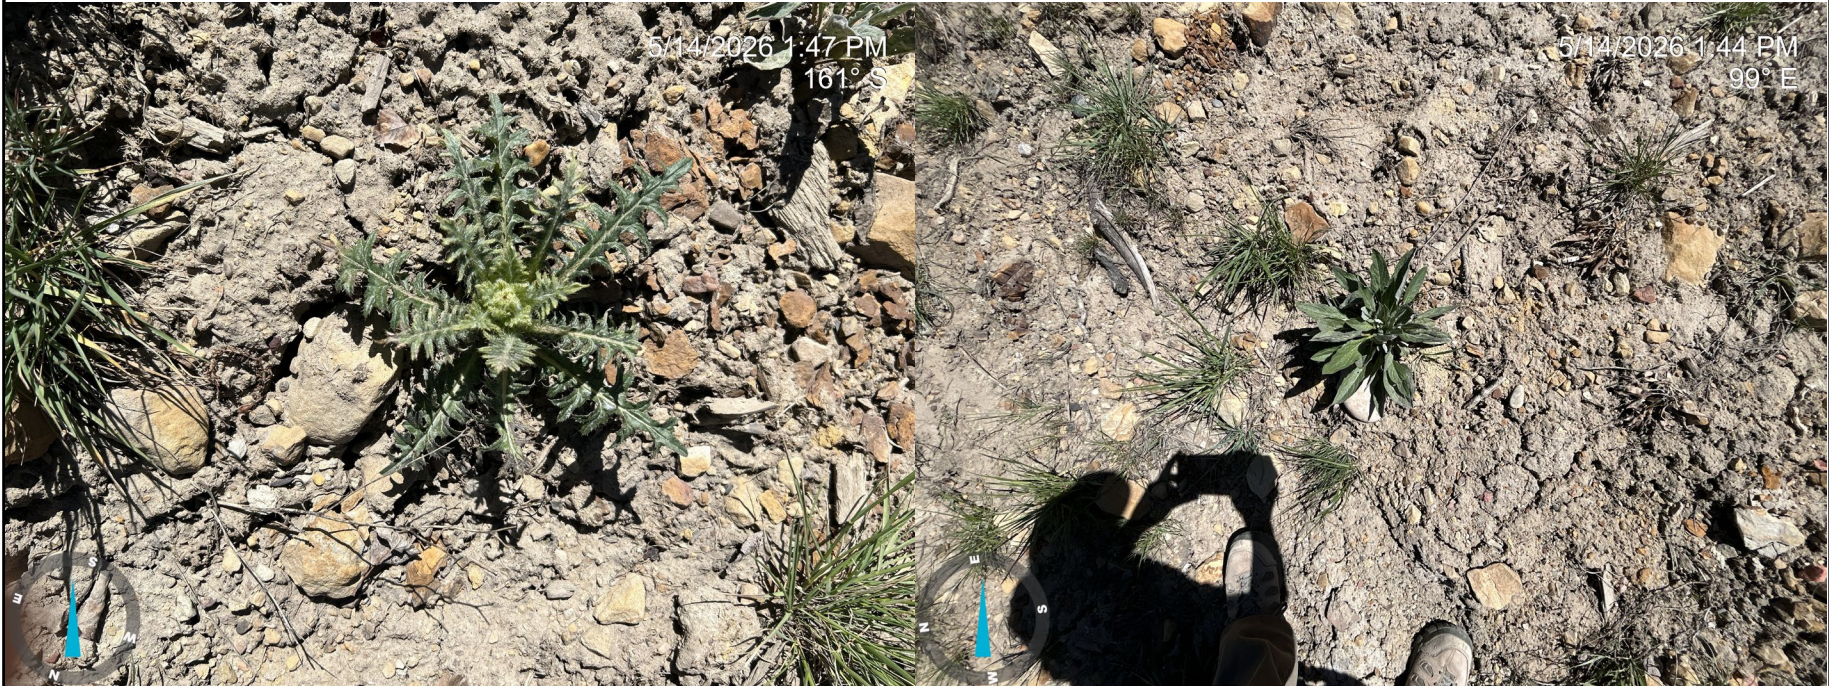
**Photo 2:** Photos showing a thistle rosette and a houndstongue rosette, both present in trace amounts. Weed control is not required at this time; however, ongoing weed monitoring and maintenance is necessary at the location.

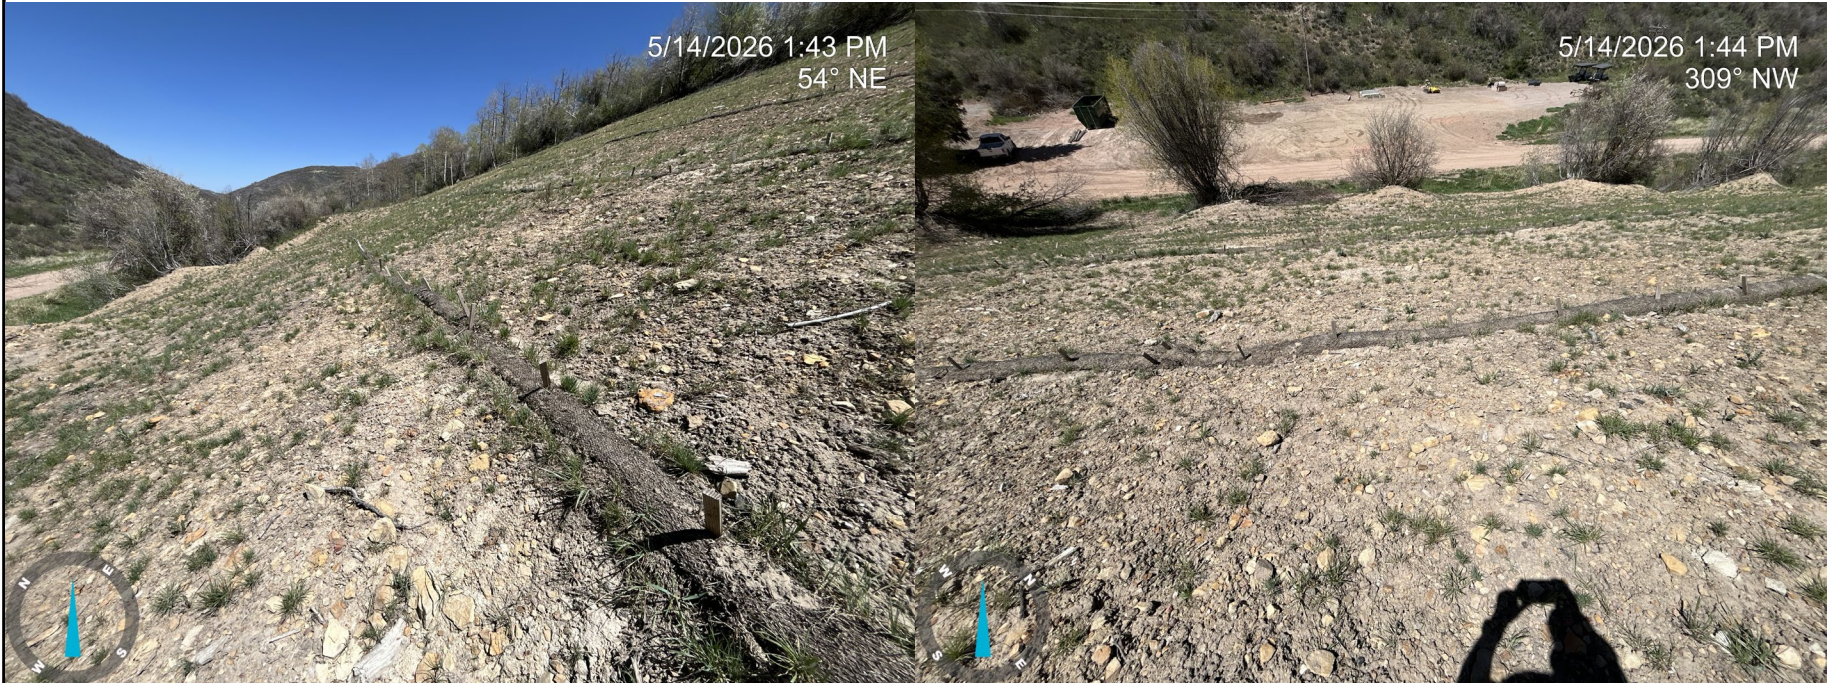
**Photo 3:** Photos showing wattle maintenance has been performed at the location. The Corrective Action from inspection #719200441 has been resolved.

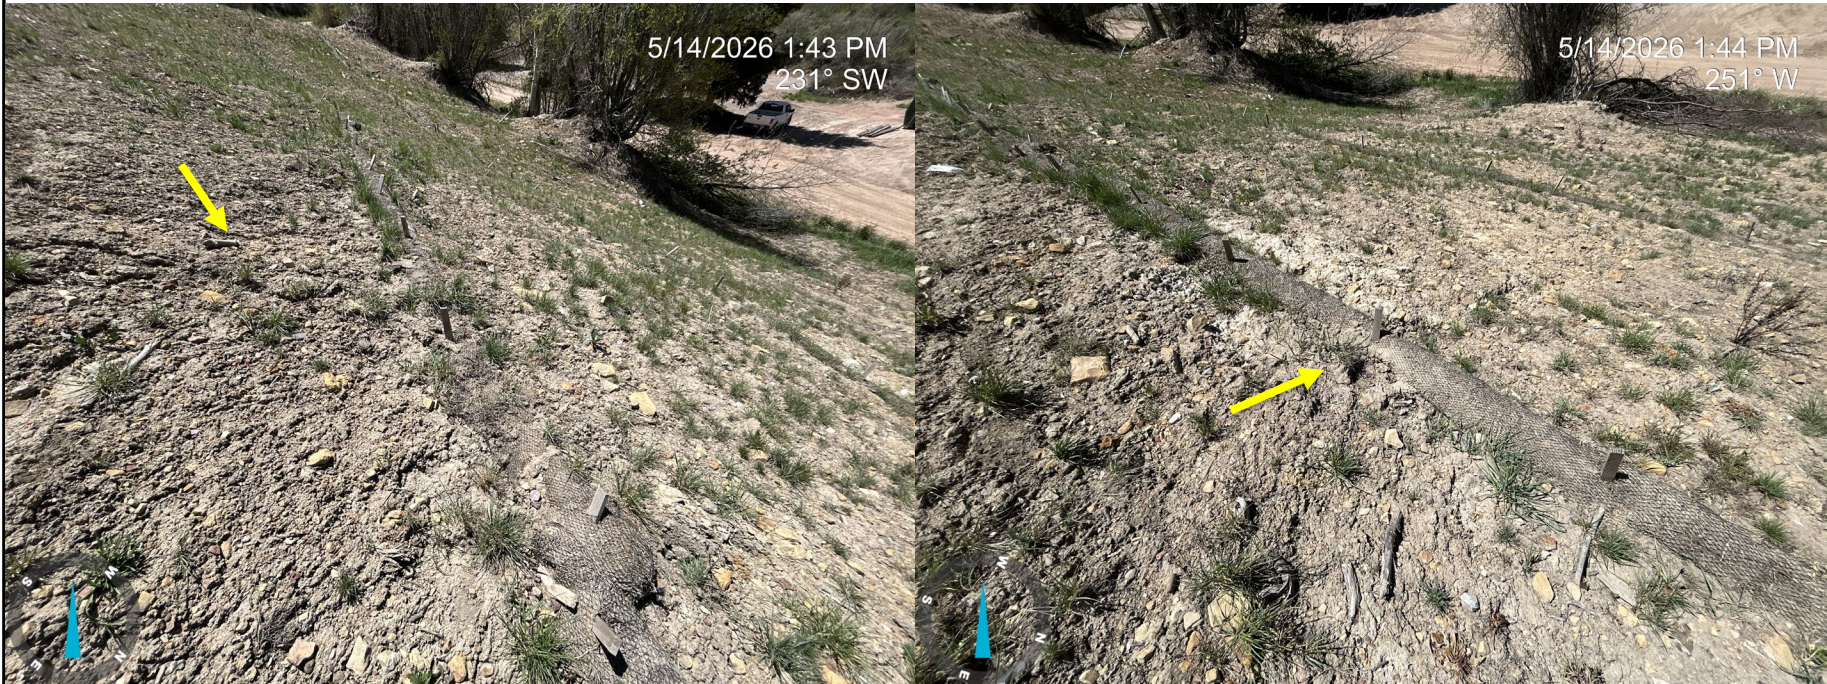
**Photo 4:** Rilling and erosion, wattles overtopped with sediment and soil piping occurring at wattles on the northwest portion of the location. Maintenance is required. Comply with 1002.f.

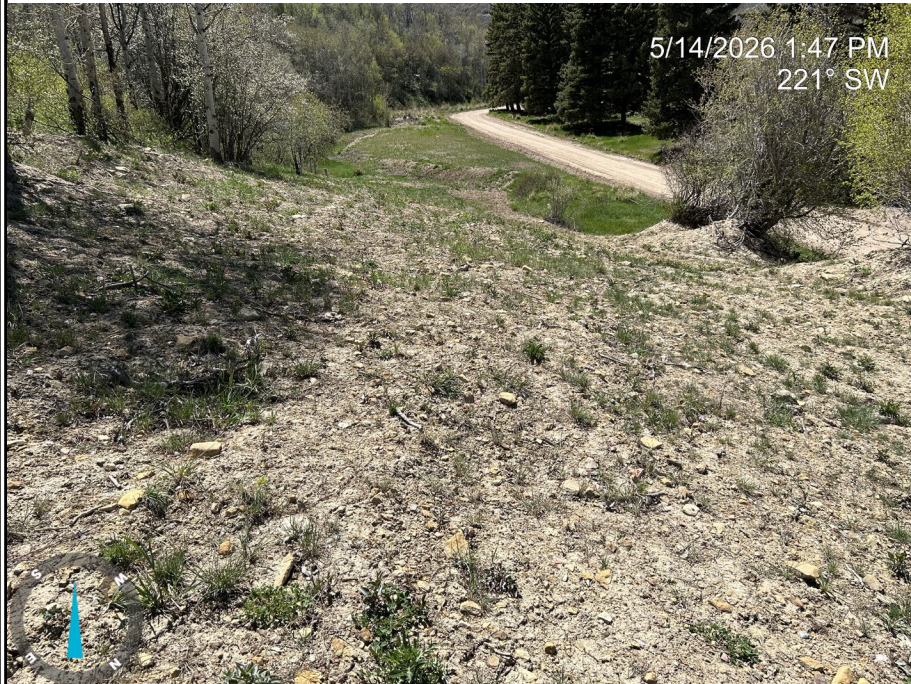
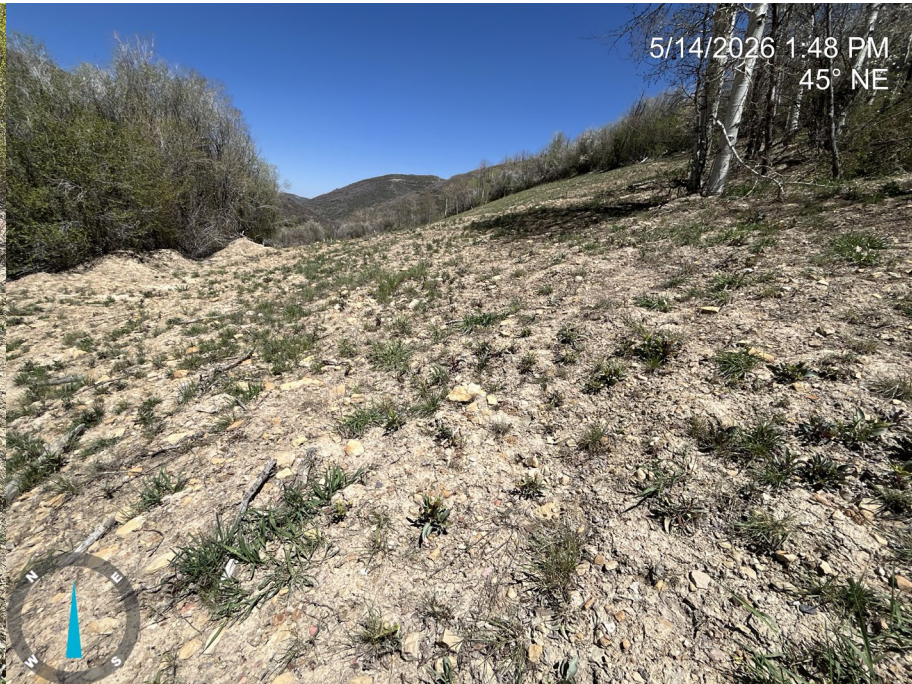
**Photo 5:** Photos showing an overview of the reclaimed access road leading to the location.
