# ECMC Inspection Photos - KP Kauffman

Location: Facility 5 @ RMFC #9

Date 05/19/2026

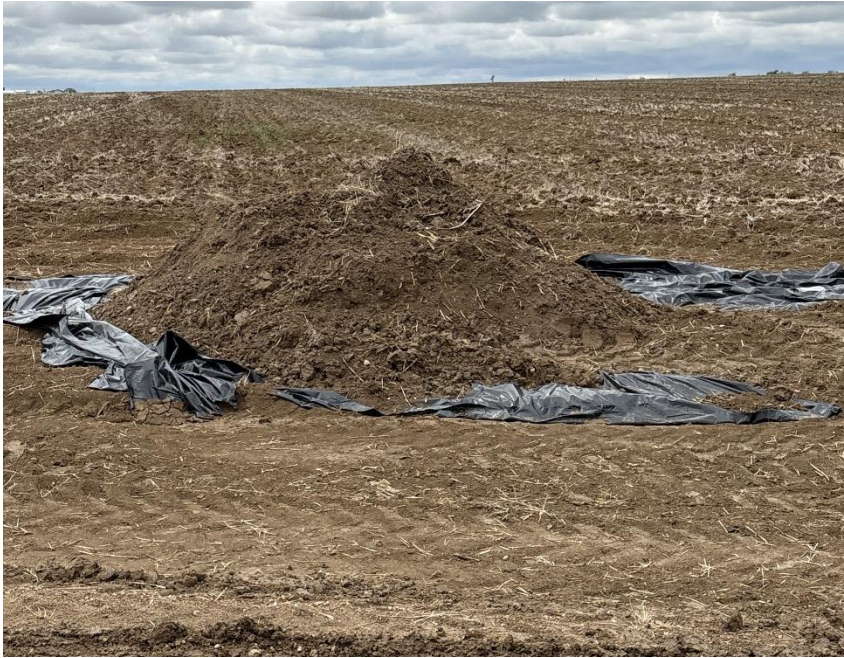
**KPK Facility 5 @ RMFC 9 spill/ release @ 40.07189, -104.89526**  
**Impacted soils stockpile**

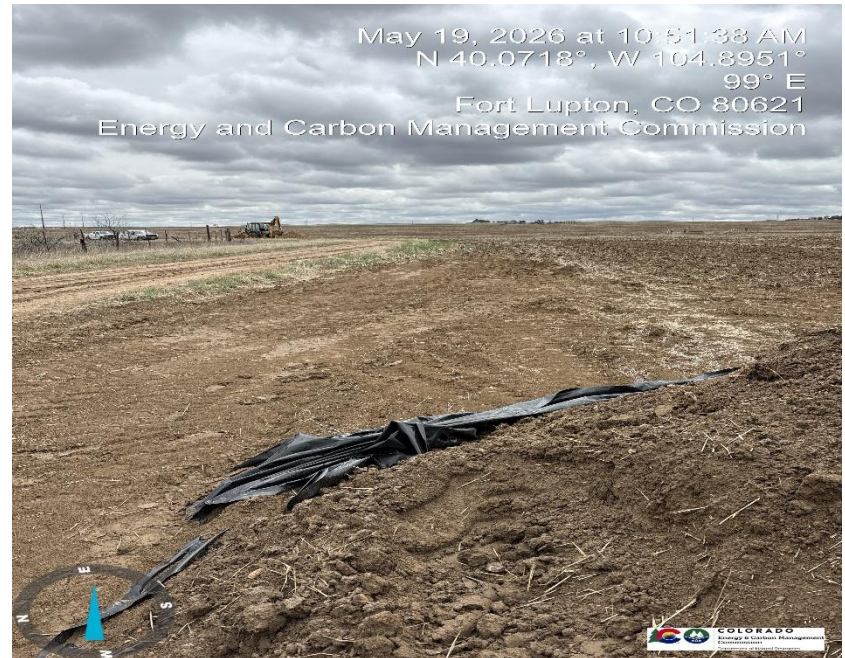
**View looking east from spill/ release point and soils**  
**stockpile toward KPK field personnel working at the eastern**  
**bell hole excavation.**

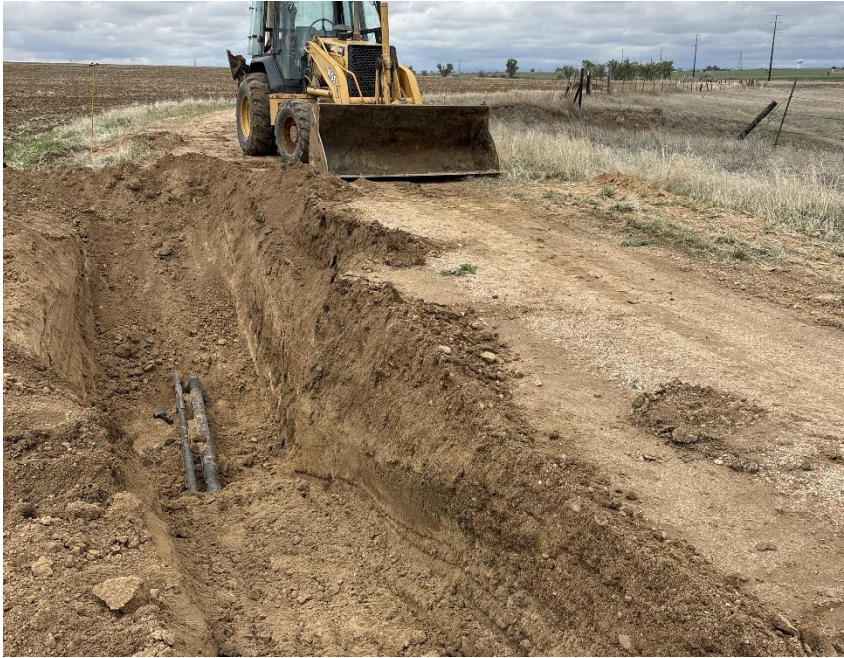
Eastern bell hole excavation exposing (1) 4" CS and (1) 2" CS off location flowlines approximately 350' east of spill/ release point @ 40.07180, -104.8940.

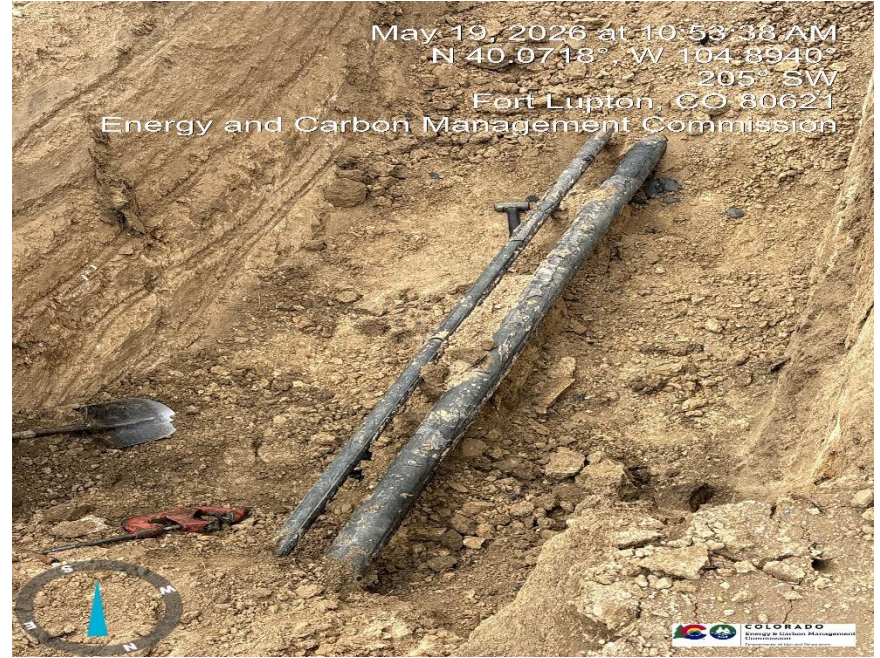
Closer view of (2) flowlines exposed in excavation
