Inspection Photos

Loc# 307407

Operator: OGRIS OPERATING LLC

Inspection Date: 5/21/2026

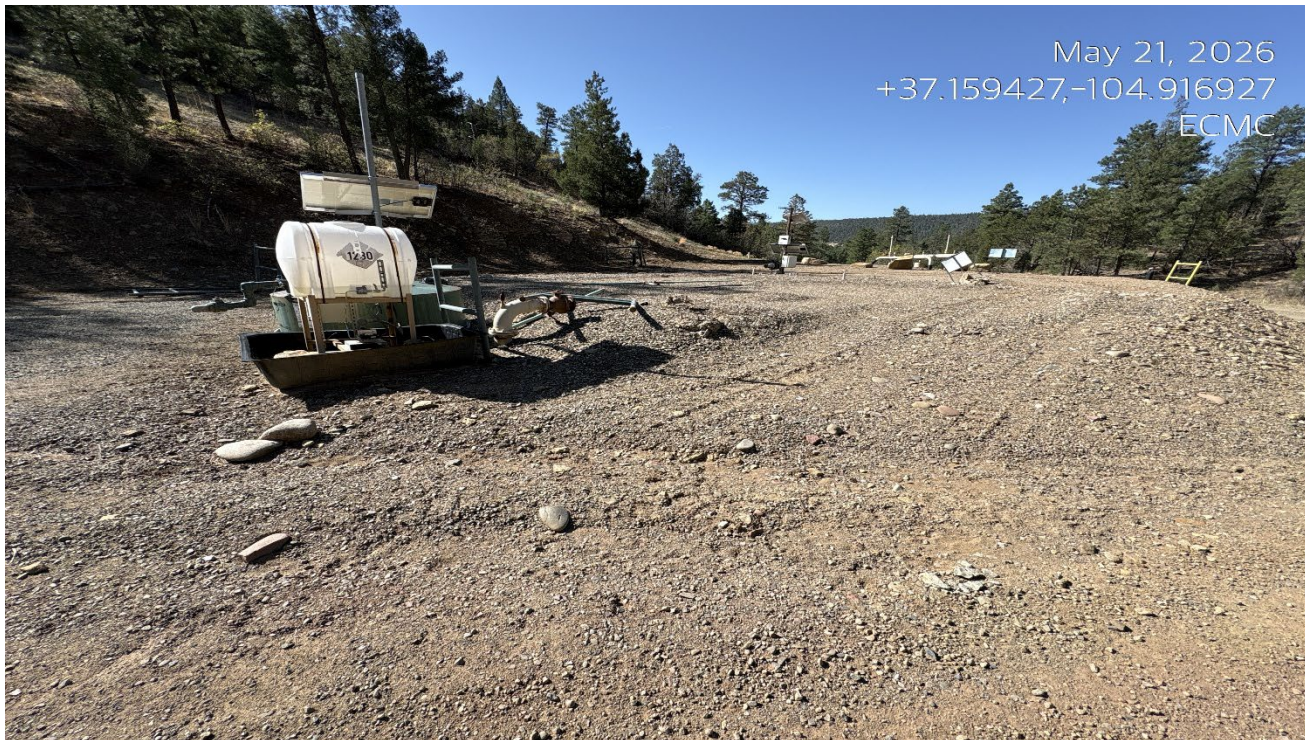
Photo 1. Facing southeast toward the GE 9 compressor station. The compressor has been removed. Unused pipe risers and equipment still remain.

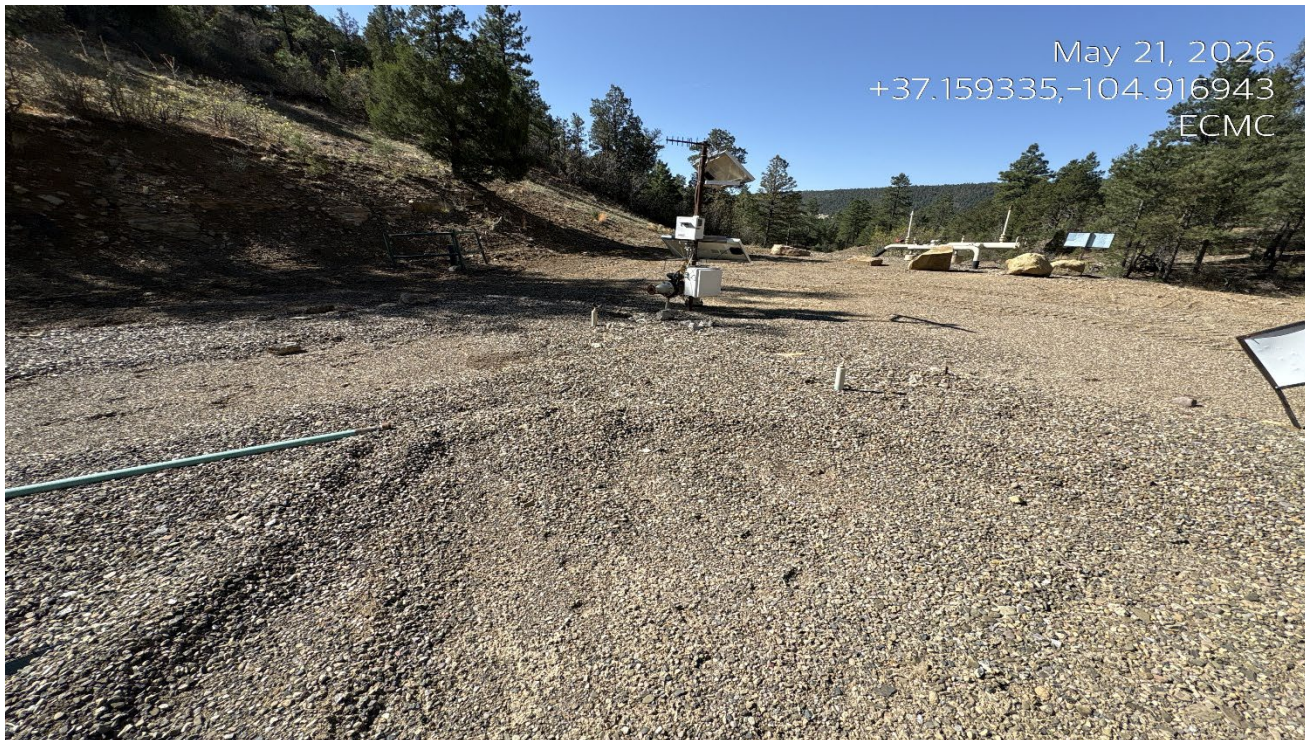
Photo 2. It appears the compressor station has been decommissioned. There is no form 27 for decommission and sampling. All unused pipe risers and equipment need to be removed.

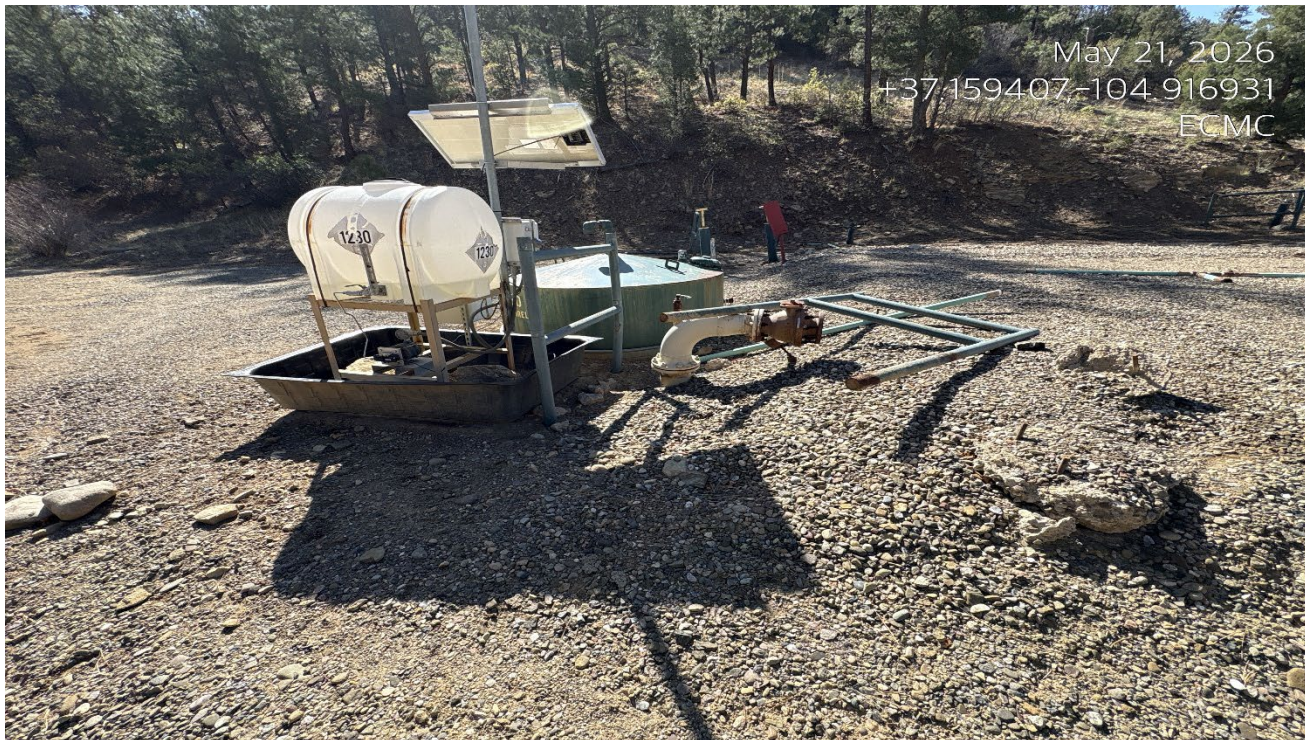
Photo 3. There are tanks and risers that don't appear to be needed or in use and must be removed.

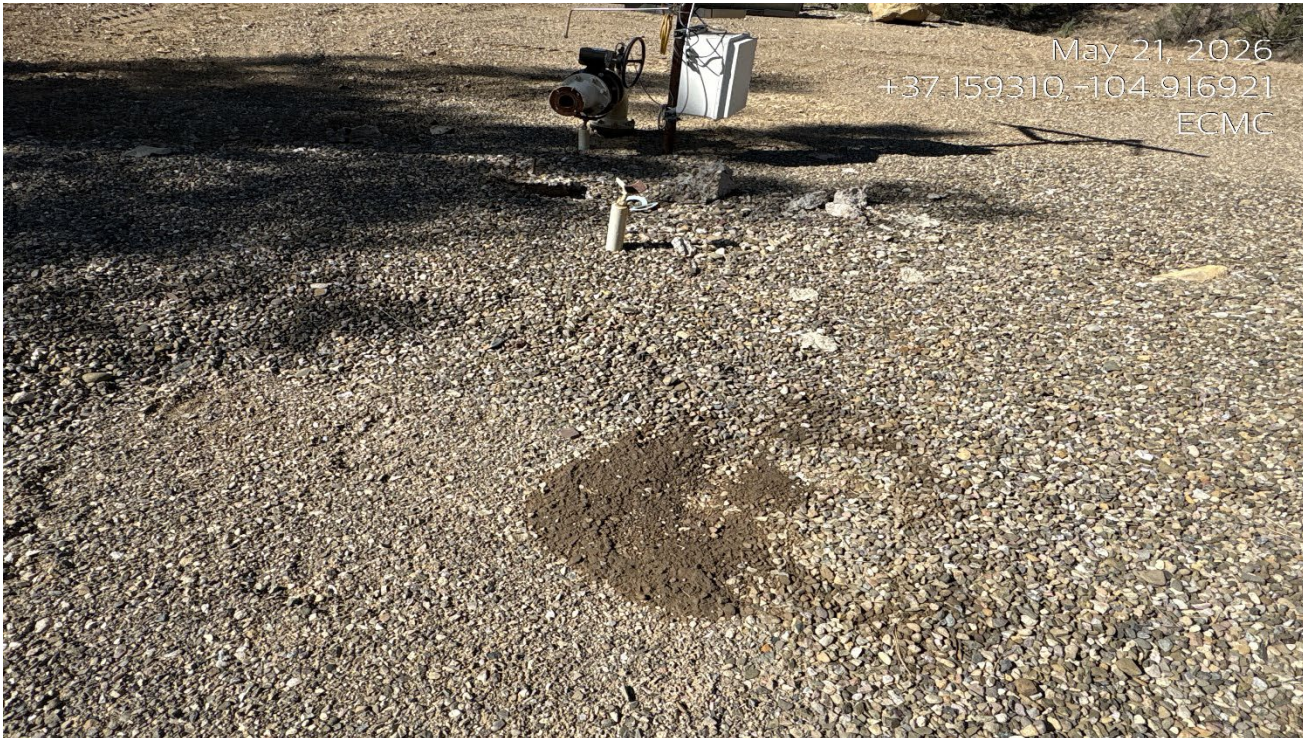
Photo 4. There is oil stained soil that needs to be cleaned up.
