# Inspection Photos

Operator: Wesco Operating Inc #95520

Location ID: 312871

Inspection Doc: 719201182

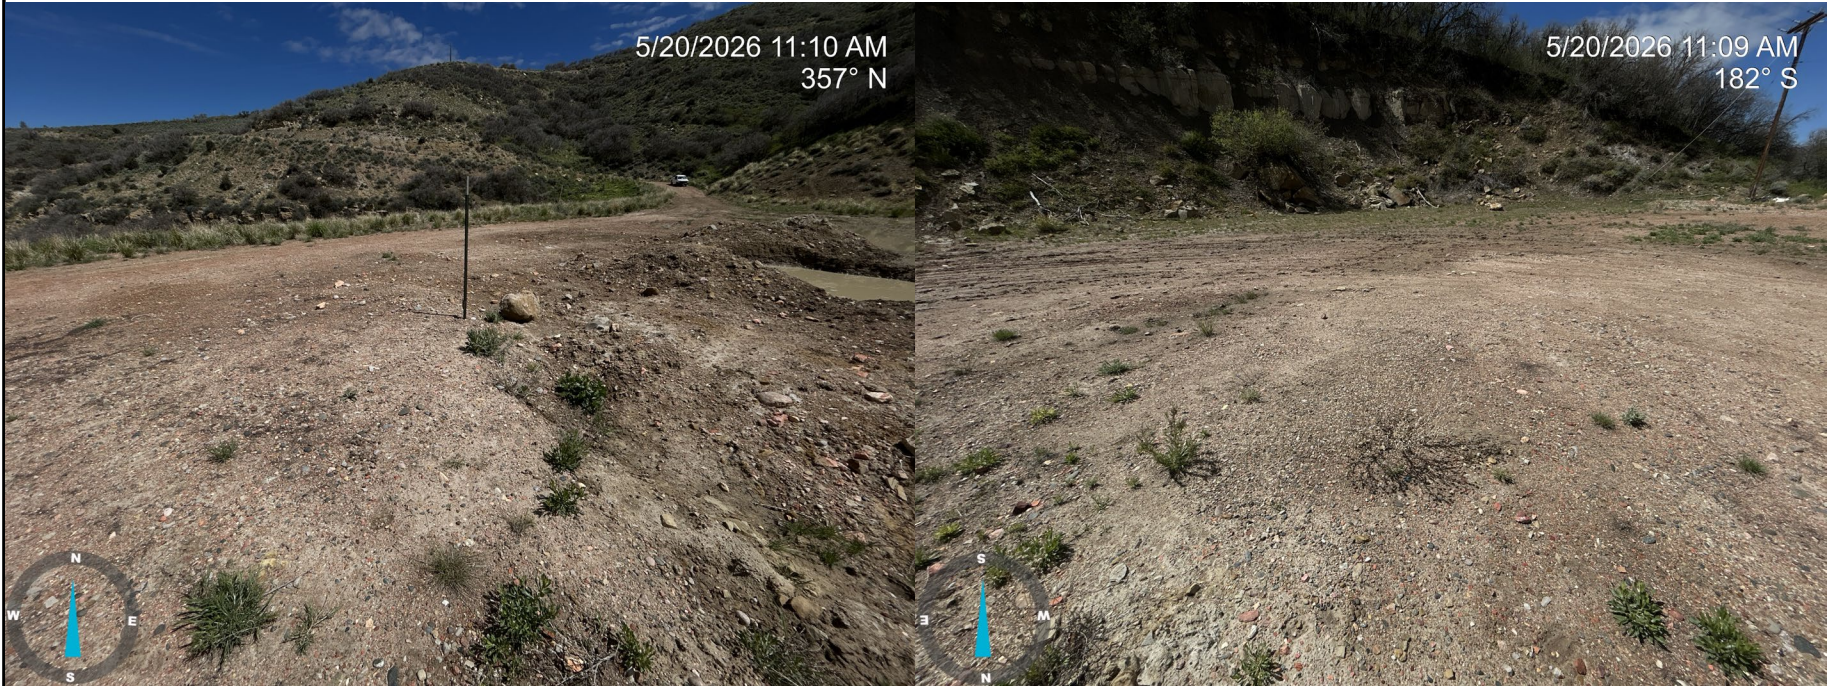
**Photo 1:** Photos showing an overview of the location looking north and south, respectively.

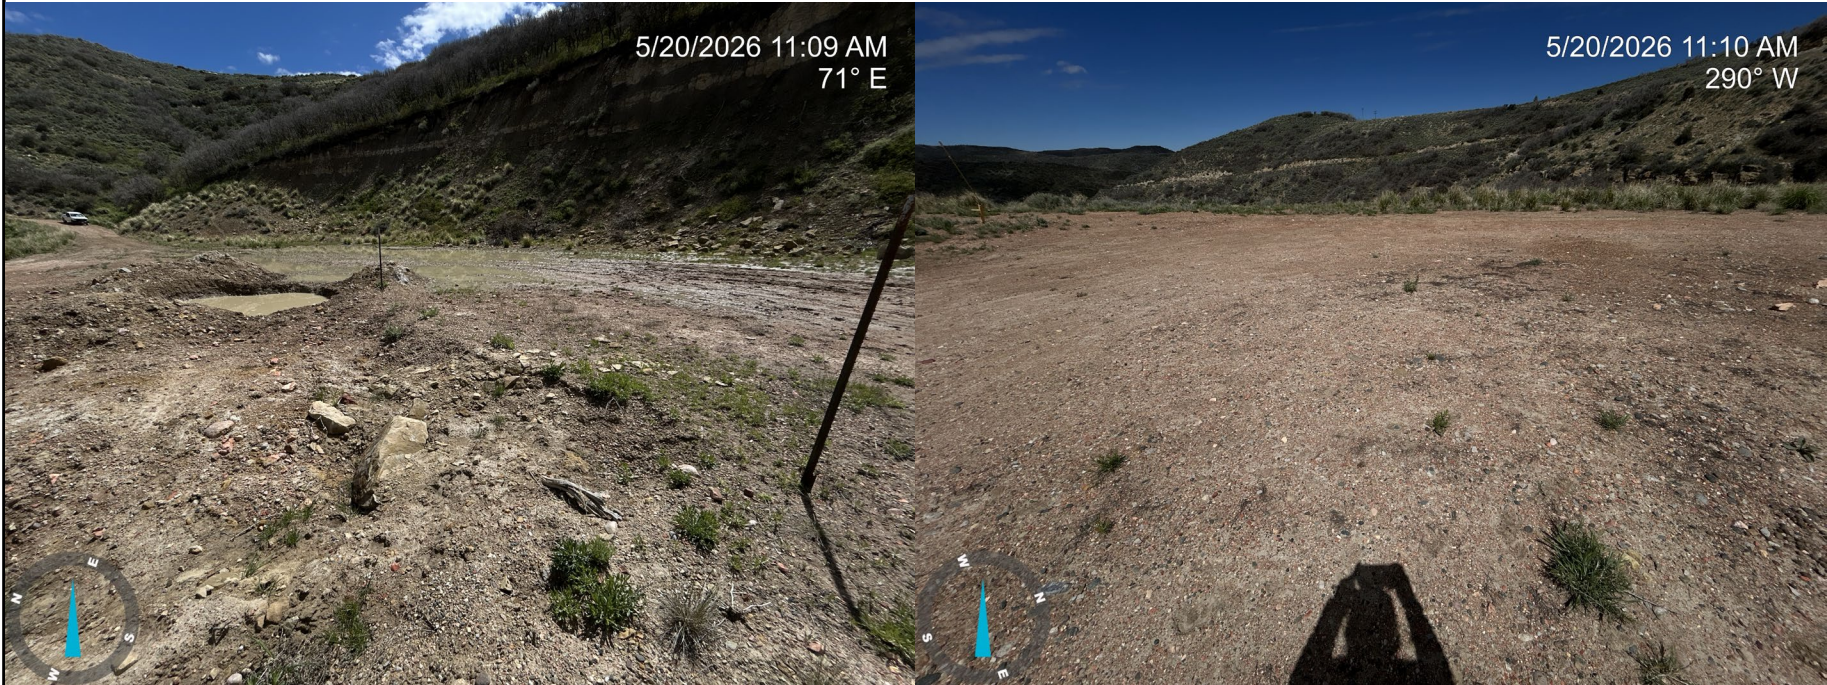
**Photo 2:** Photos showing an overview of the location looking east and west, respectively.

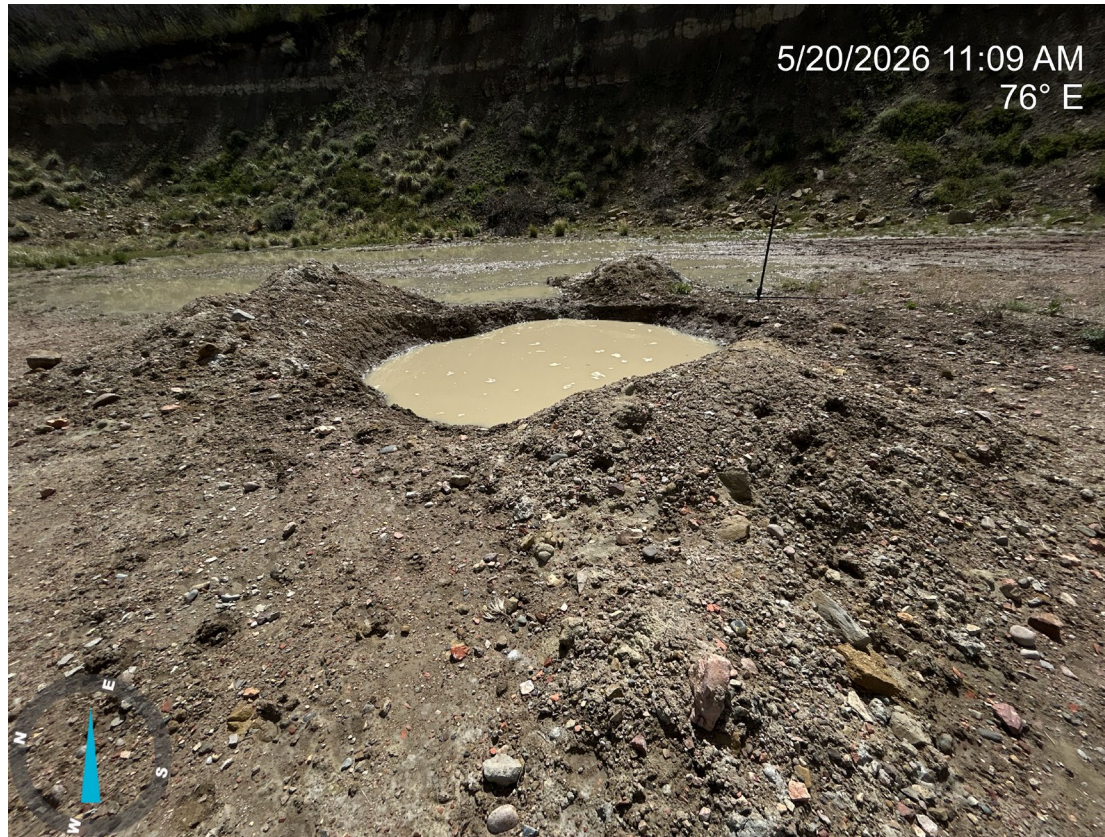
**Photo 3:** Photo showing stockpiled soils around the open excavation appear to lack adequate fencing and stormwater protections; implementation and/or maintenance of wildlife protections and stormwater BMP's is required.

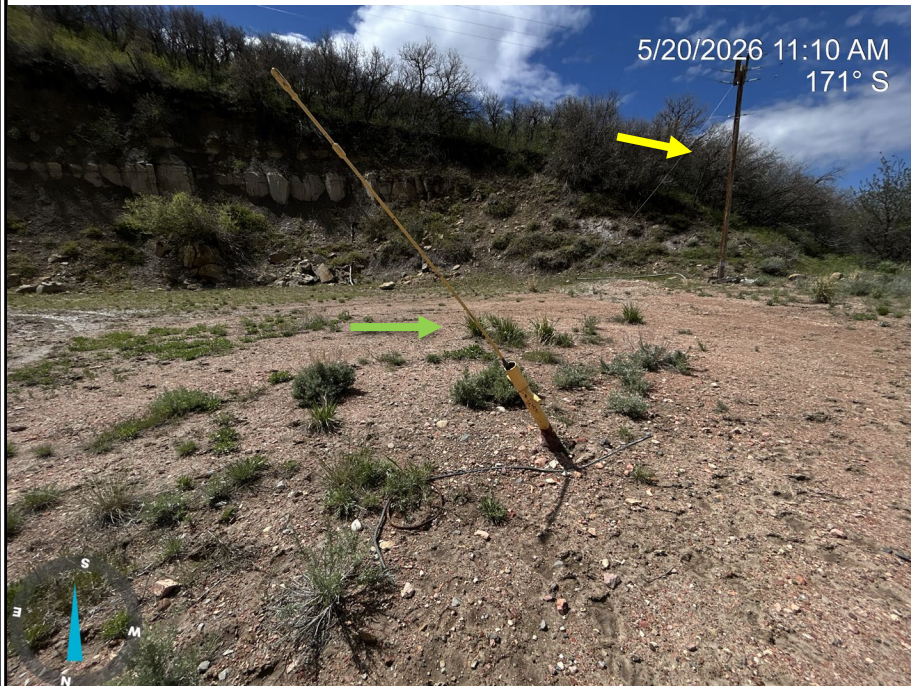
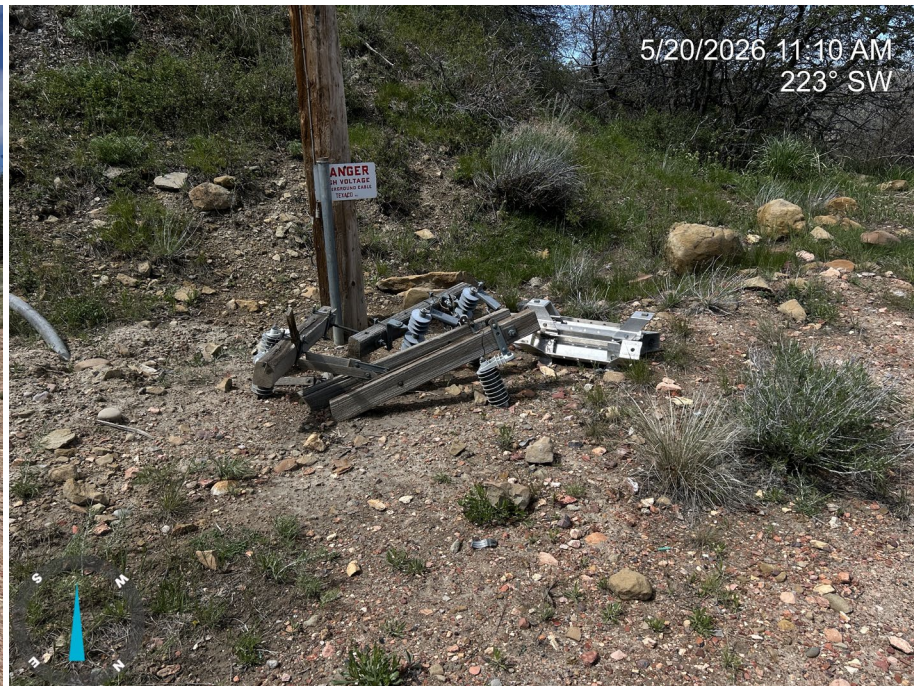
**Photo 4:** Photos showing the utility pole (yellow arrow) and unused equipment/supplies remain throughout the location. Utility equipment will be removed in 2026; all additional surface equipment (green arrow) requires removal by 4/1/2027.

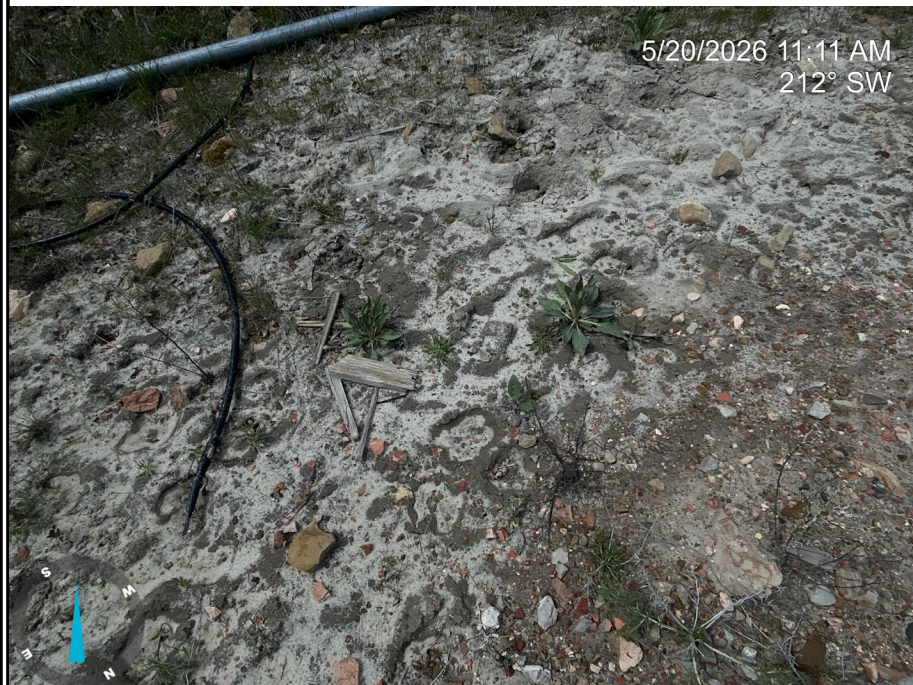
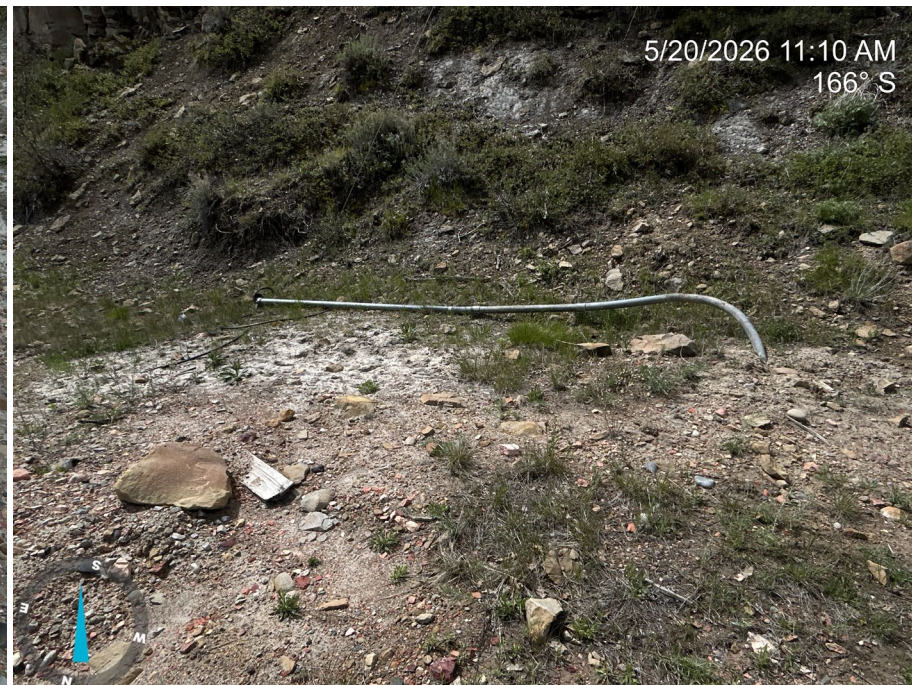
**Photo 5:** Photos showing trash/debris is scattered throughout the location and requires removal.

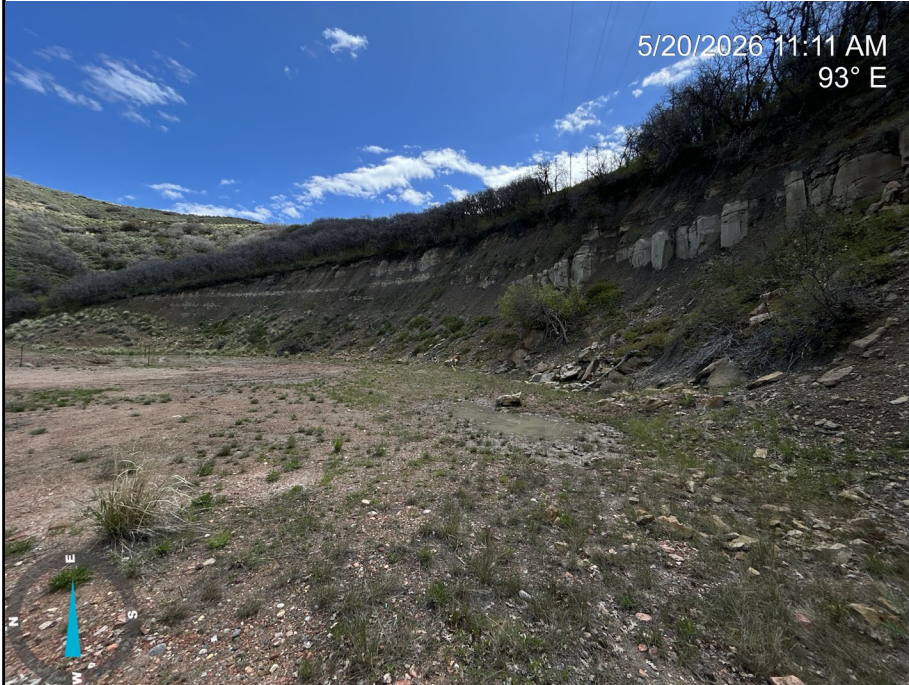
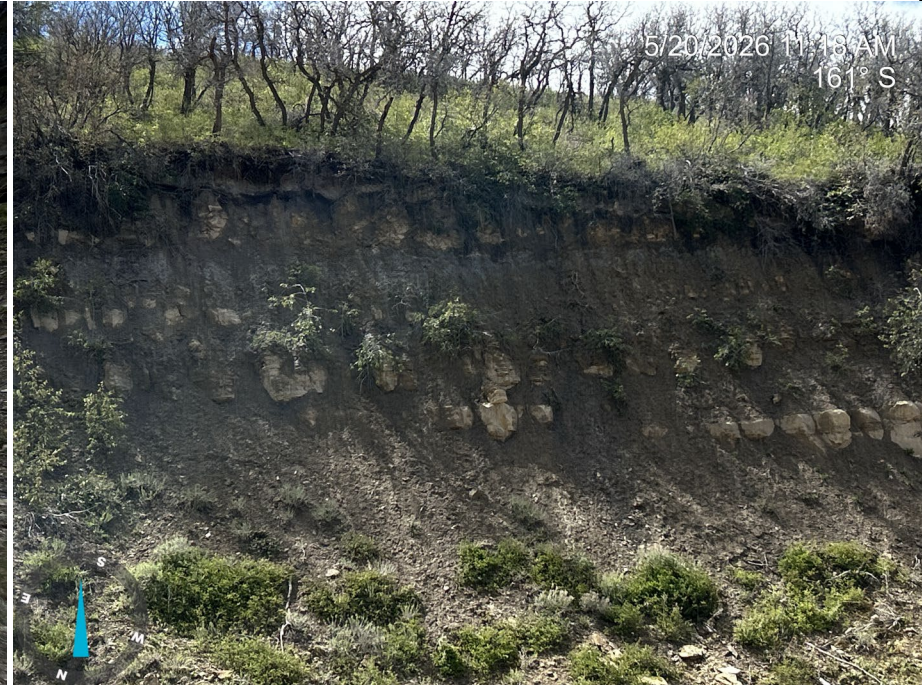
**Photo 6:** Photos showing the upper portion of the cut slopes are predominantly bare; exposed roots indicate active degradation. Check dams have not yet been installed and additional stormwater controls may be necessary to stabilize the slopes. Comply with Rule 1002.f.

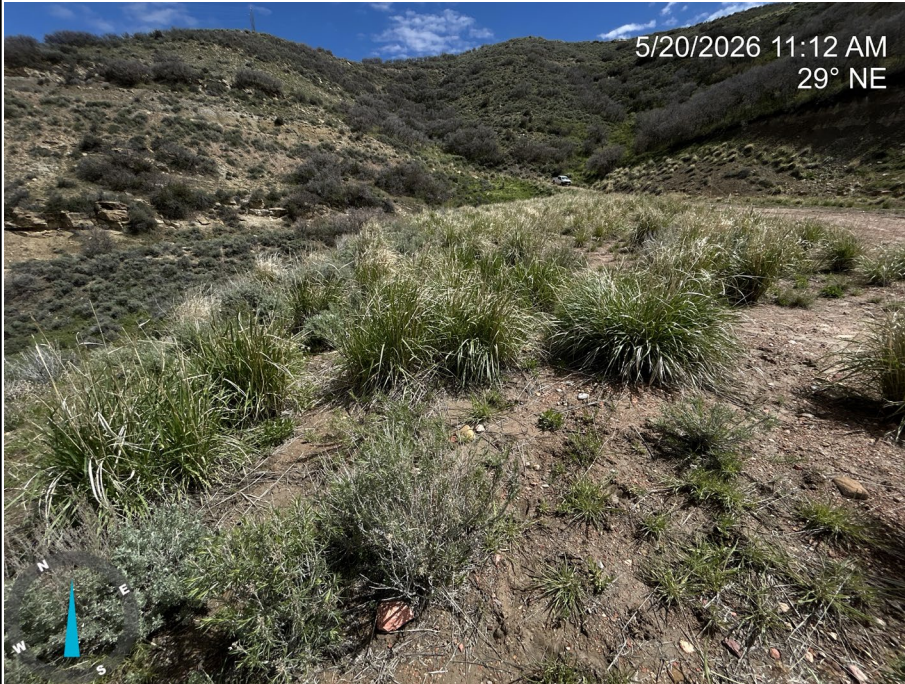
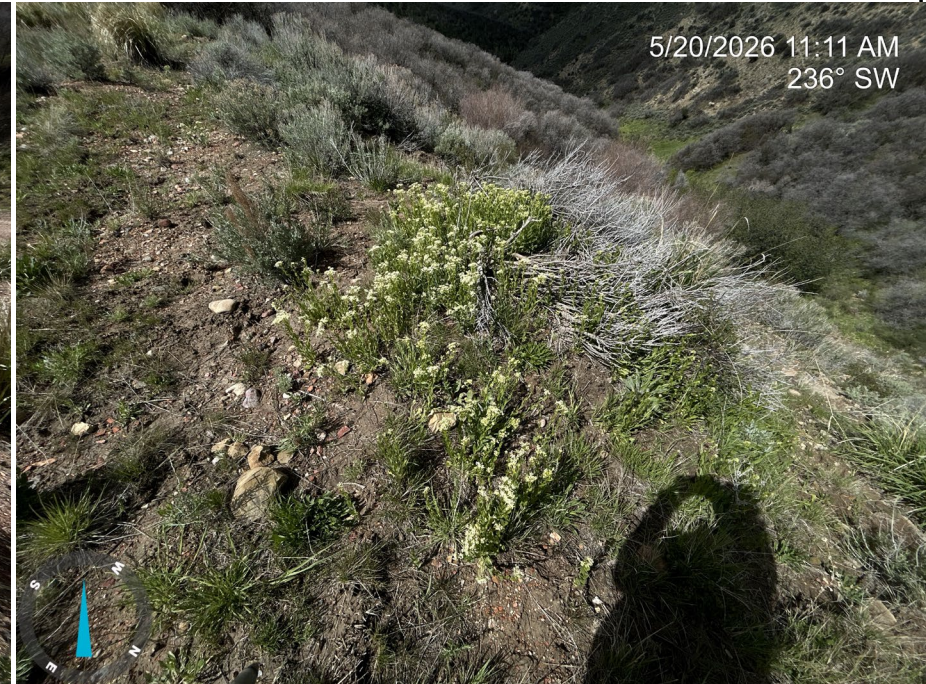
**Photo 7:** Photos showing the edges of the pad are primarily composed of Great Basin wildrye and sagebrush; hoary cress, and houndstongue, both a noxious weed, are present in tertiary amounts. Weed control is not required at this time; however, ongoing weed monitoring and maintenance is necessary.

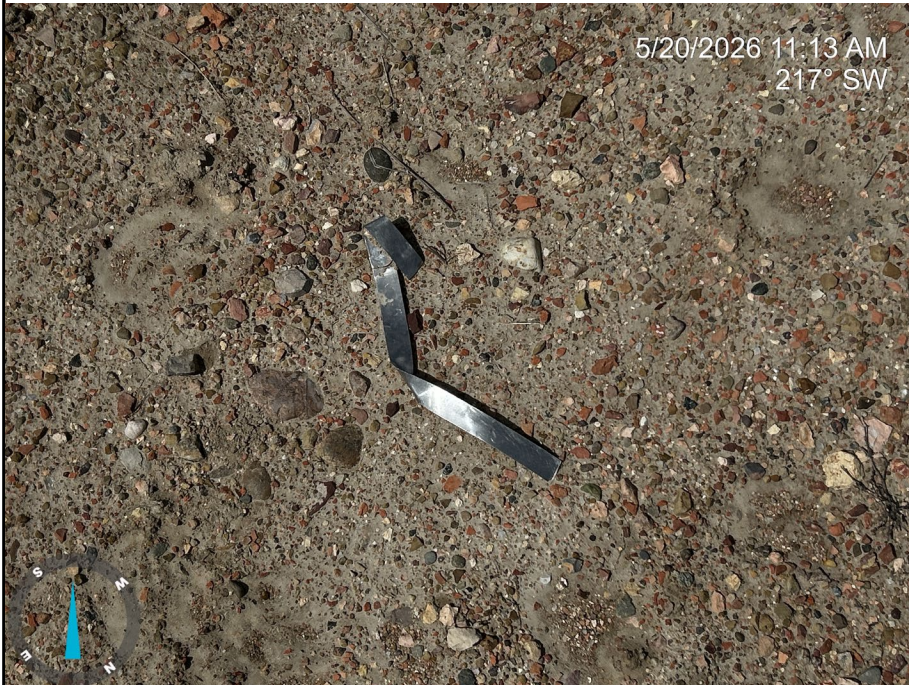
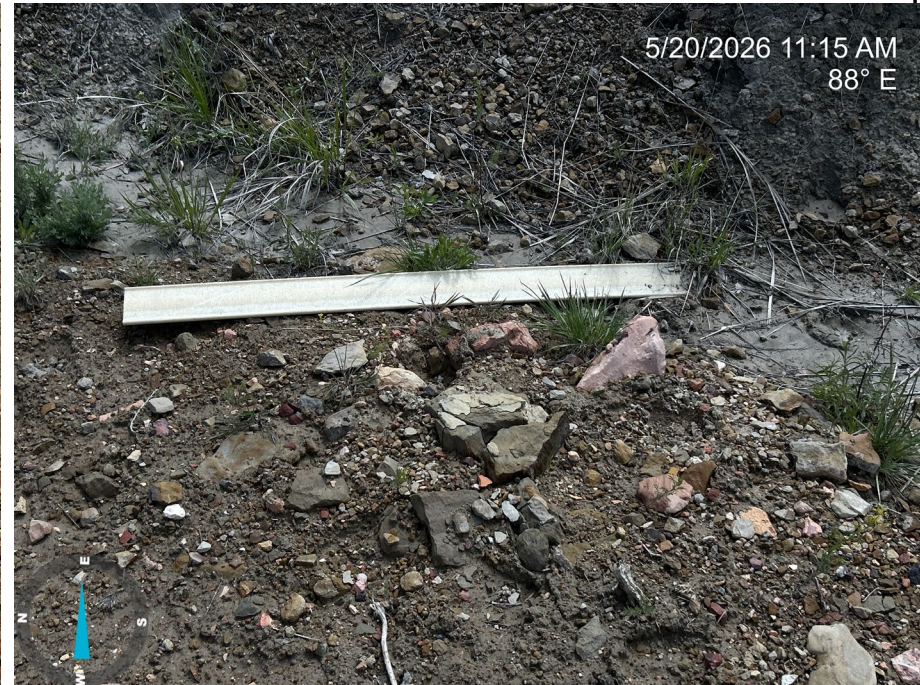
**Photo 8:** Photos showing additional examples of trash/debris that requires removal from the location.

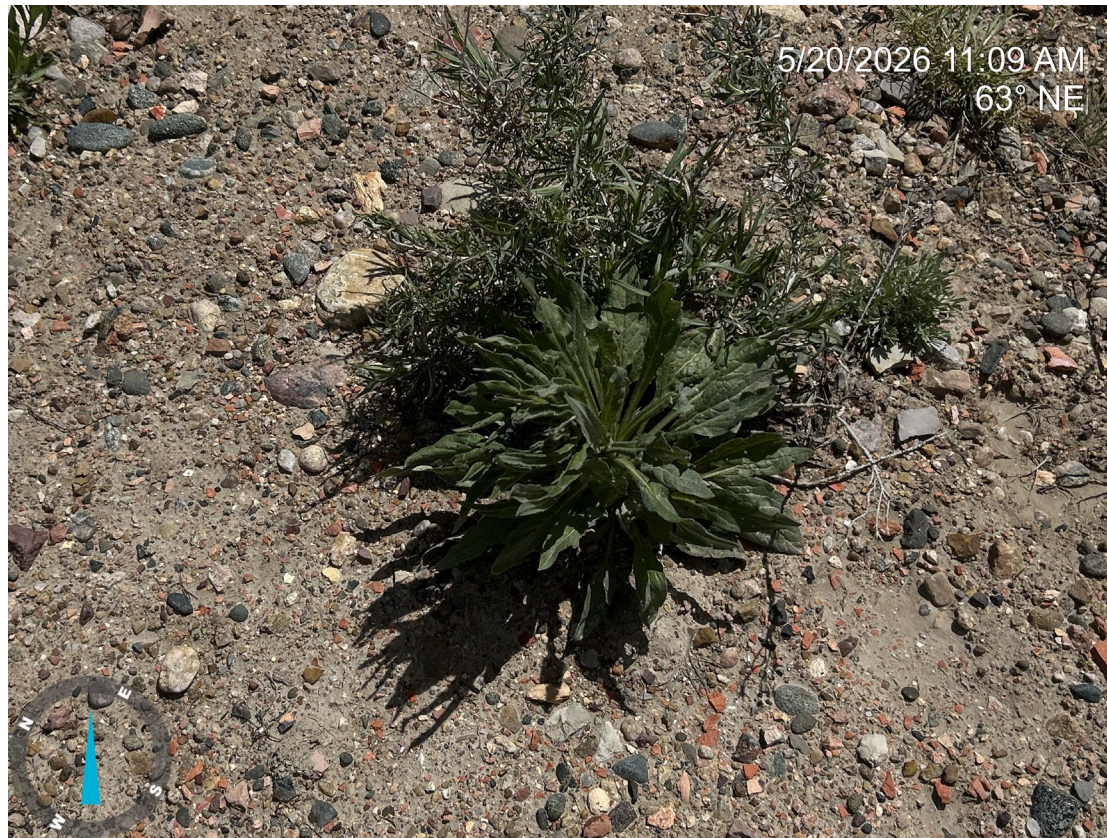
**Photo 9:** Houndstongue, a noxious weed, is present in tertiary amounts along the margins of the pad.

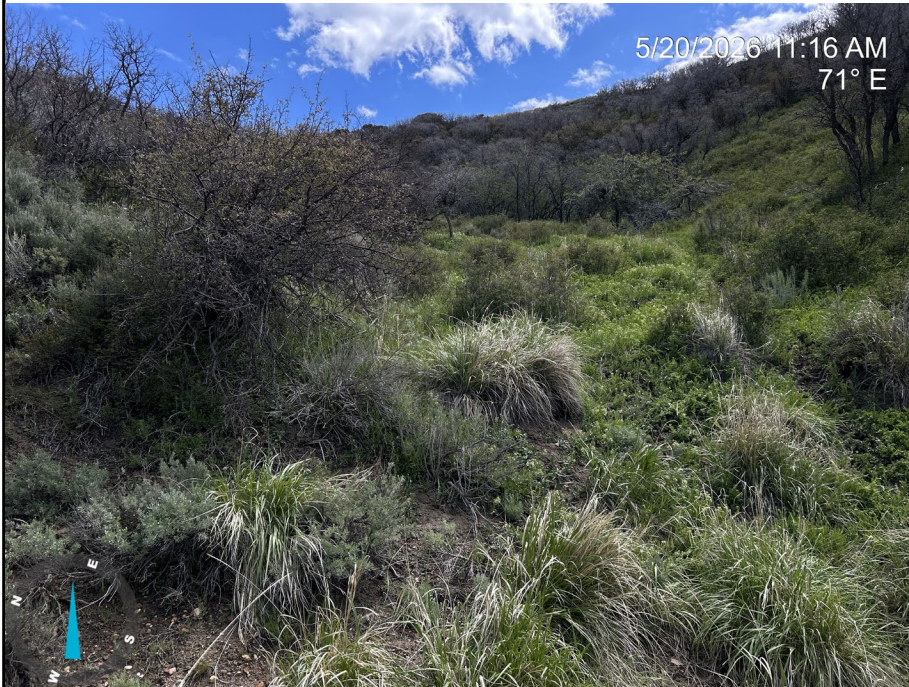
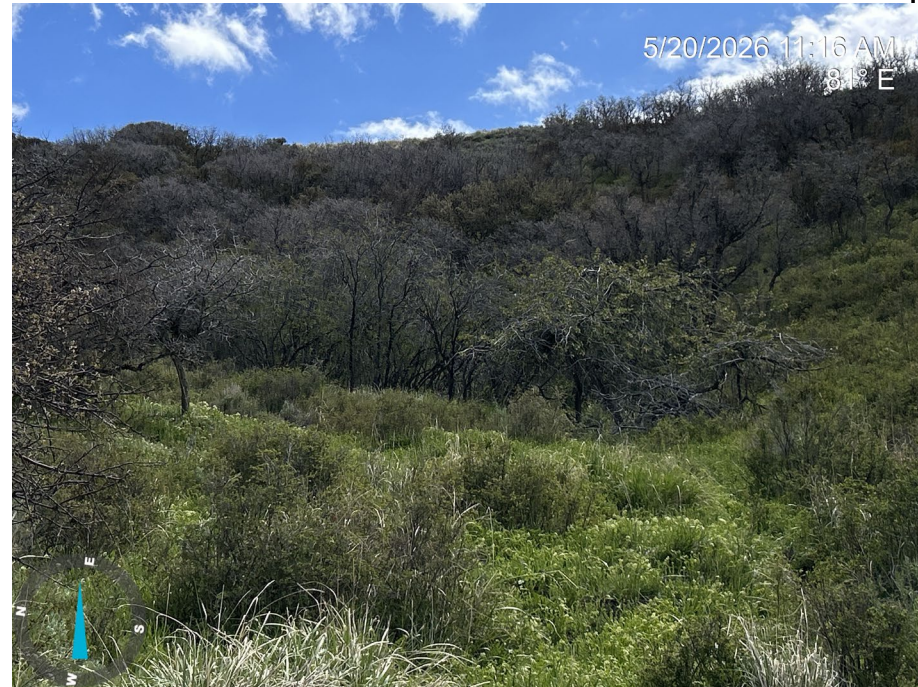
**Photo 10:** Photos showing examples of the nearby reference area, directly northeast of the location. Scrub oak is dominant. Cheatgrass and hoary cress are present in the understory, along with native grasses and forbs.

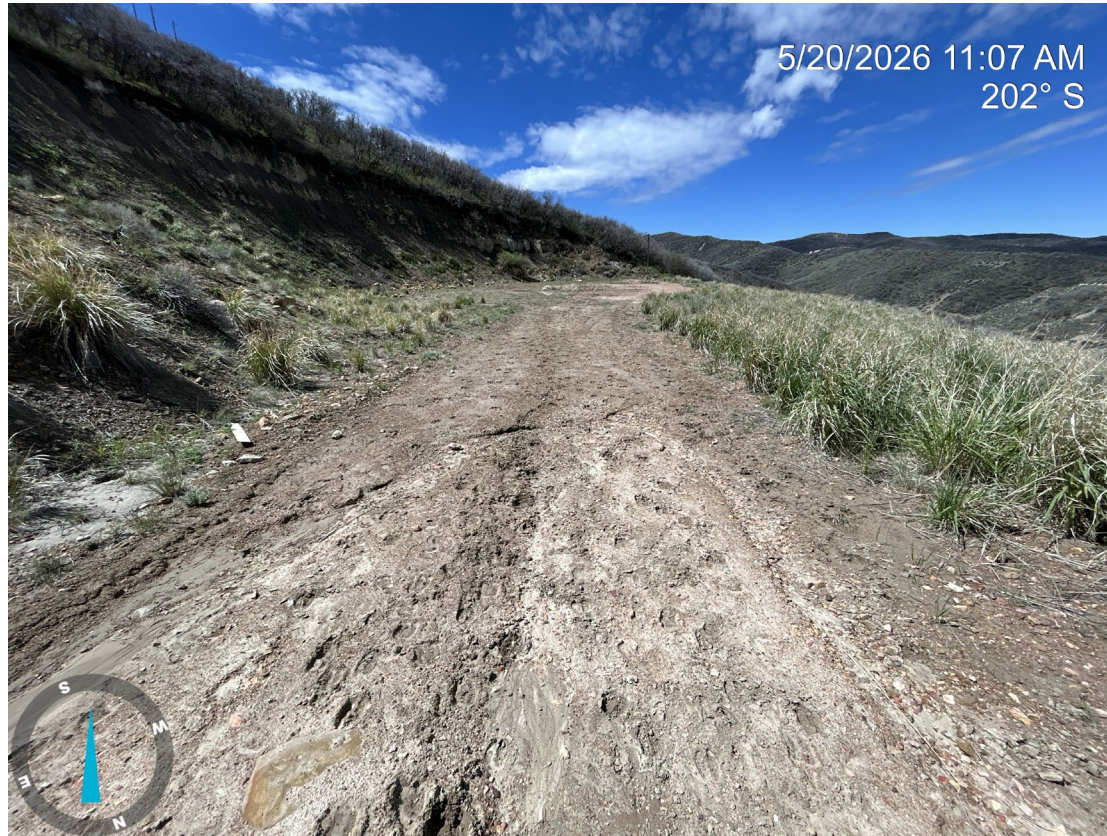
**Photo 11:** Photo showing the access road leading to the location. Erosion and rilling is occurring in some place along the road; maintenance is recommended.
