2026 Big Mountain Viper Reclamation Plan Weld County, Colorado

MAY 2026

Taproot Rockies Midstream, LLC

SWCA Environmental Consultants

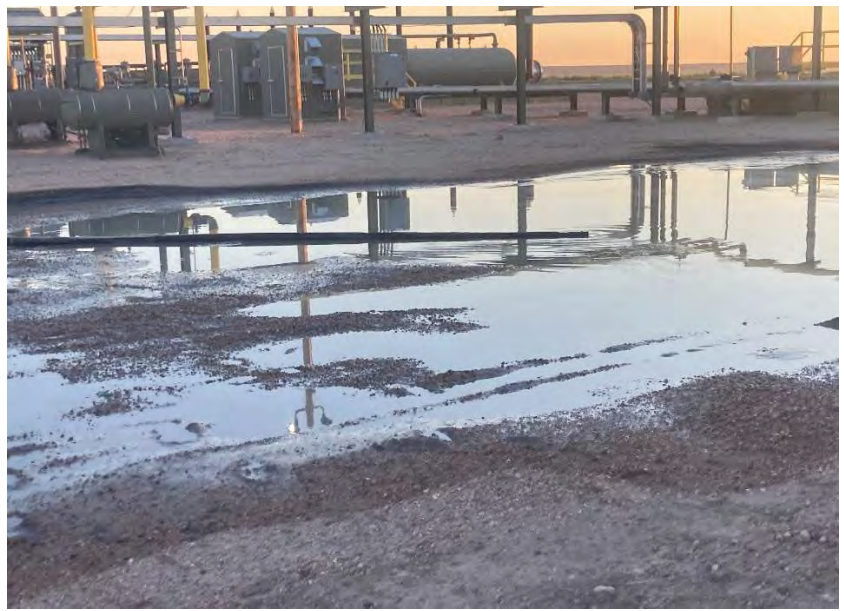
Initial site conditions on 9/5 looking east.

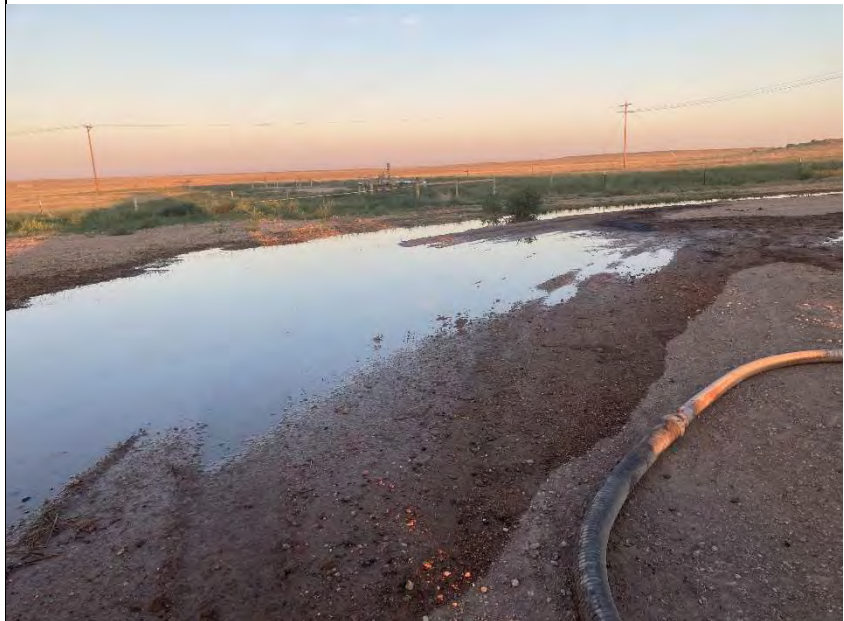
Photo: 2

Initial site conditions looking southwest.

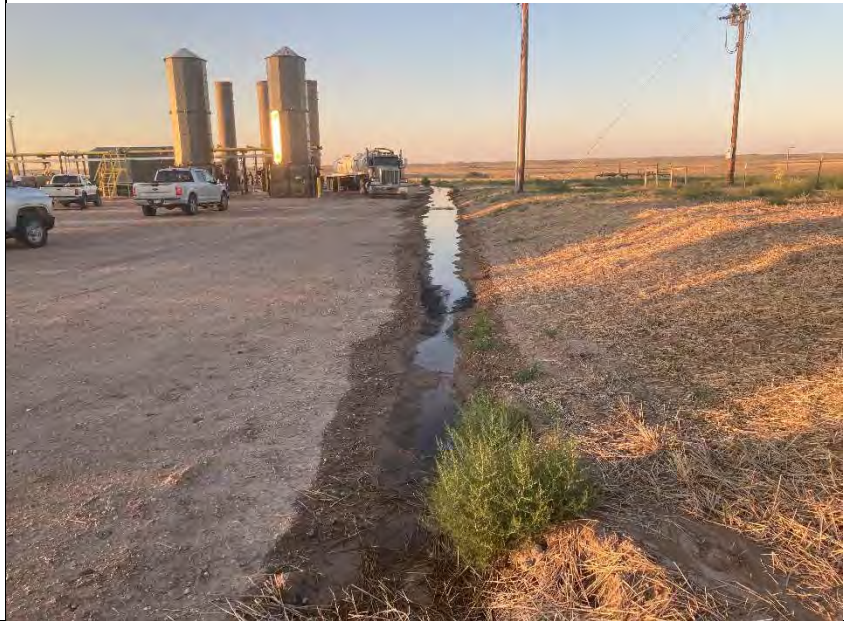
Photo: 3

Initial site conditions looking south.

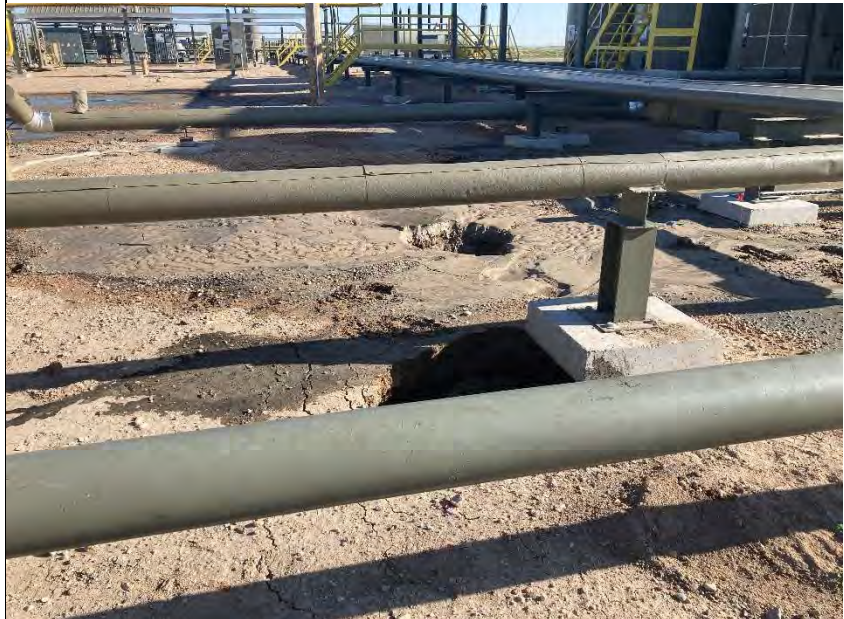
Photo: 4

Release location.

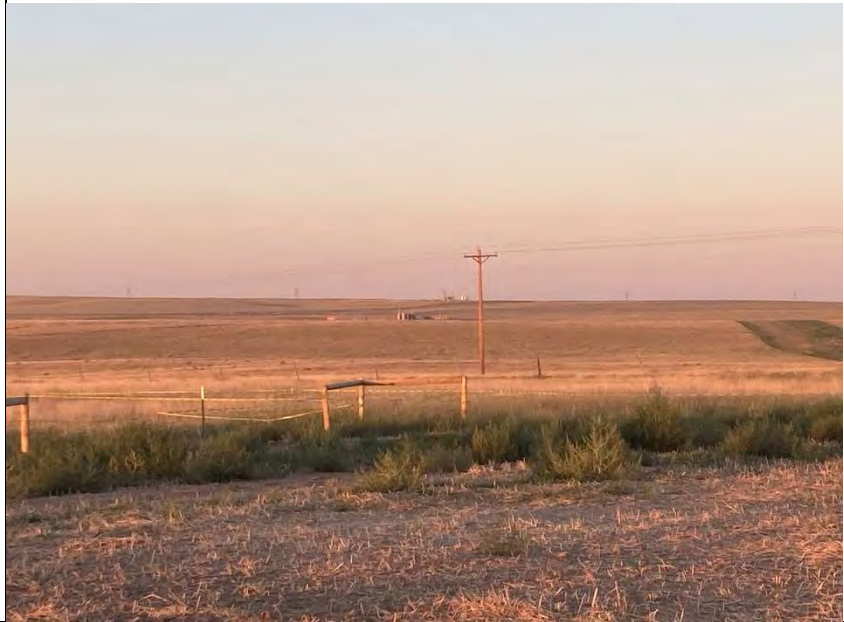
Photo: 5

The outlined impacted area of the adjacent property to the southwest.

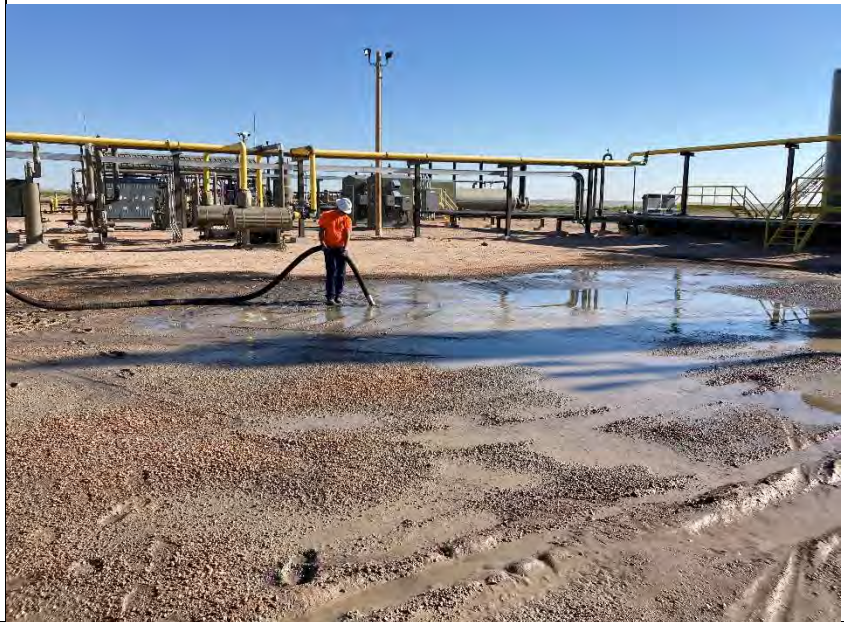
Photo: 6

Liquid Vac Truck Operator working to remove free liquids.

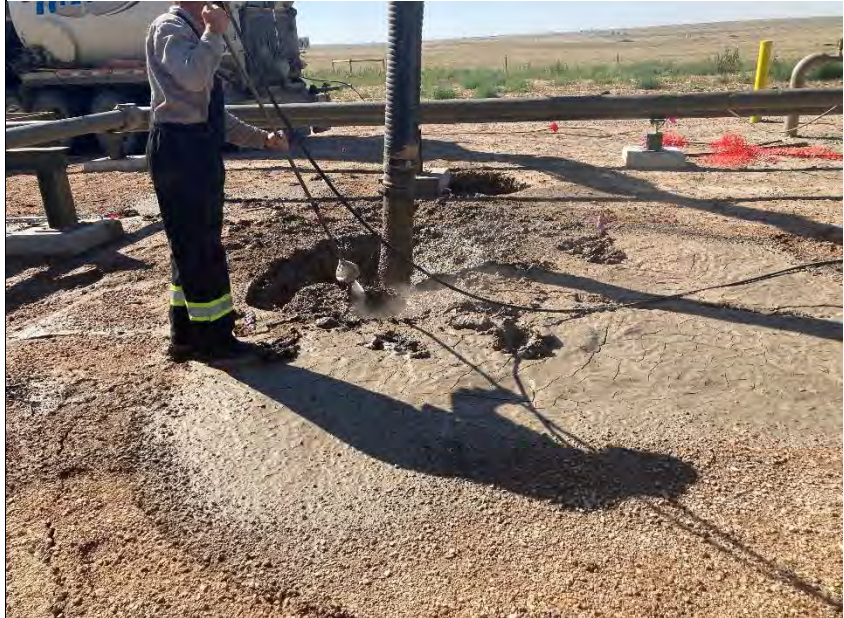
Photo: 7

Hydro excavator working in the primary excavation area to locate the pipeline failure.

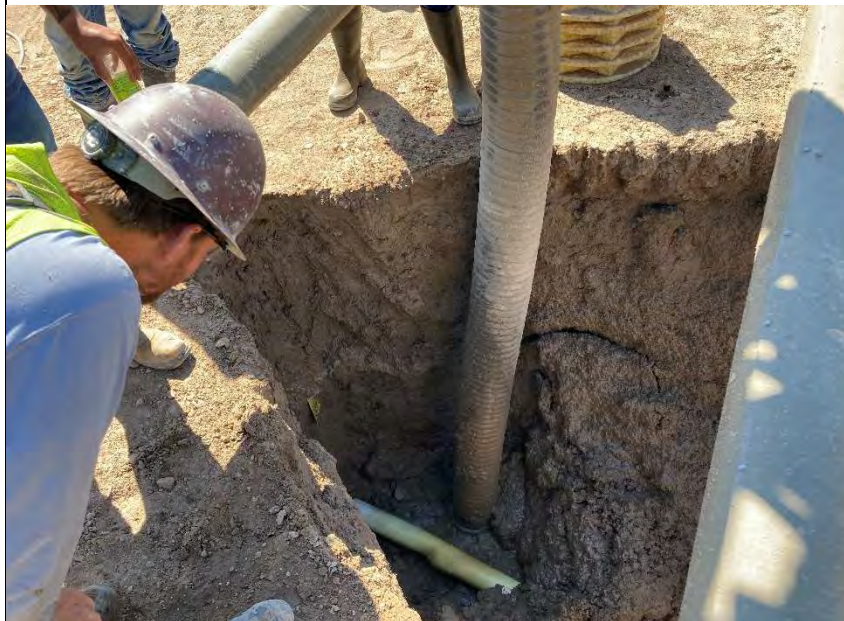
Photo: 8

Locating the failure in the pipeline.

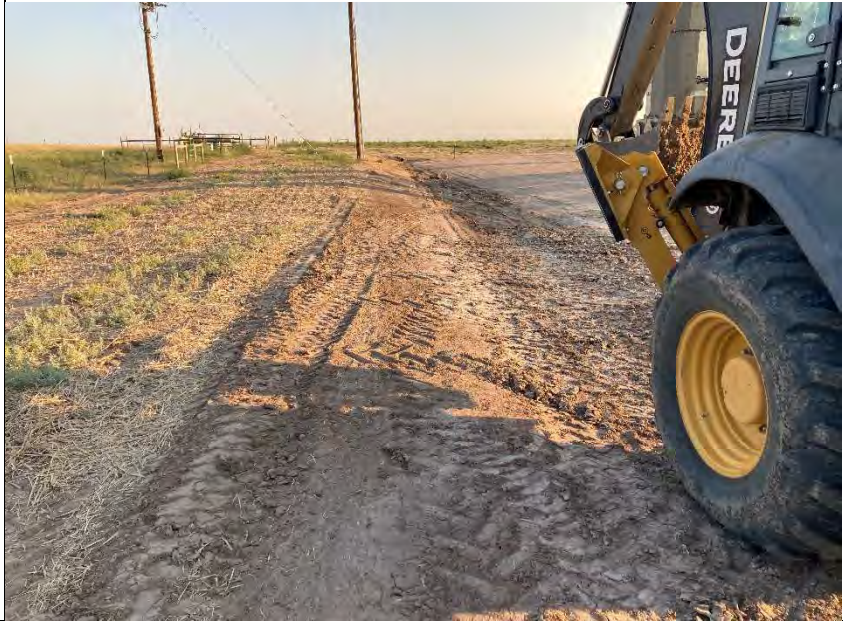
Photo: 11

Surface scrapping of impacted area to remove visible wet soil.

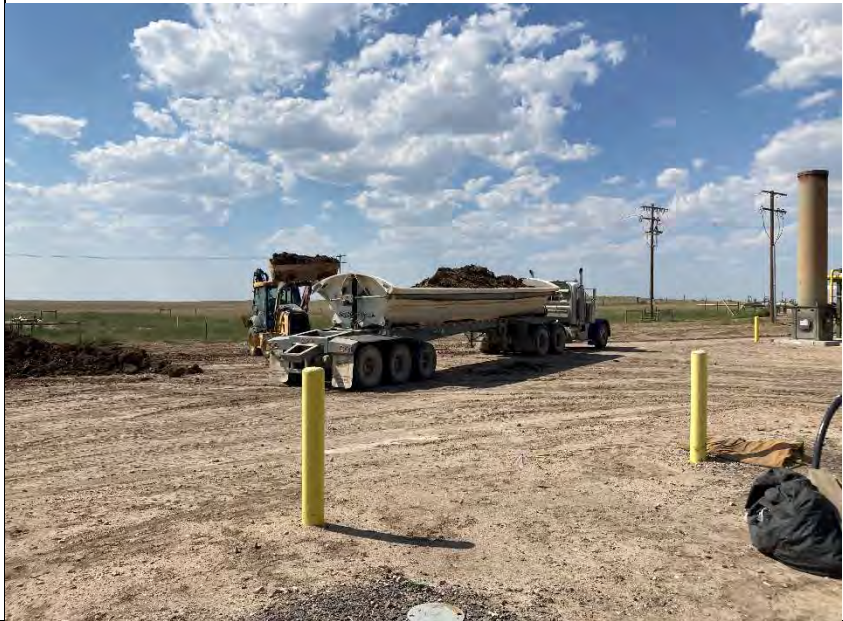
Photo: 12

Loading impacted soil for disposal.

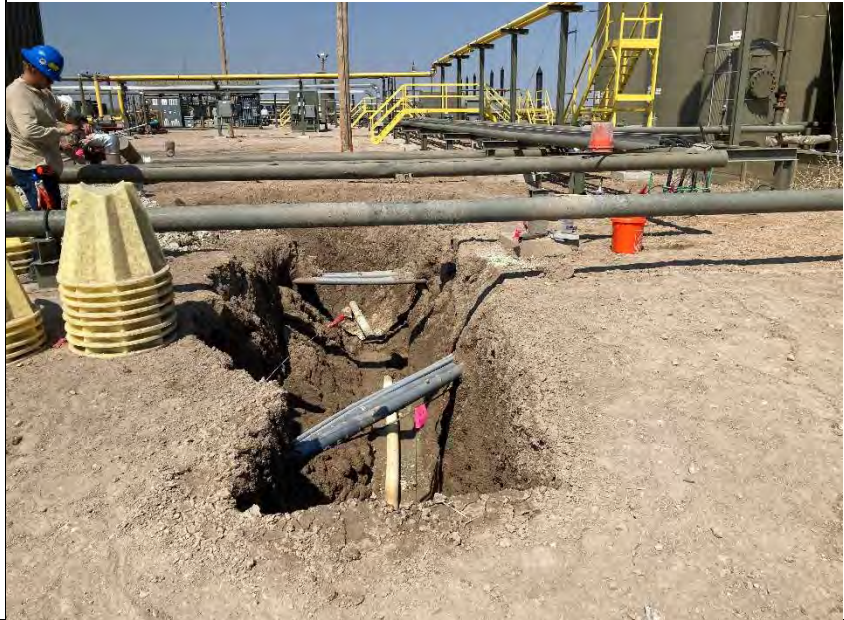
Photo: 13

Primary excavation area after exposing failed pipeline. View looking north.

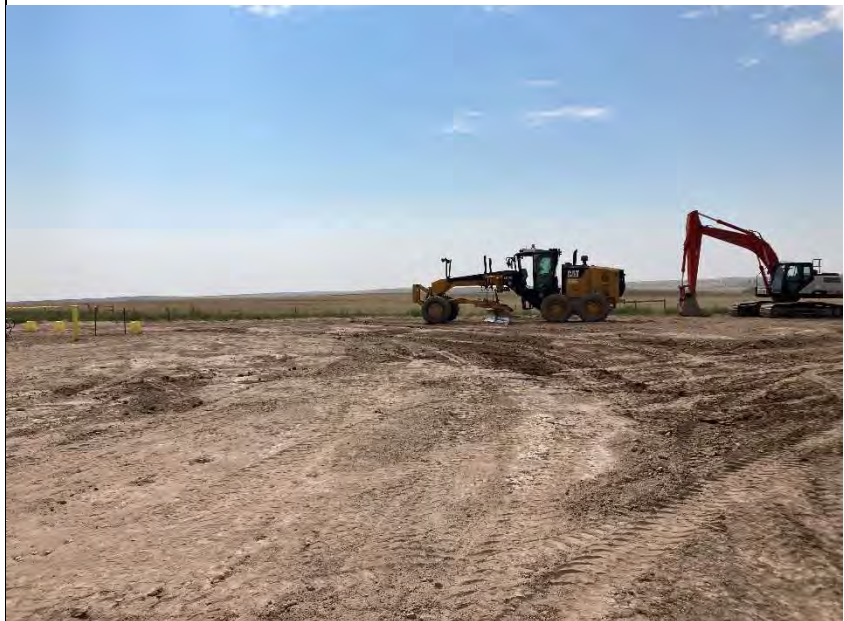
Photo: 14

Secondary excavation area after surface scrape looking west.

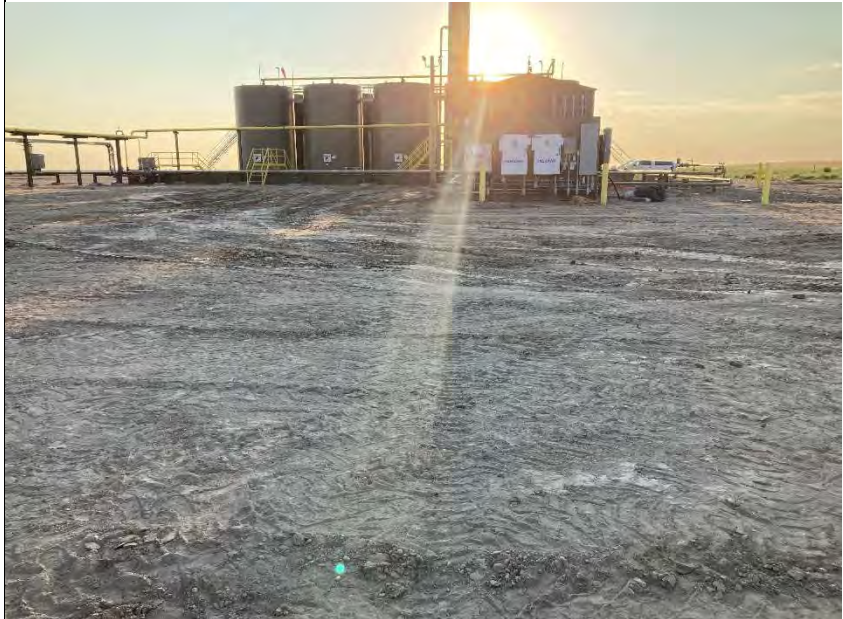
Photo: 15

Secondary excavation area after surface scrape, looking east.

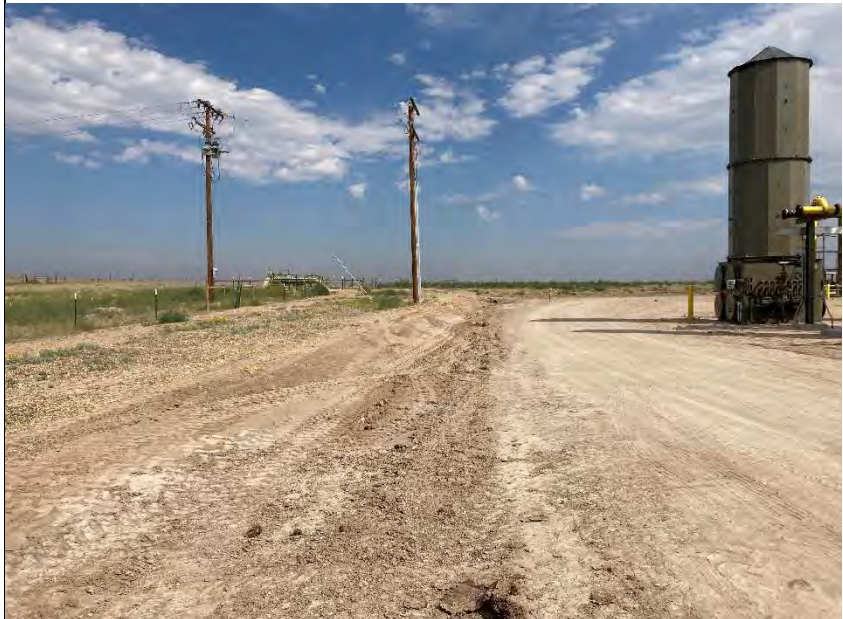
Photo: 16

Secondary excavation area after surface scrape looking north.

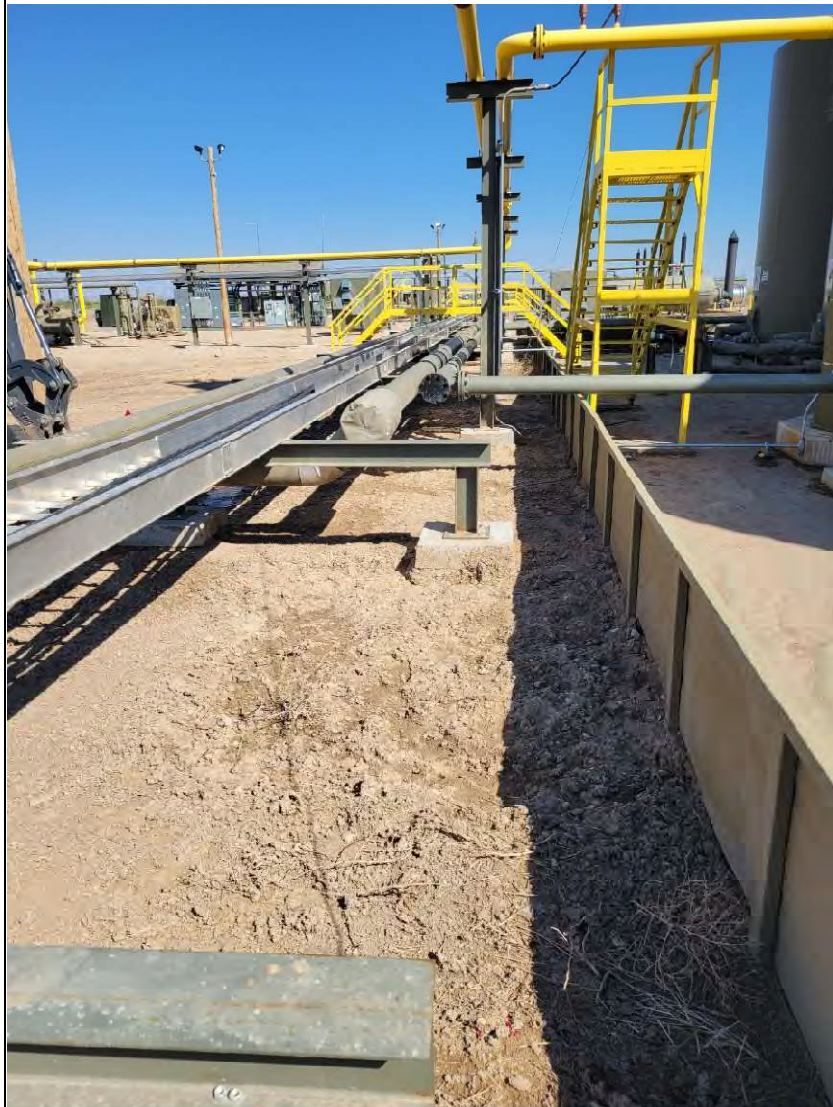
Area of surface impacts to the east of the primary excavation. Hand digging and hydroexcavation performed until no observed impacts. View looking north.

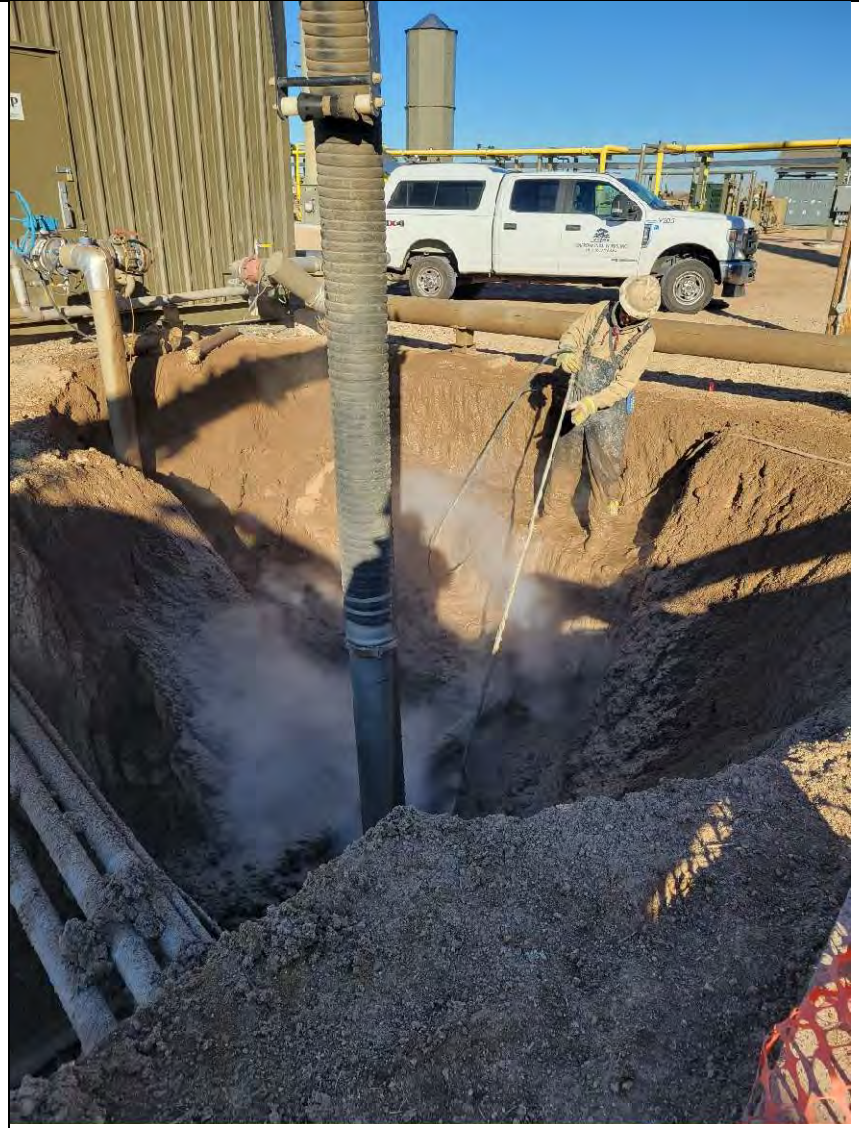
Photo: 20

Widening of primary excavation completed on 11/10 and 11/11. Secondary sidewall samples collected.

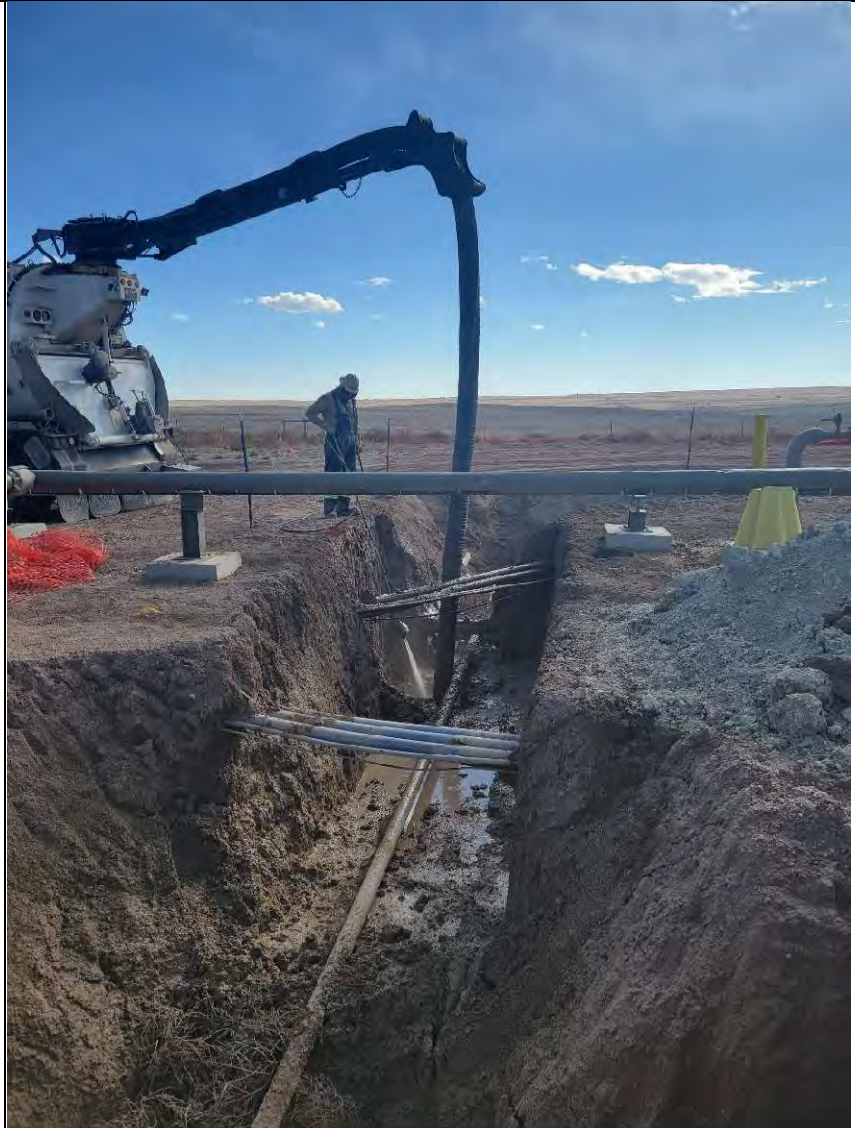
Photo: 21

Widening of primary excavation completed on 11/10 and 11/11. Existing infrastructure hindering further excavation.
