Inspection Photos

Operator: Wesco Operating Inc #95520

Location ID: 312881

Inspection Doc: 719201188

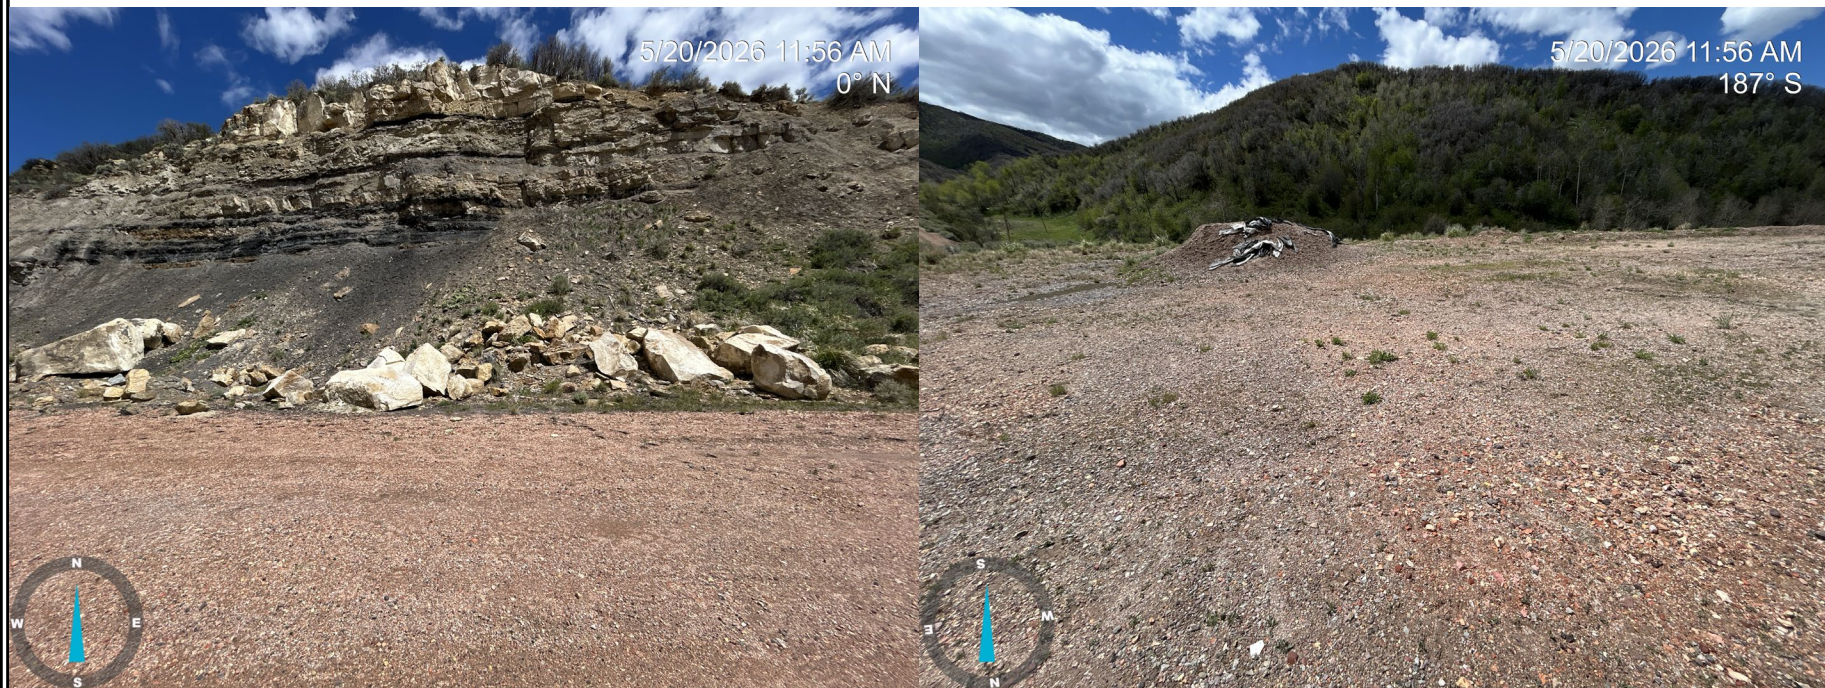
Photo 1: Photos showing an overview of the location looking north and south, respectively.

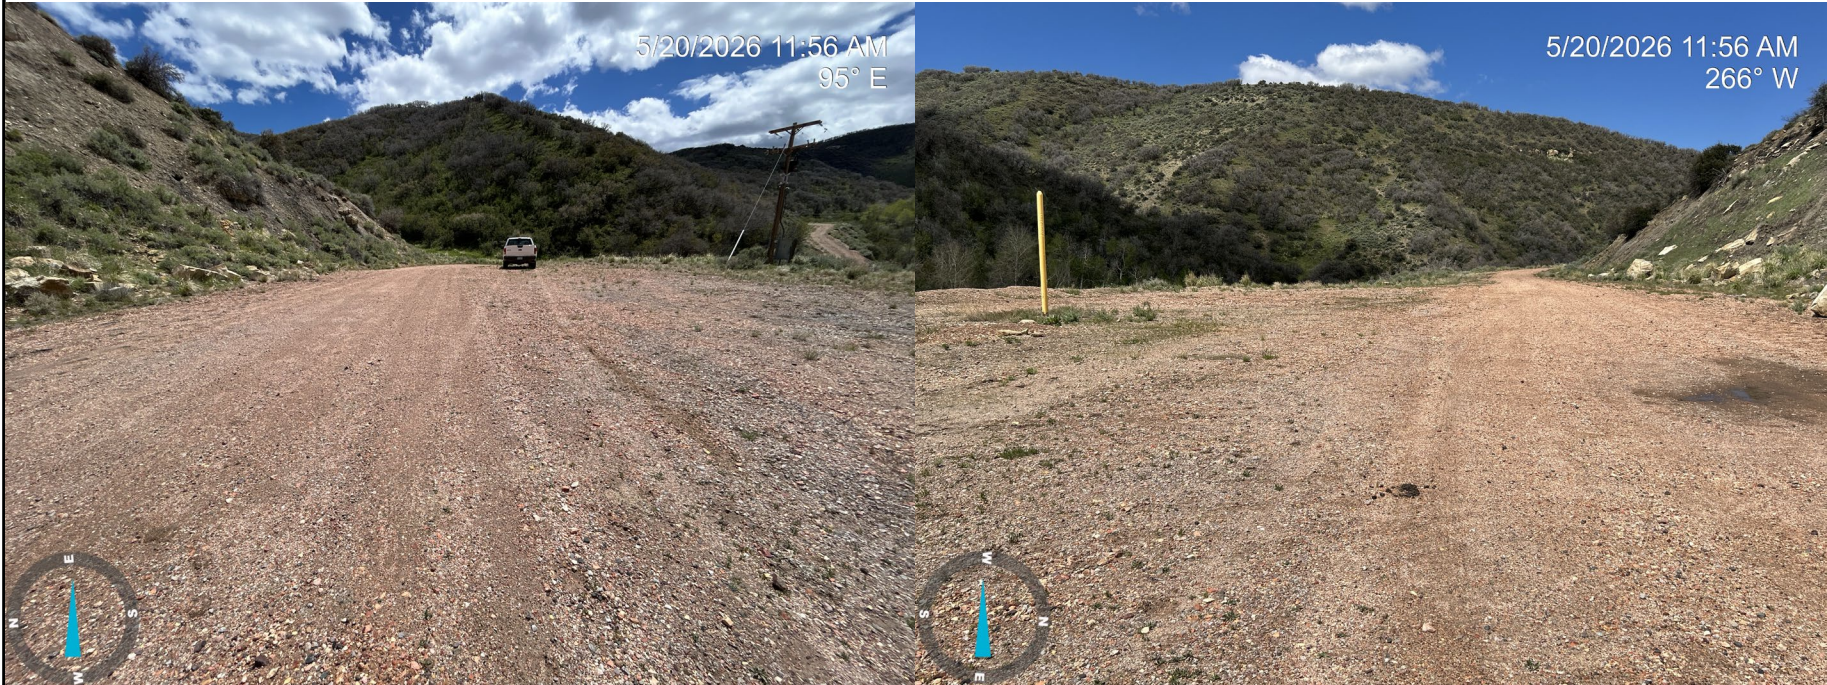
Photo 2: Photos showing an overview of the location looking east and west, respectively. The Operator plans to retain the access road through the location.

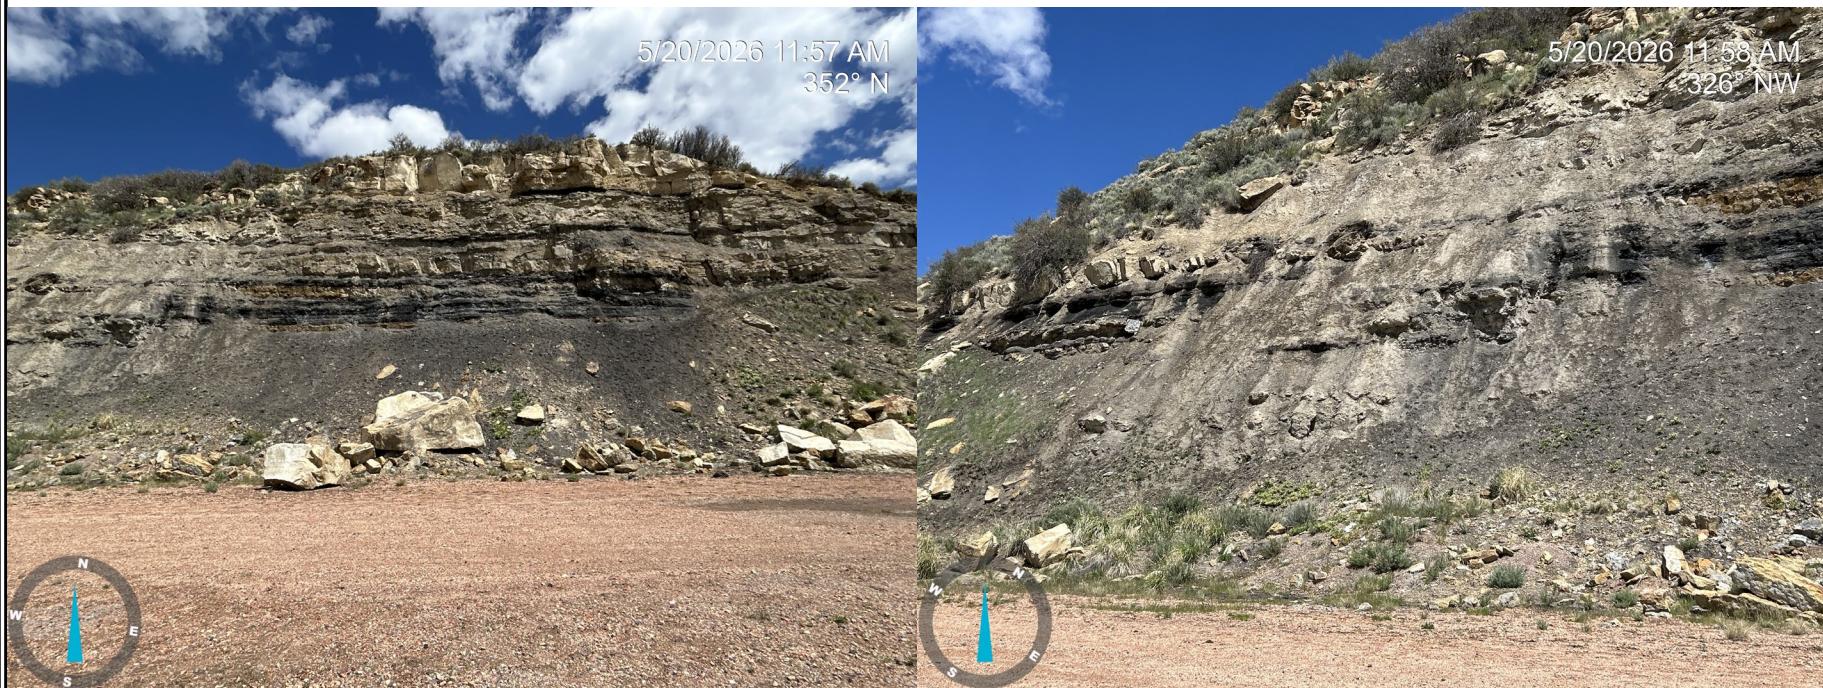
Photo 3: Cut slopes at the location are bare; active erosion was occurring while the inspector was at the location. Stabilization is required.

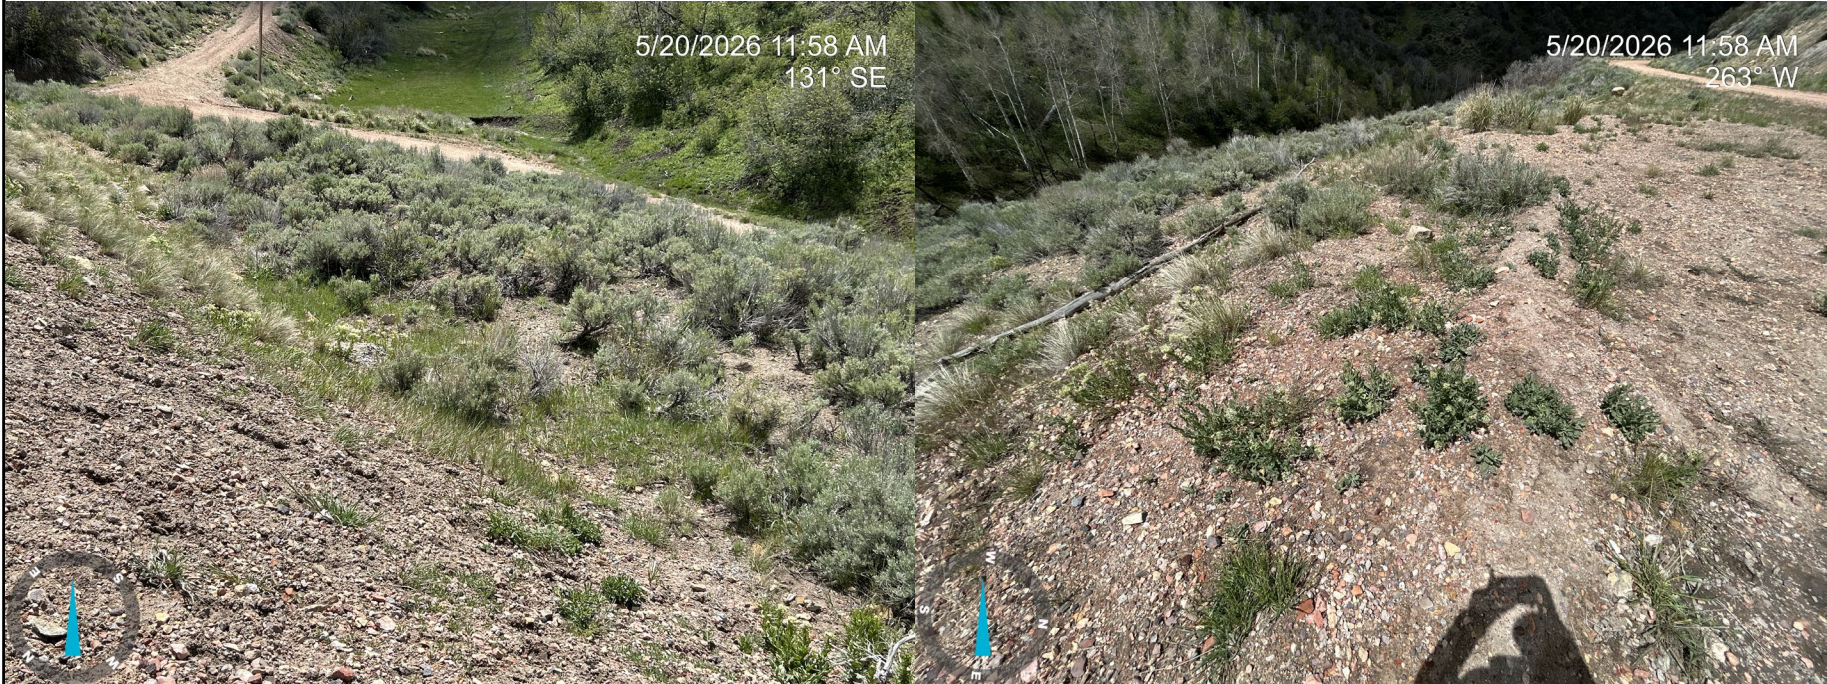
Photo 4: Photos showing the southern reclaim area. Hoary cress and cheatgrass, both noxious weeds, are present in tertiary amounts along the edges of the pad.

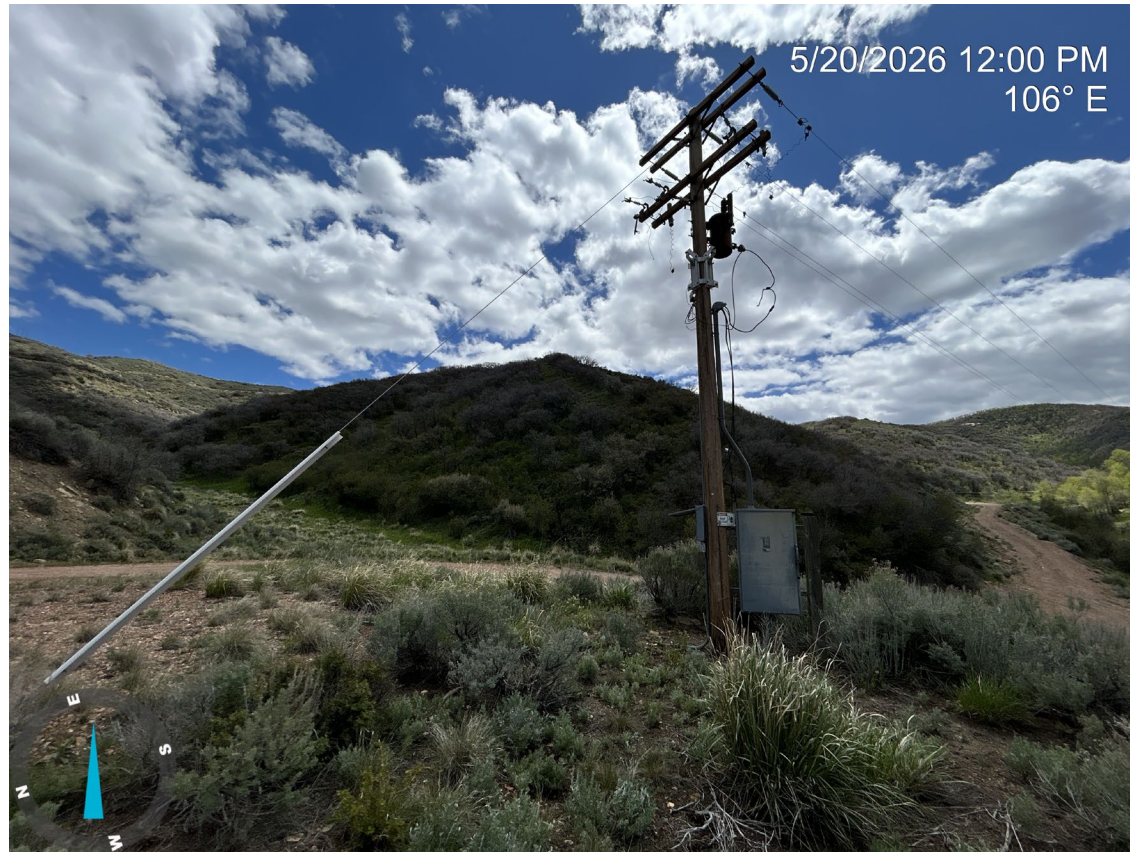
Photo 5: Photos showing utility equipment that is present at the location. The Operator plans to remove utility equipment.
