Inspection Photos

Operator: Mobil Oil Corporation

Location ID: 381598

Inspection Photos
Location Name: Spargo 1-23

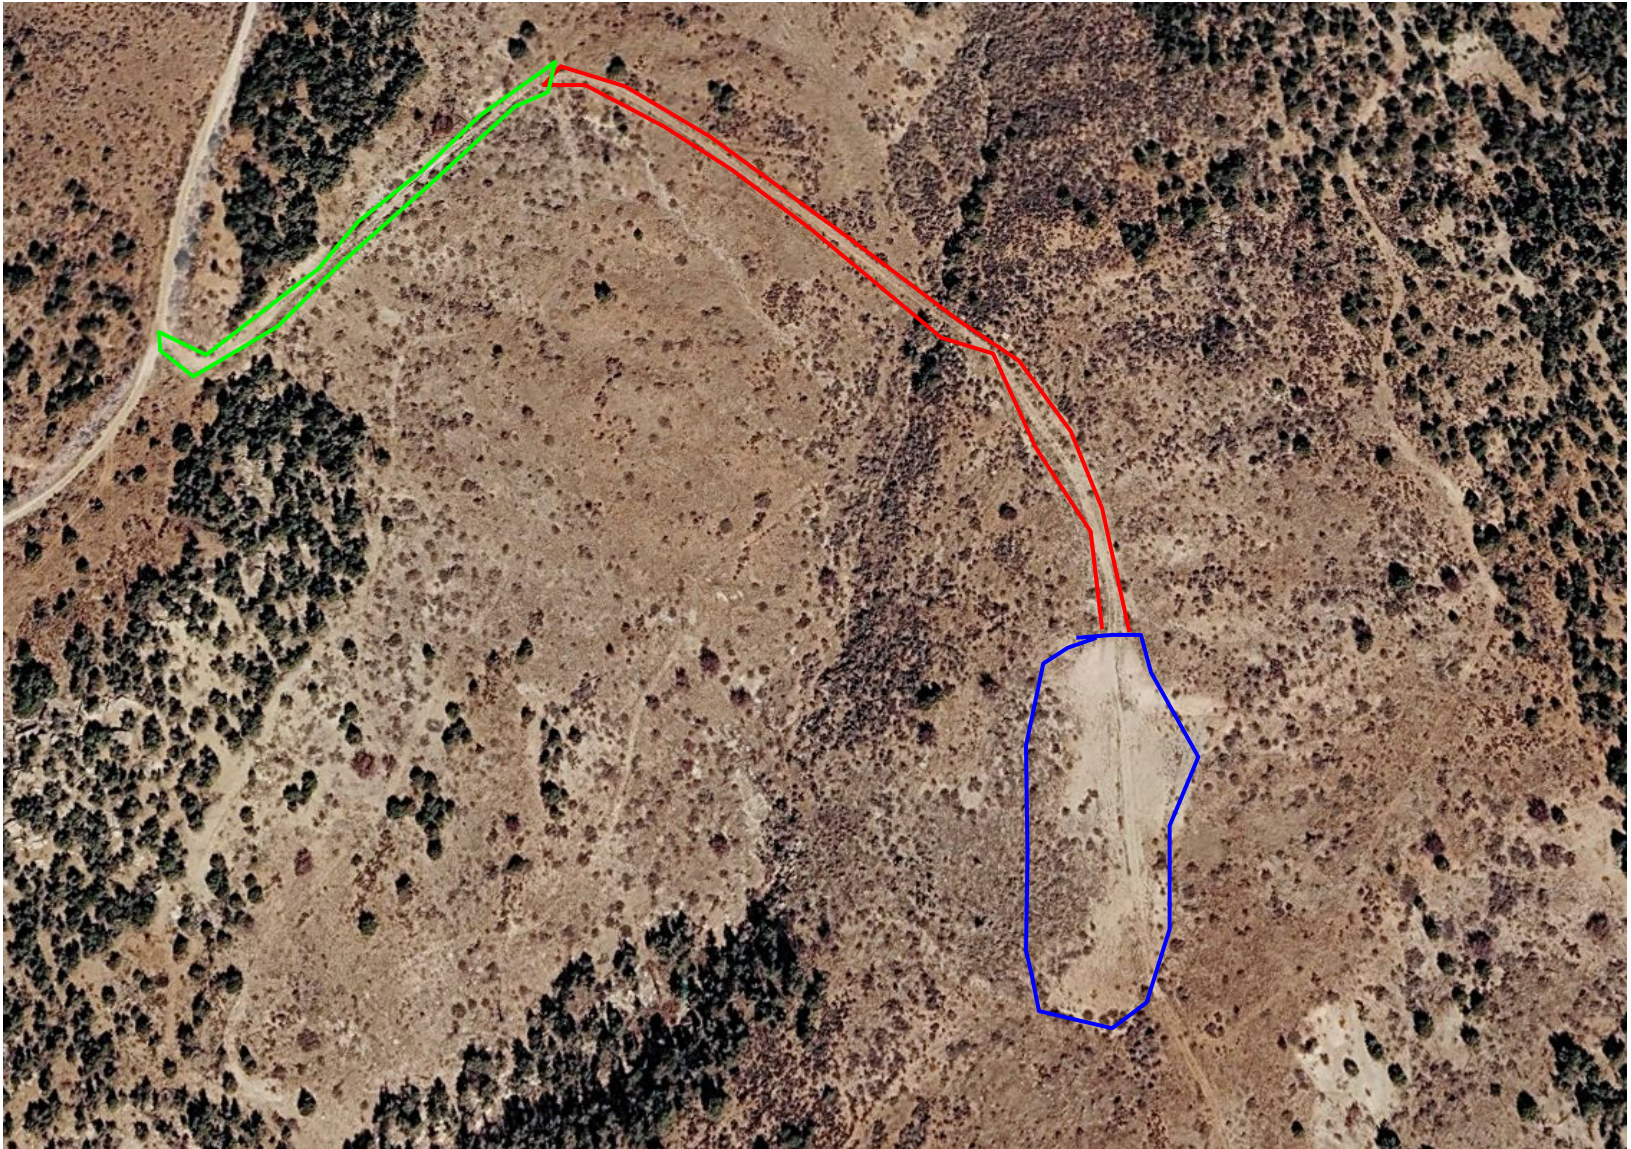
Photo 1. 2023 NAIP Imagery of the well pad (highlighted in blue) and associated access road (highlighted in red). Note: portion of access road highlighted in green predates oil and gas location and does not require reclamation.

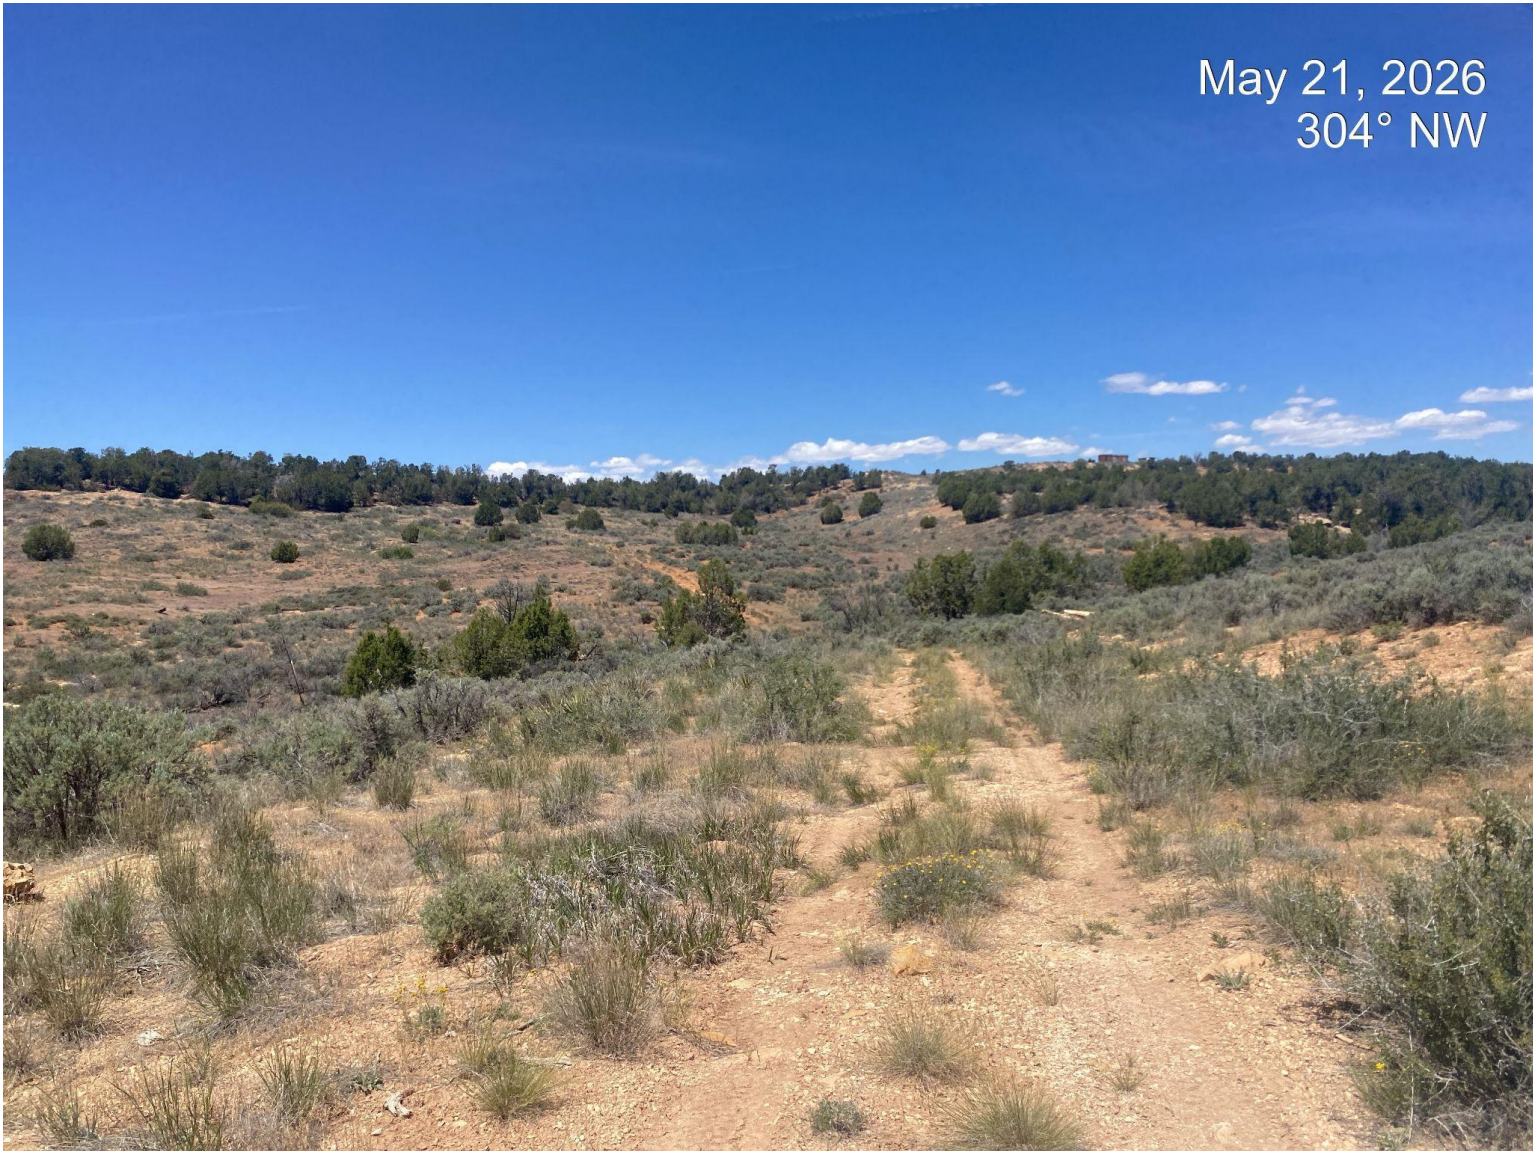
May 21, 2026
304° NW

Photo 2. View of associated access taken from the well pad access point facing northwest. Note: access road has not been reclaimed per 1004 rules.

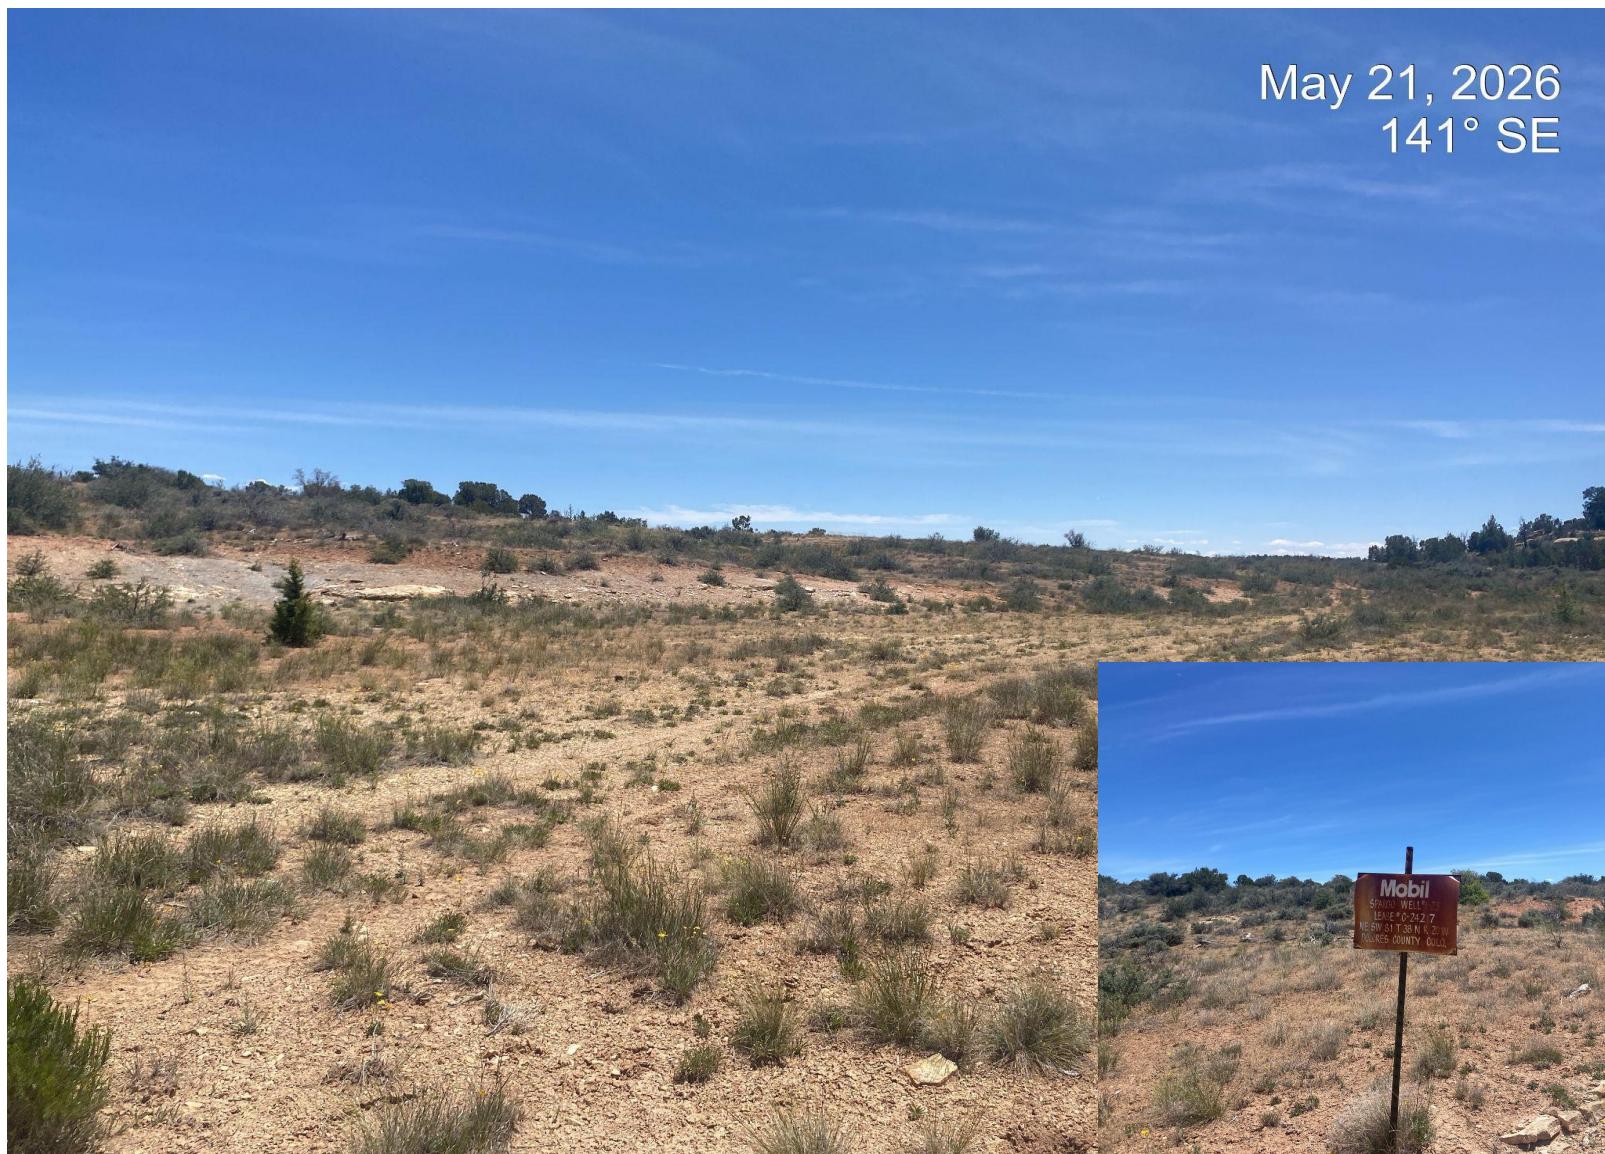
Photo 3. View of well pad project area taken from the northern edge facing center. Note: Location sign remains on location. Vegetation establishment along location cut slopes and within portions of the project area have not met 1004 standards.

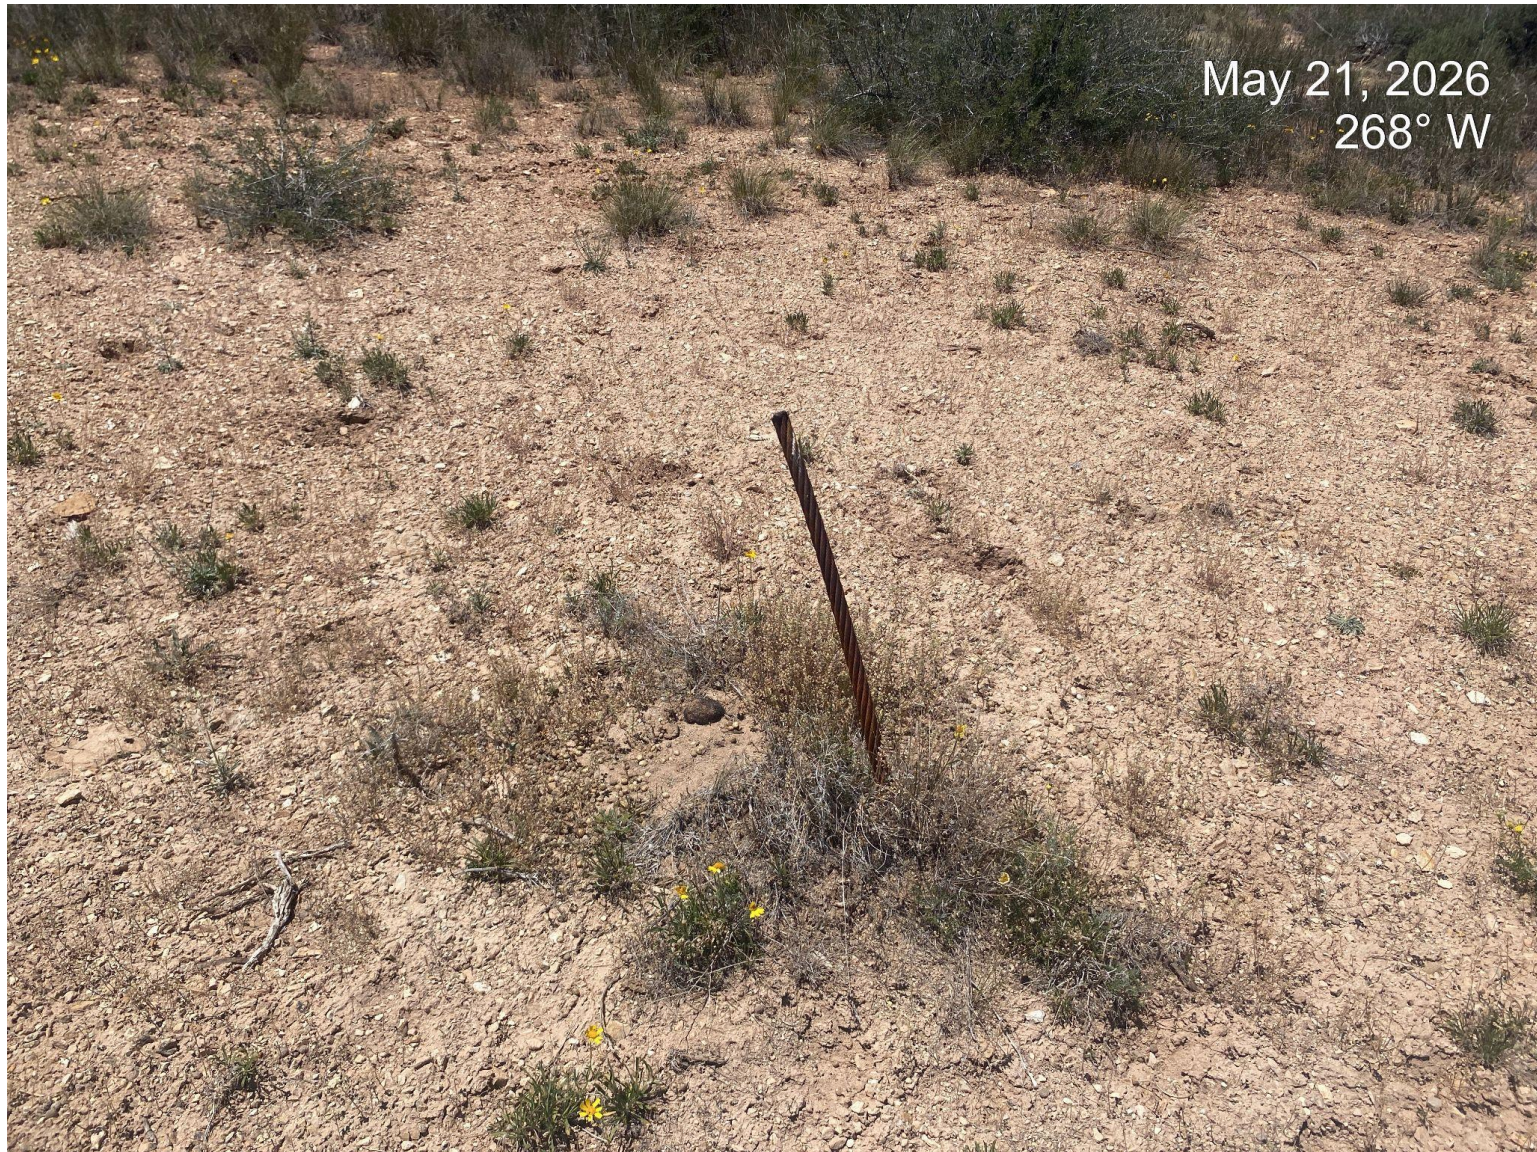
Photo 1. Anchor cable remains on the western edge of the project area.
