Inspection Photos

Operator: Highpoint Operating
Corporation

Location ID: 313626

Inspection Photos
Location Name: Gray 13H-15-37-17

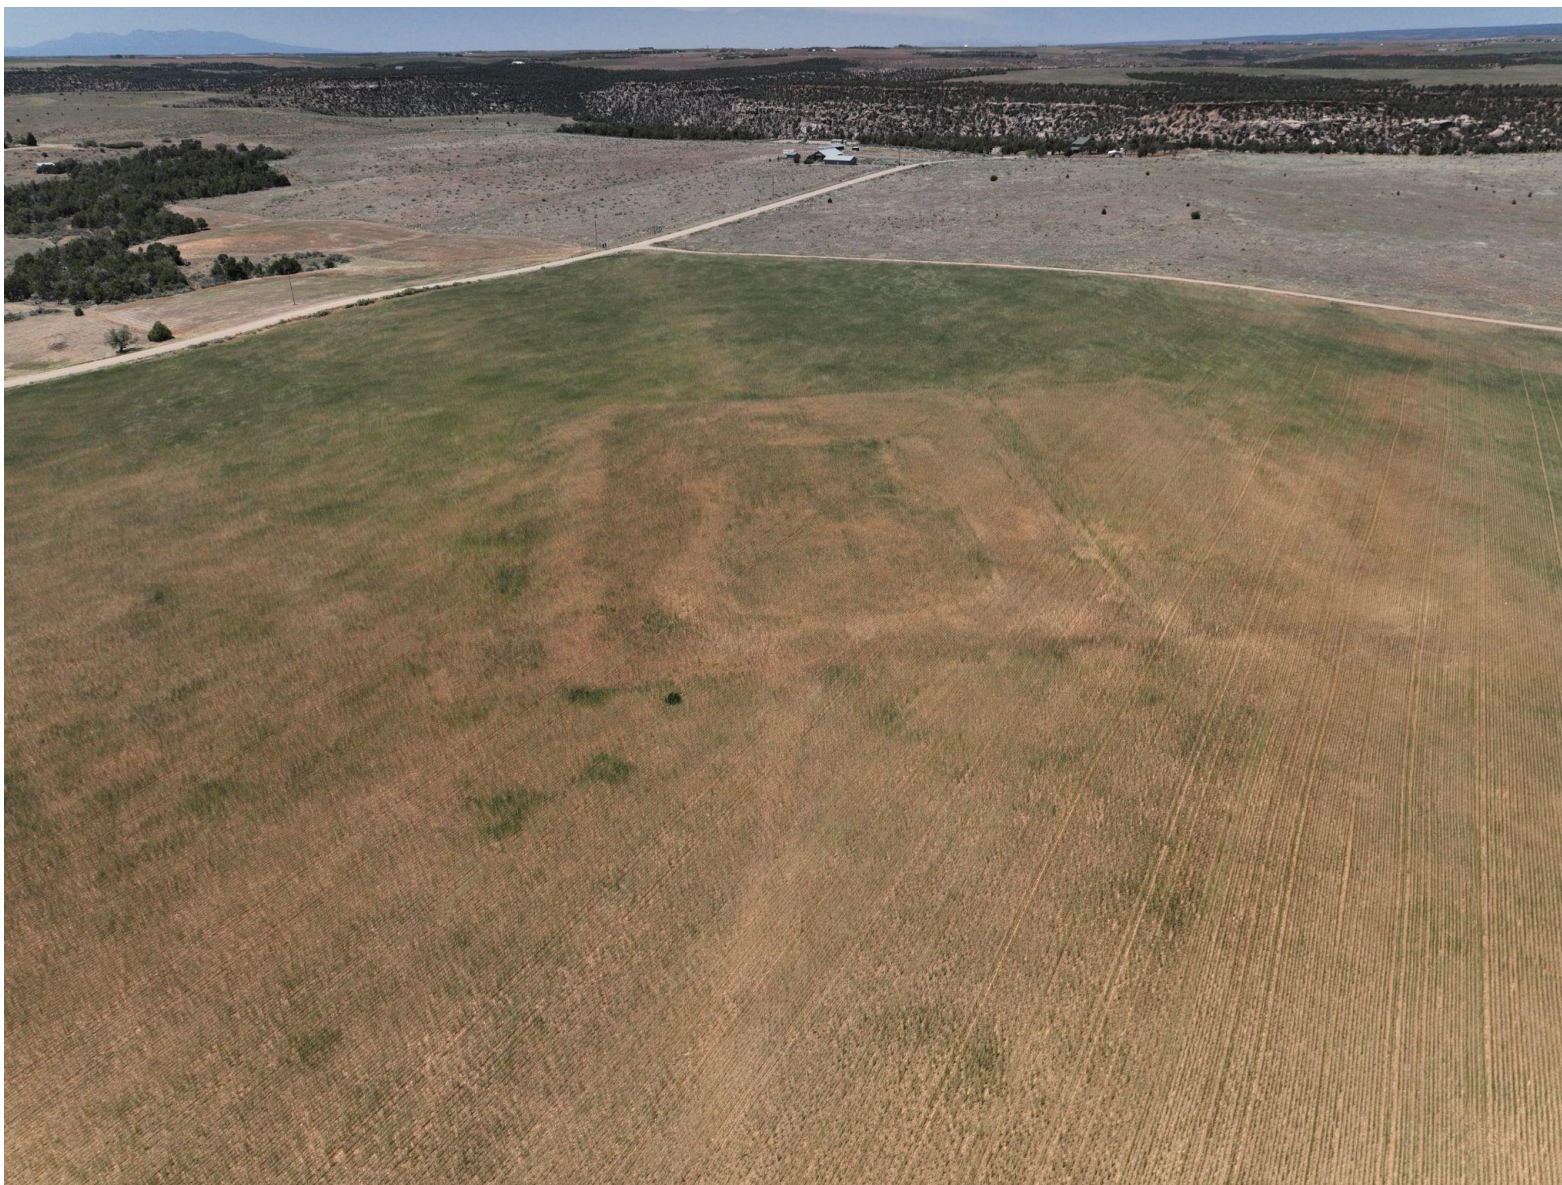
Photo 2. View of well pad and associated access road taken with a drone during the time of the inspection from the southern edge facing north. Note: stunting observed at well pad compared to reference areas, see photo 4.

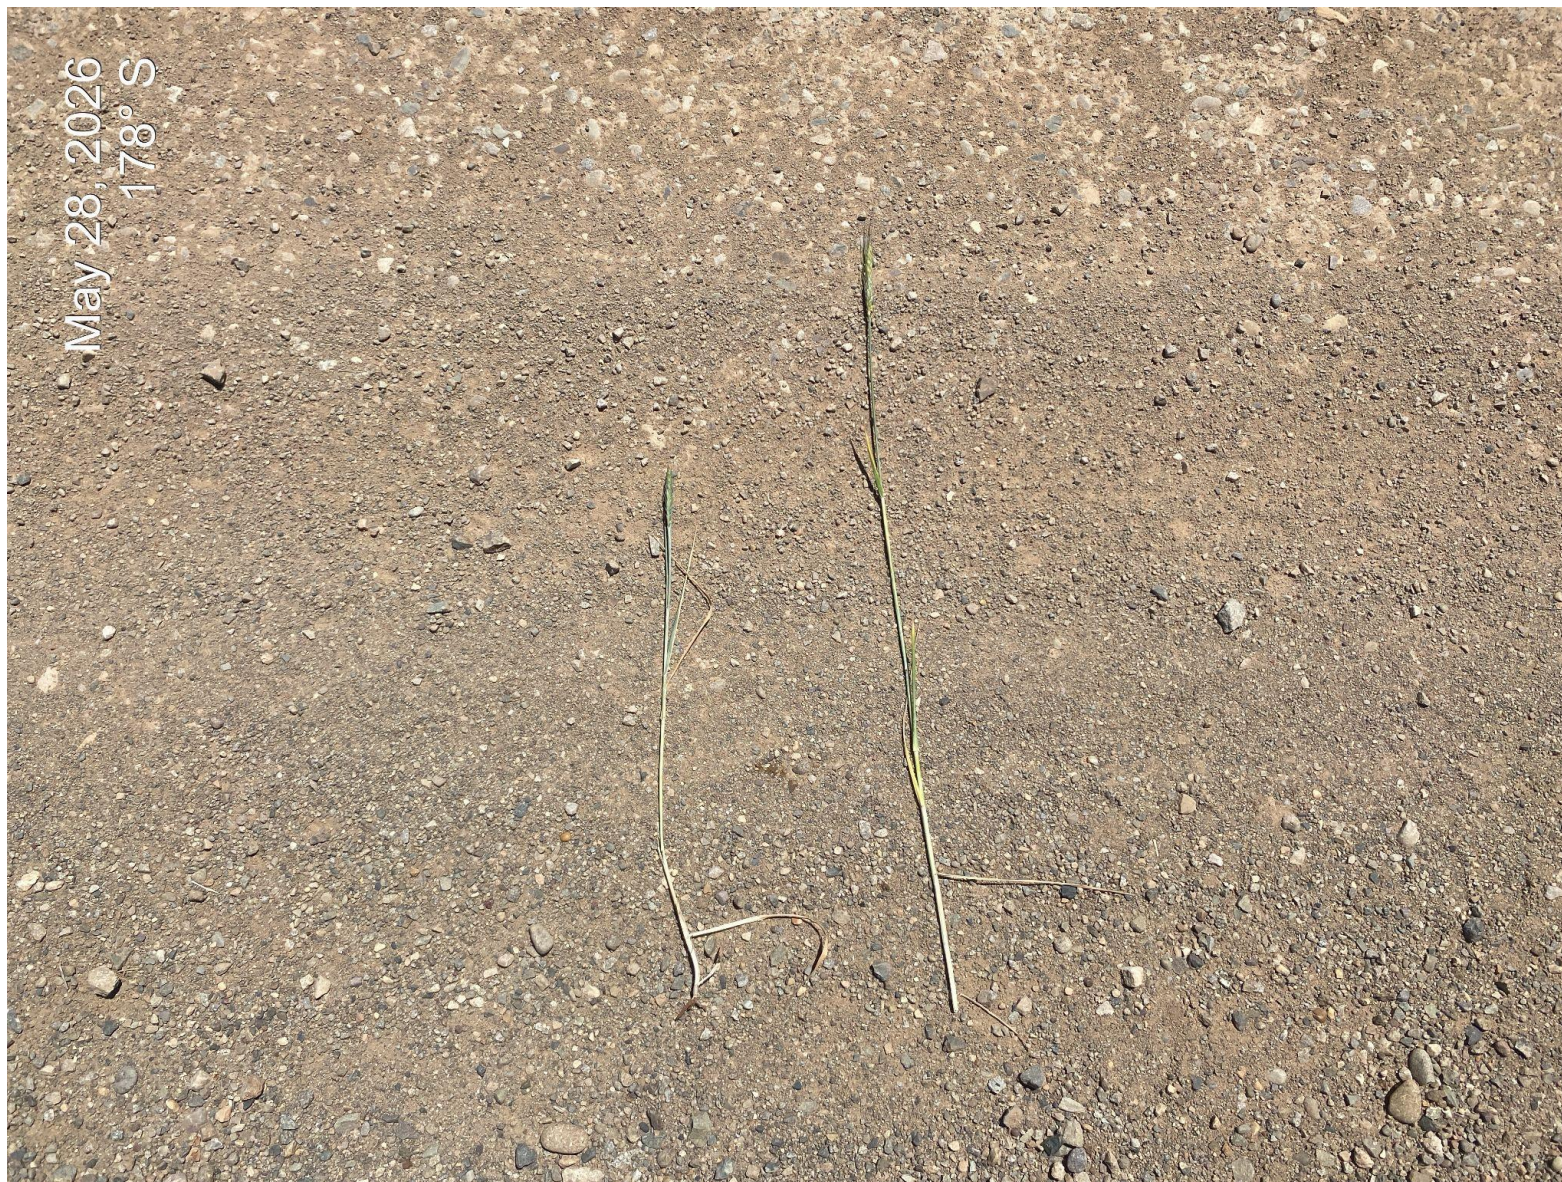
Photo 4. Well pad sample crop (left) and reference area crop (right) taken during the time of the inspection. Sample shows that project area has stunted crop compared to adjacent reference areas.
