Inspection/Audit Photos
Location Name: QB ENERGY OPERATING LLC PUCKETT 216-25 Pad
Location #: 324202

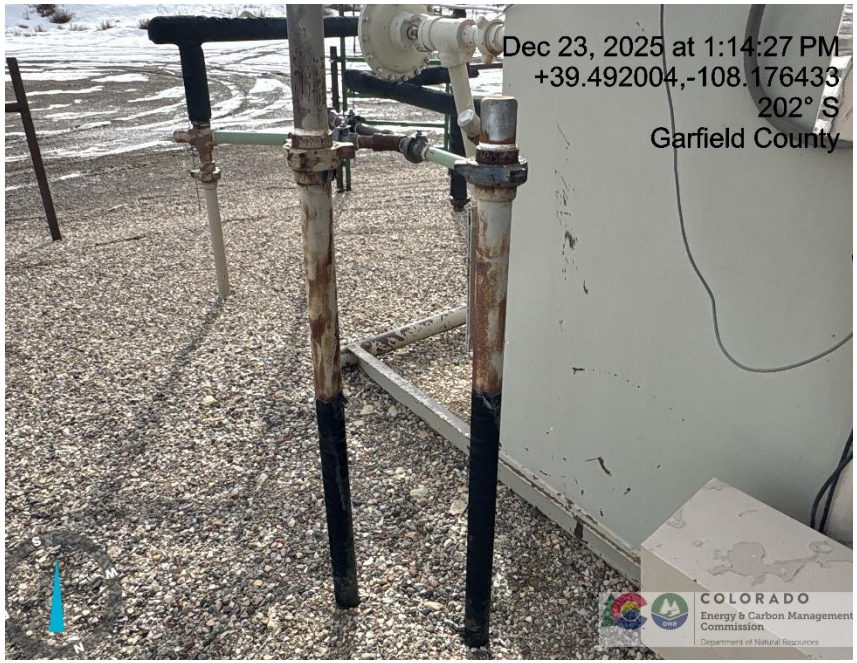
Photo # 5745 Unused flowline lacks lockout tagout (OOSLAT)

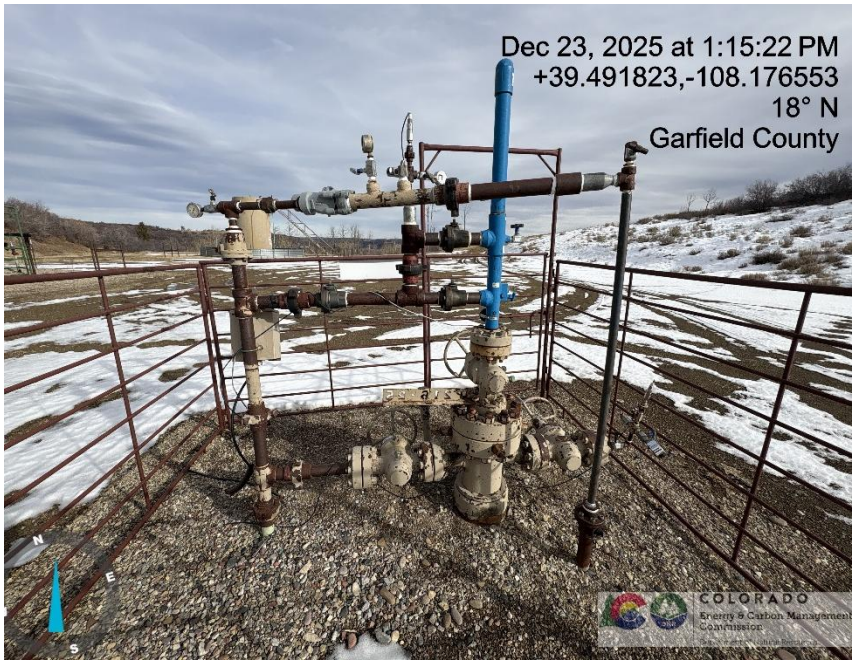
Photo # 5747 Bradenhead line tied into flowline (line lacks a check valve)
