SITE ASSESSMENT

DRAINAGE PLAN

SOUTHERN UTE 26-5

LA PLATA COUNTY, COLORADO

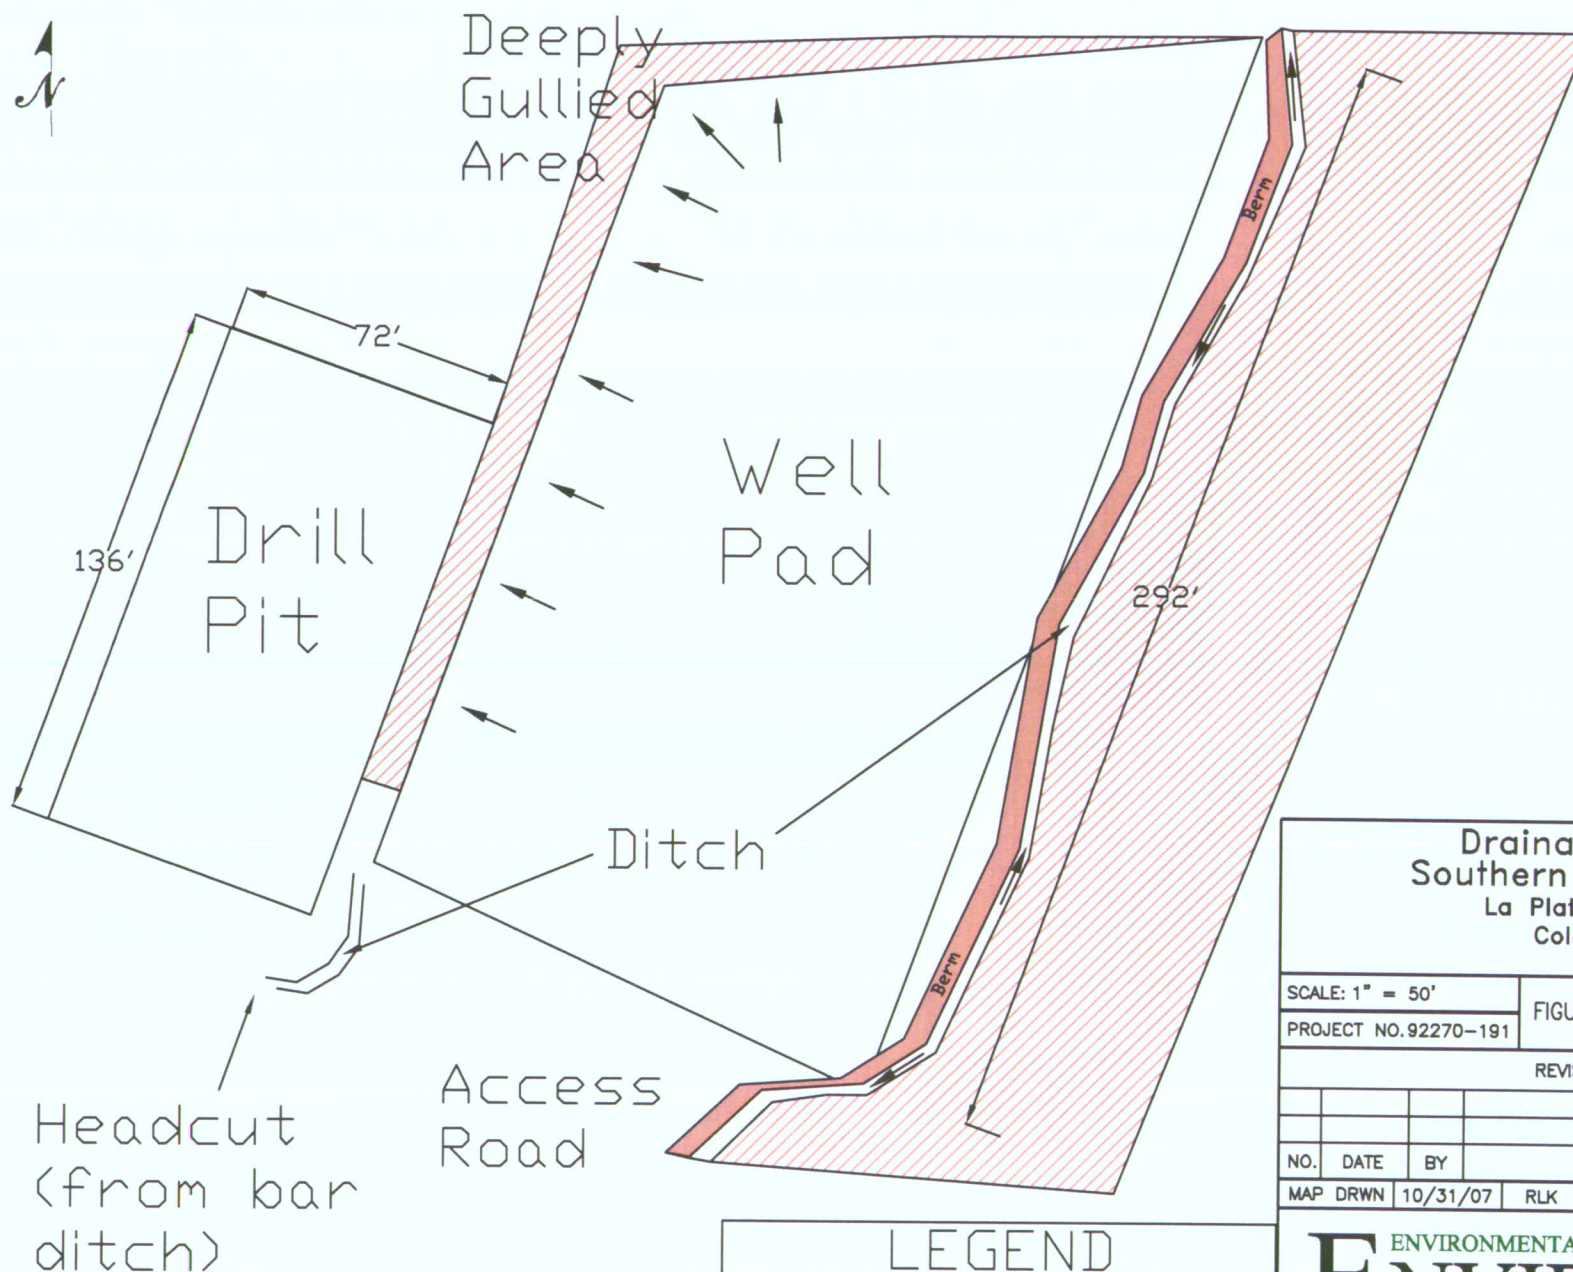
Drainage Map Southern Ute 26-5 La Plata County Colorado			
SCALE: 1" = 50'		FIGURE NO. 2	REV
PROJECT NO. 92270-191			
REVISIONS			
NO.	DATE	BY	DESCRIPTION
MAP DRWN	10/31/07	RLK	BASE DRWN
ENVIRONMENTAL SCIENTISTS & ENGINEERS ENVIROTECH 5796 U.S. HIGHWAY 64, FARMINGTON, NM 87401 505-632-0615

Envirotech, Inc. was contracted to do a site assessment and drainage plan to address significant erosion at Chevron North America's Southern Ute 26-5 well site; see **Figure 1, Vicinity Map**. Drainage off of the well pad is causing gullies to be formed on the north and west side of the pad where construction of the pad has caused steep slopes; see **Figure 2, Site Map**. There gullies are down cutting rapidly due to the slopes' angle and soil characteristics; see **Appendix A, Site Photography**.

The existing gullies at the north and west edges of the pad are being prevented from revegetating by continuous erosion. Construction of the cobble lined ditch would essentially stop the erosion by redirecting the water away from them. The steepness of these arroyos will make it difficult for vegetation to reestablish itself here. This process could be facilitated by the construction of juniper wicker dams to increase retention of soil moisture and fine sediment.

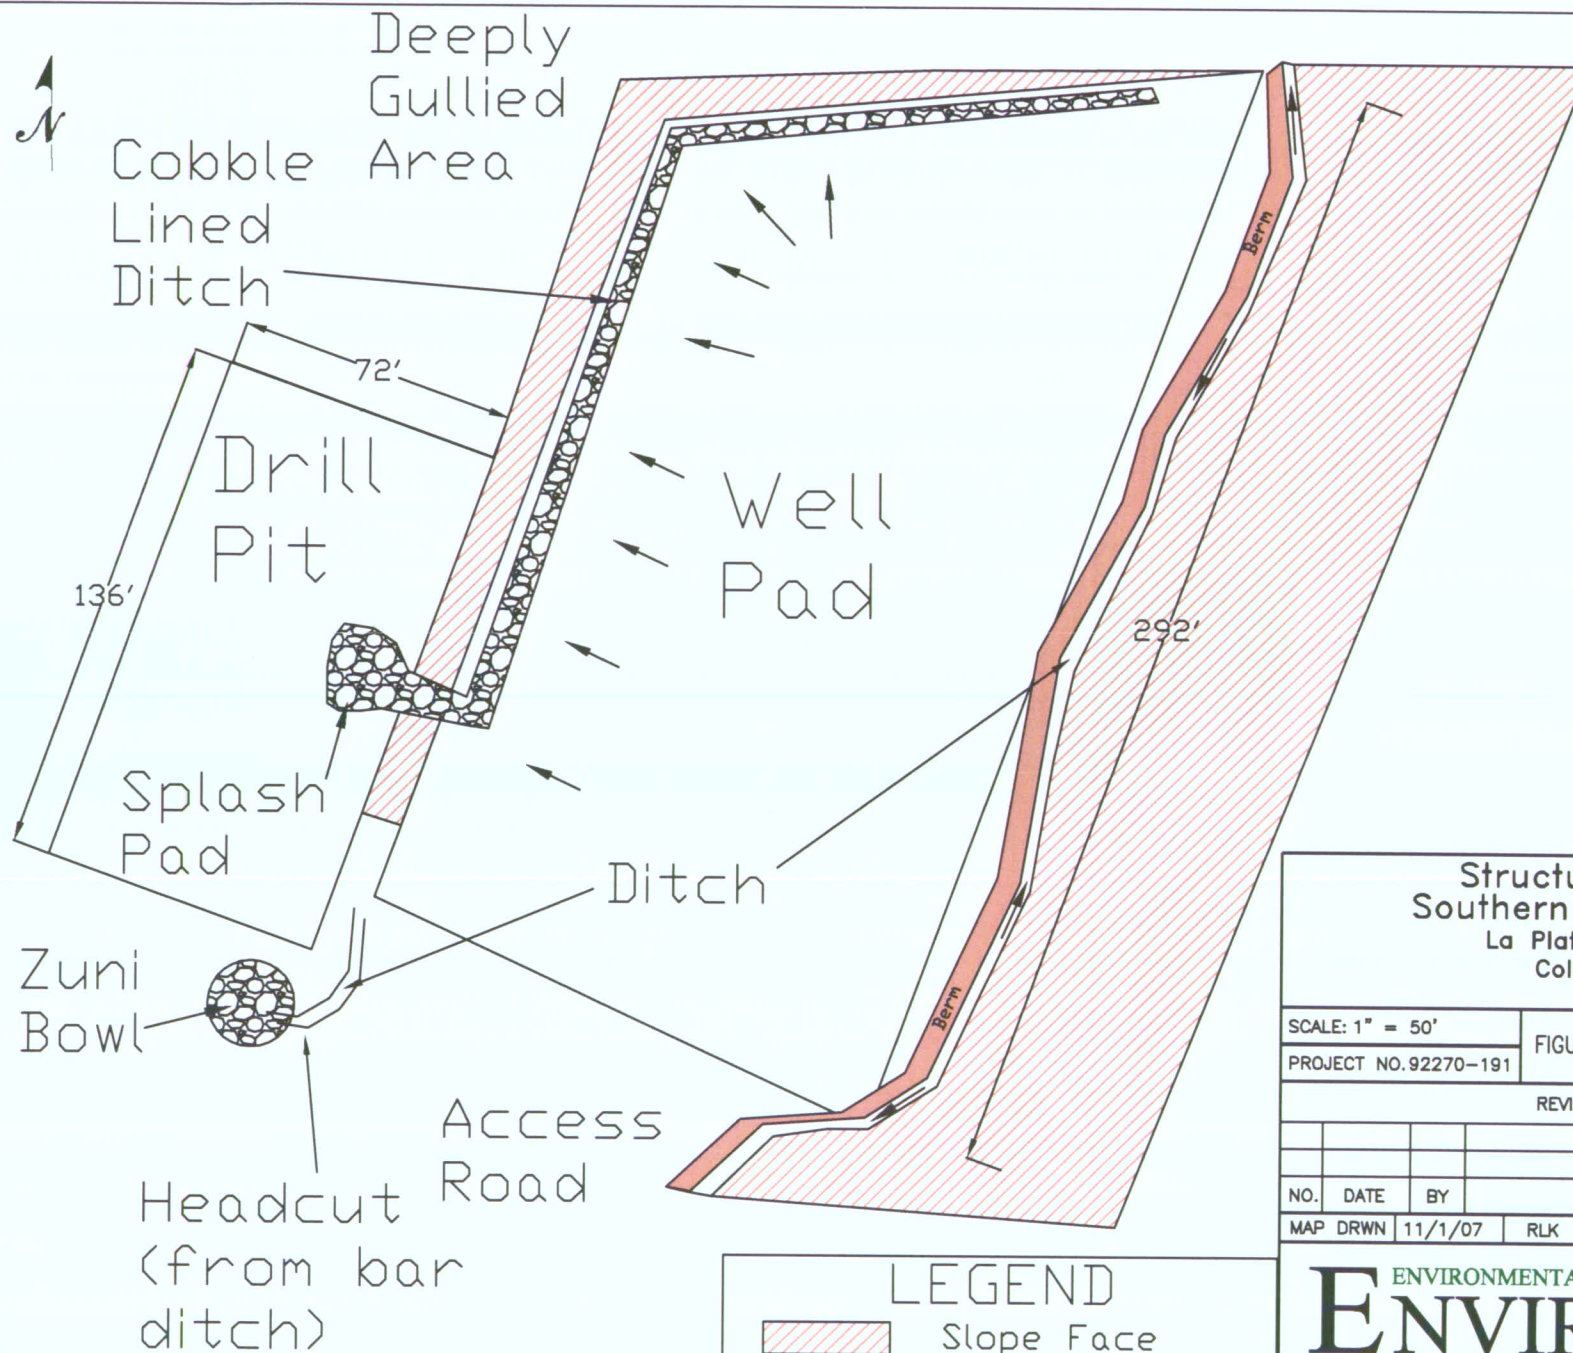
Structure Map
Southern Ute 26-5
La Plata County
Colorado

The steep slope to the north and west of the pad causes the runoff to gain velocity very quickly, leading to significant incising. The soil type is easily eroded, as demonstrated by gullies and tunneling apparent at the edge of the pad. An abandoned reserve pit is to the west of the well pad at the bottom of a steep slope approximately 20 feet high; see **Figure 2, Site Map**. This reserve pit is revegetating well and could serve as a kinetic energy sink for the runoff. The structure constructed for achieving this must be appropriate to the soil type. Because of the observed tunneling it is believed that installation of a berm to redirect the runoff would be undercut and fail due to water tunneling underneath it and creating a new channel. The remaining berm would continue to concentrate the flow into the new channel created by the berm failure and a new arroyo would be created. A cobble lined ditch along the north and west sides of the drill pad would be a more stable solution under these conditions; see **Figure 3, Structure Map**. The channel constructed from the well pad down to the reserve pit would also need to be cobble lined (a rock rundown); see **Figure 4, Structure Detail**. Due to slope angle this rock rundown should be reinforced with green juniper pickets and heavily seeded with a site appropriate mix of grasses and shrubs. The juniper pickets will keep the cobble in place until vegetation is established. The size of picket required does not necessitate the cutting down of entire live trees. If such action is approved the needed pickets could be harvested near the site by limbing surrounding juniper trees with a chain saw. A cobble splash pad at the bottom of the rock rundown will prevent the structure from failure caused by undercutting. A pipe or culvert installation here is not recommended as it is likely that water would tunnel around it in this soil type, causing failure and creation of a new arroyo in place of the pipe or culvert.
