Casing Inspection Evaluation Report

Client: Kinder Morgan
Well: Sand Canyon 8
Field: McElmo Dome
County: Montezuma
State: Colorado

Analyst: Chris McIlroy
Date: 10/05/2010
Location: Denver RES
Phone: (303) 899-4694

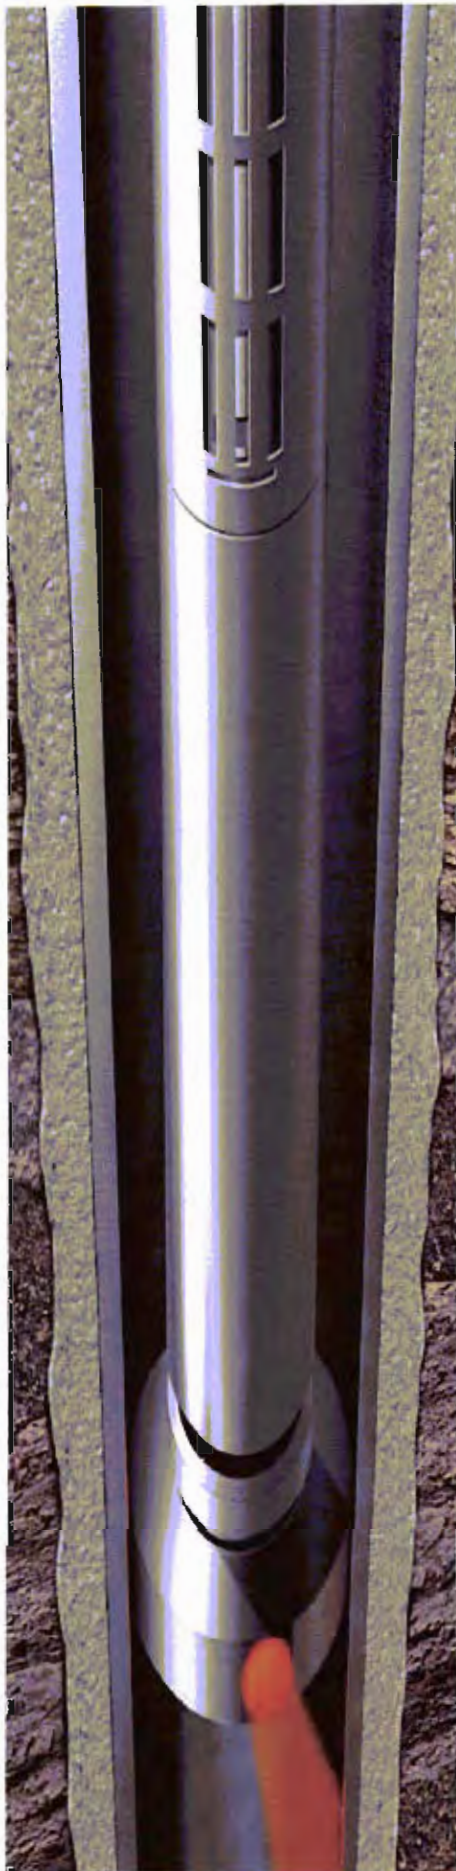
In track 3 we see both internal and external damage. This is corroborated by the thickness curves in track 6. Track 8, the total damage track, tells us that at its worst this damage is less than 20% as shown by the green color.

6664-6678 Looking at track 2 the amplitude curve points to the area around 6570' that we need to look at. The eccentricity in track 1 could be due to pipe damage at the joint or hole problems highlighting the overall poor condition of this collar.

7228-7235 Starting in the depth track, the CCL shows a 5' color. Track 2 shows the collar at 7230' appears over a 5 foot interval. Tracks 4 and 5 show enlarged radius, tracks 6 and 7 show small thickness. Track 8 shows damage greater than 20% and is a cause for concern.
