July 17, 2012

Evaluation of Encana 12" Water Line or "CBM" – Poly Pipeline

Introduction:

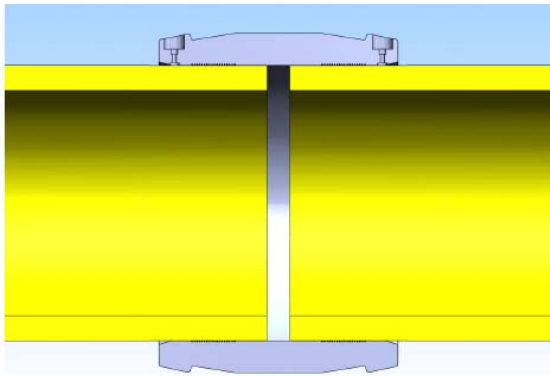
Fig 4

This evidence indicates improper installation of this coupling. A normal or proper connection should look like this. (figure 4)

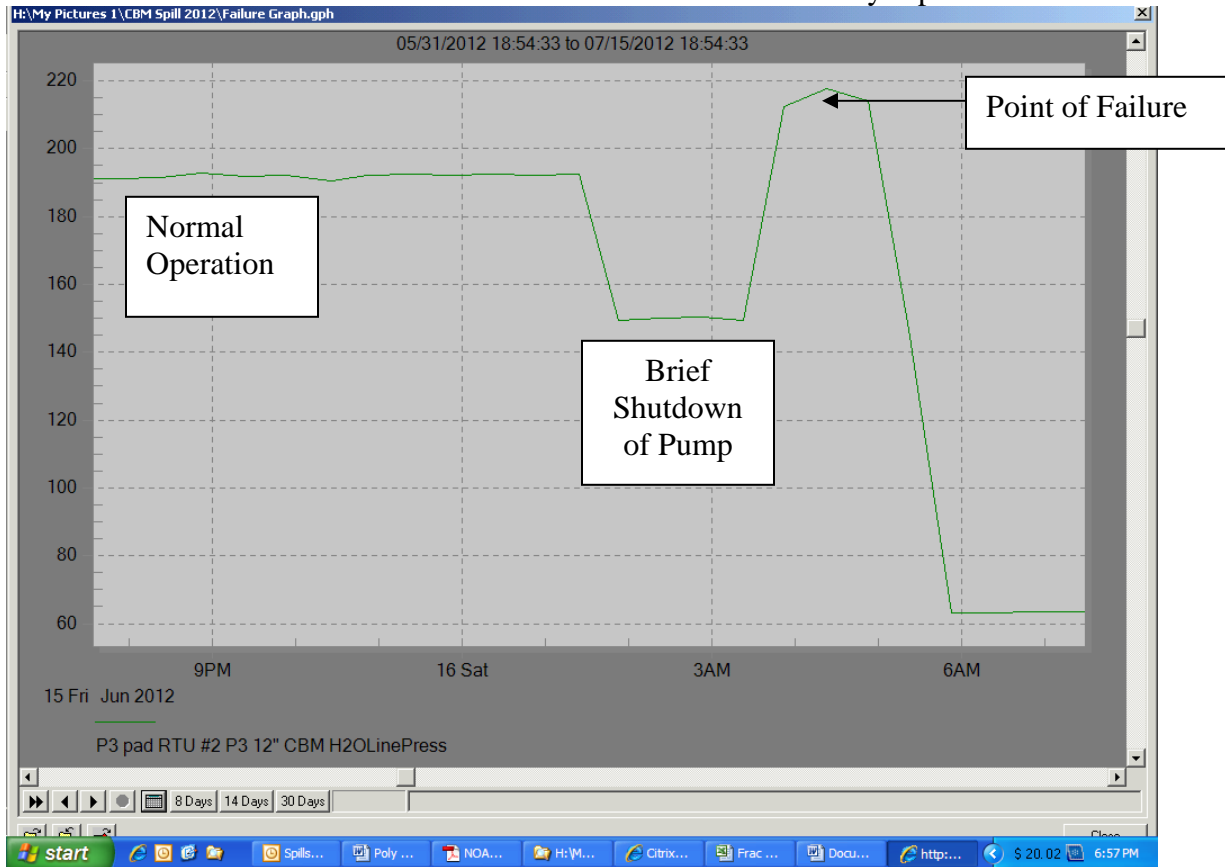
Fig 12

This chart shows the various operating conditions (pressure) at the closest point to the failure in the line. Next figures will look at the various operations in greater detail.
