July 17, 2012

## Evaluation of Encana 12" Water Line or "CBM" – Poly Pipeline

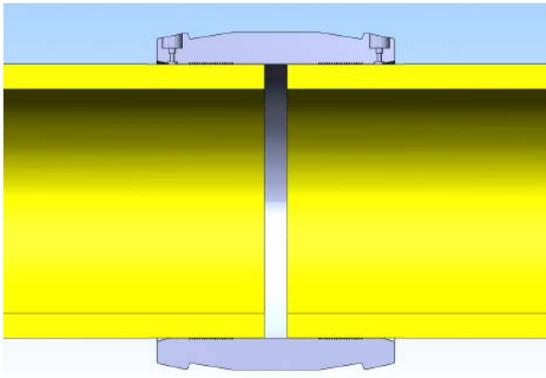
Fig 4

This evidence indicates improper installation of this coupling. A normal or proper connection should look like this. (figure 4)

Good Fusion with even alignment (90 deg)

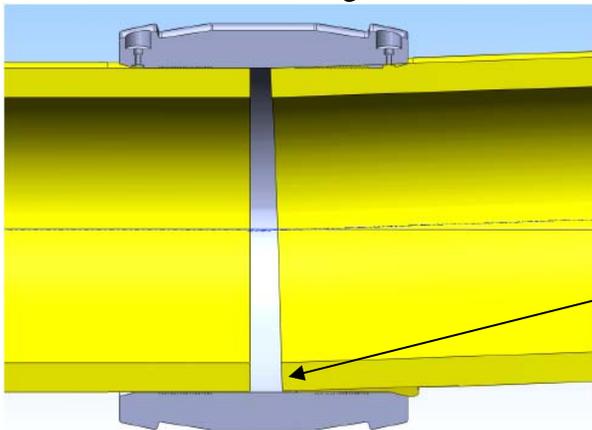
Fig 5

A connection that is misaligned will look like this (figure 5)

Increased Gap

Notice the larger gap on bottom

It appears that the coupling was not put on the end of the pipe square this would account for the deviation in the center of the fitting. In other words the pipe was put in on one end at an angle which is improper. The pipe should have been marked to prevent this from Happening. Dale Electro Fuse couplers are rated for 200 PSI especially 6-8 years ago. To sum it up the failure was most likely caused from improper installation.

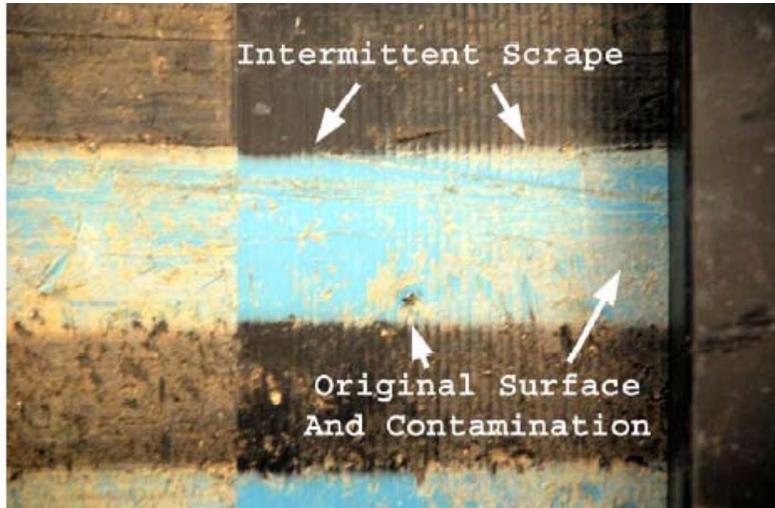
Here is an example of poor bonding from the Plastics Institute. This is very similar to what is seen in the coupling that failed.

Poor Scrape Unacceptable

Possible Causes: Incorrect Scraper, Poorly Maintained Scraper. Inadequate Number of Passed With Scraper, and Ineffective evaluation of Scraping

Per our earlier conversation regarding the Electro Fusion coupler failures. After looking at these pictures all indication are directed at improper installation of these fittings. It appears that the pipe O.D. was not properly prepared and shows signs of contamination this contamination was also evident in the coupler.

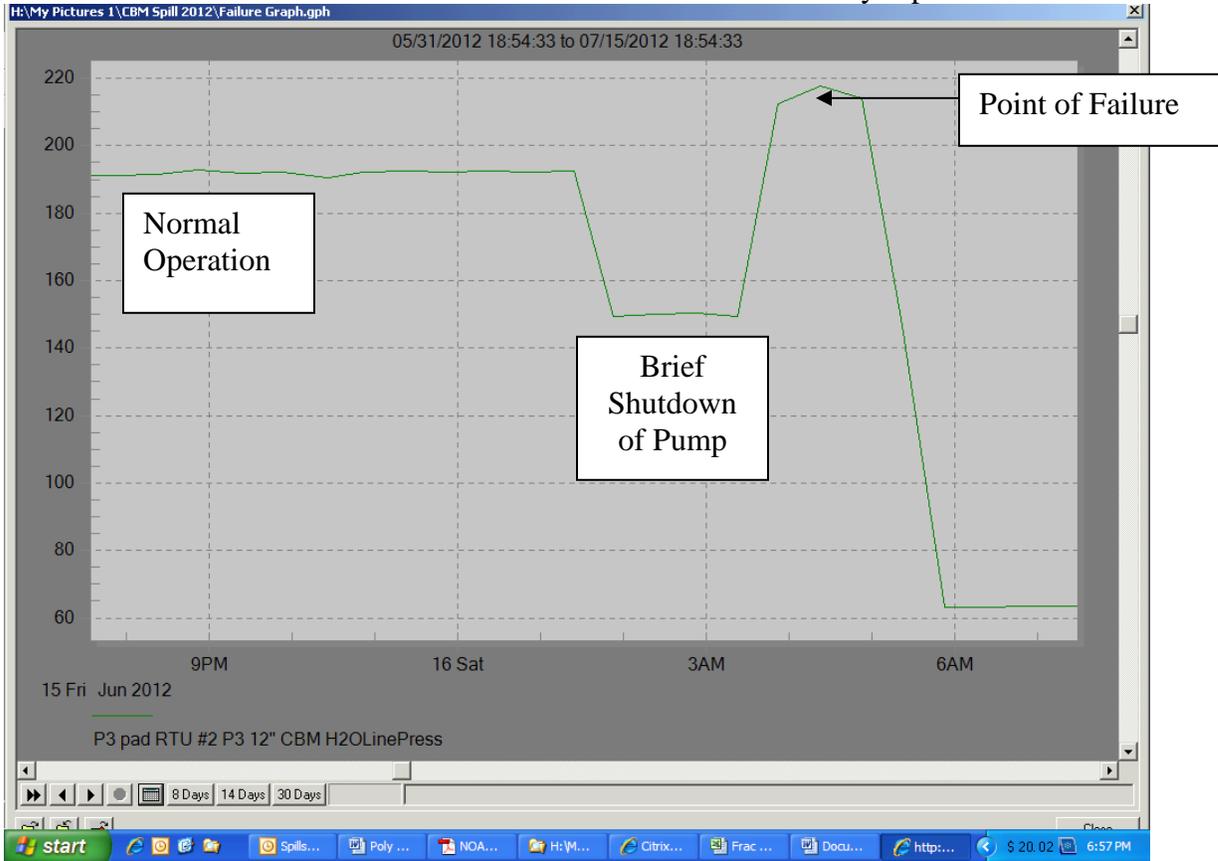
Fig 12

This chart shows the various operating conditions (pressure) at the closest point to the failure in the line. Next figures will look at the various operations in greater detail.

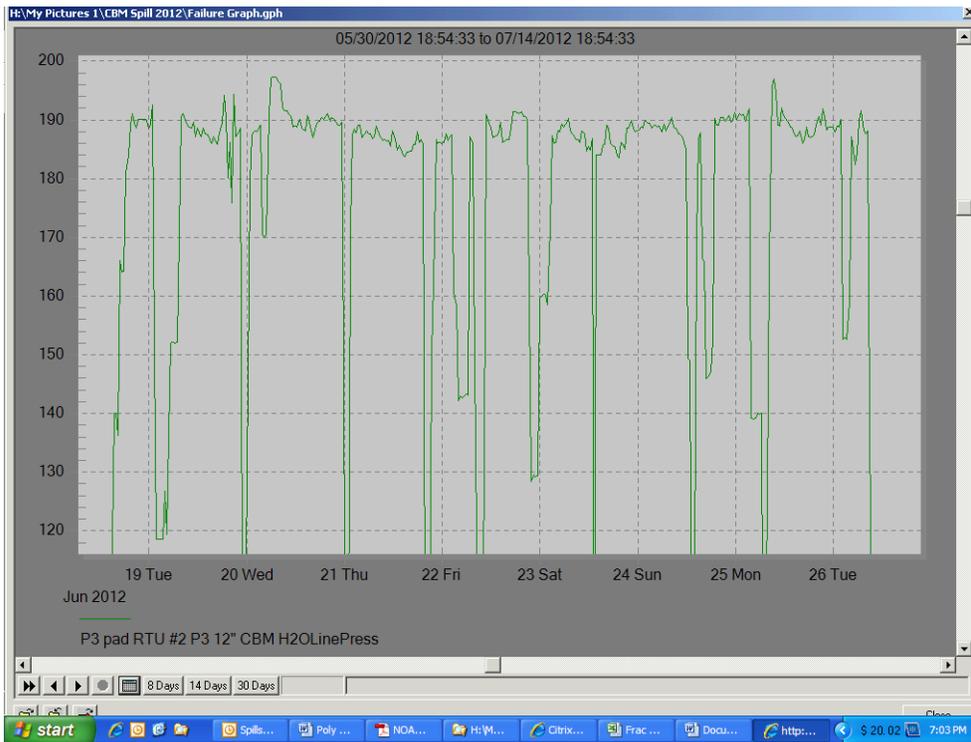
Fig 13

Resume operations after repairs – Finish Frac Operations on F12E

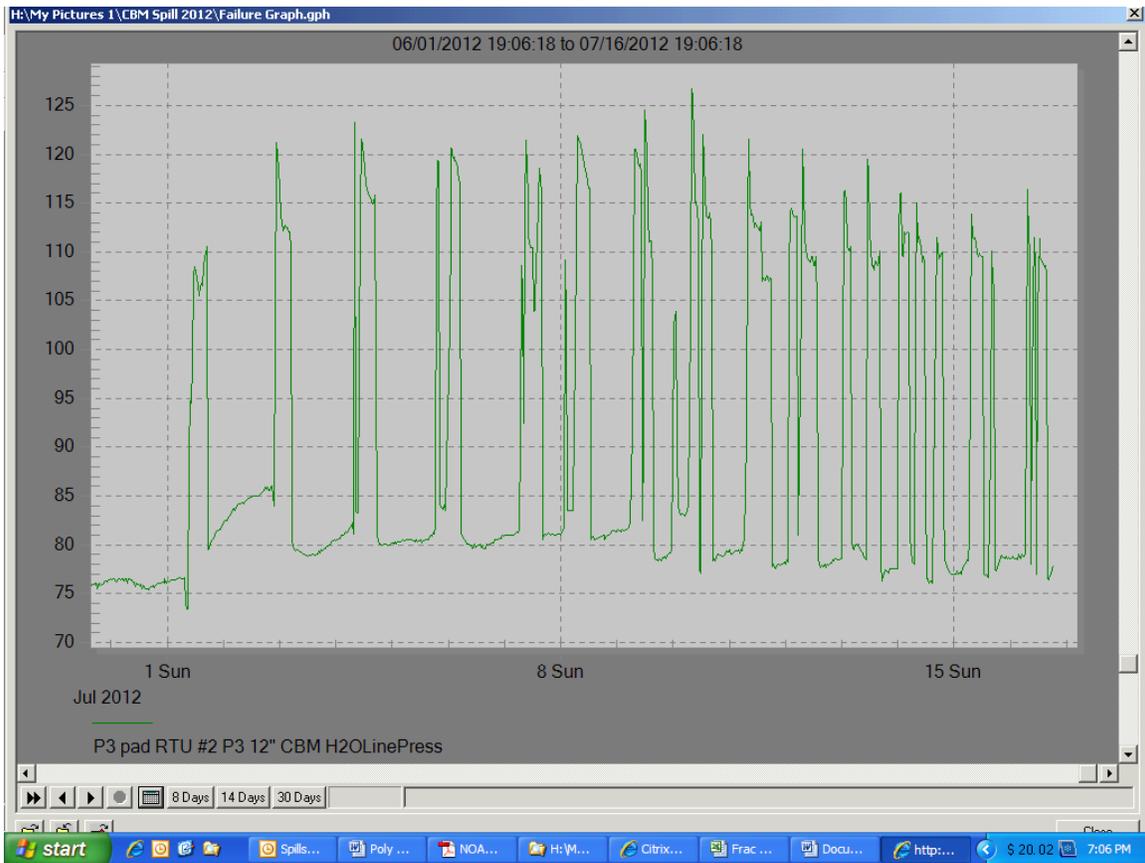
Fig 14

Chart of pressure to pump water back to Hunter Mesa
