Praxair Walden CO2 Plant

October 22, 2013

CO2 Plant Operations

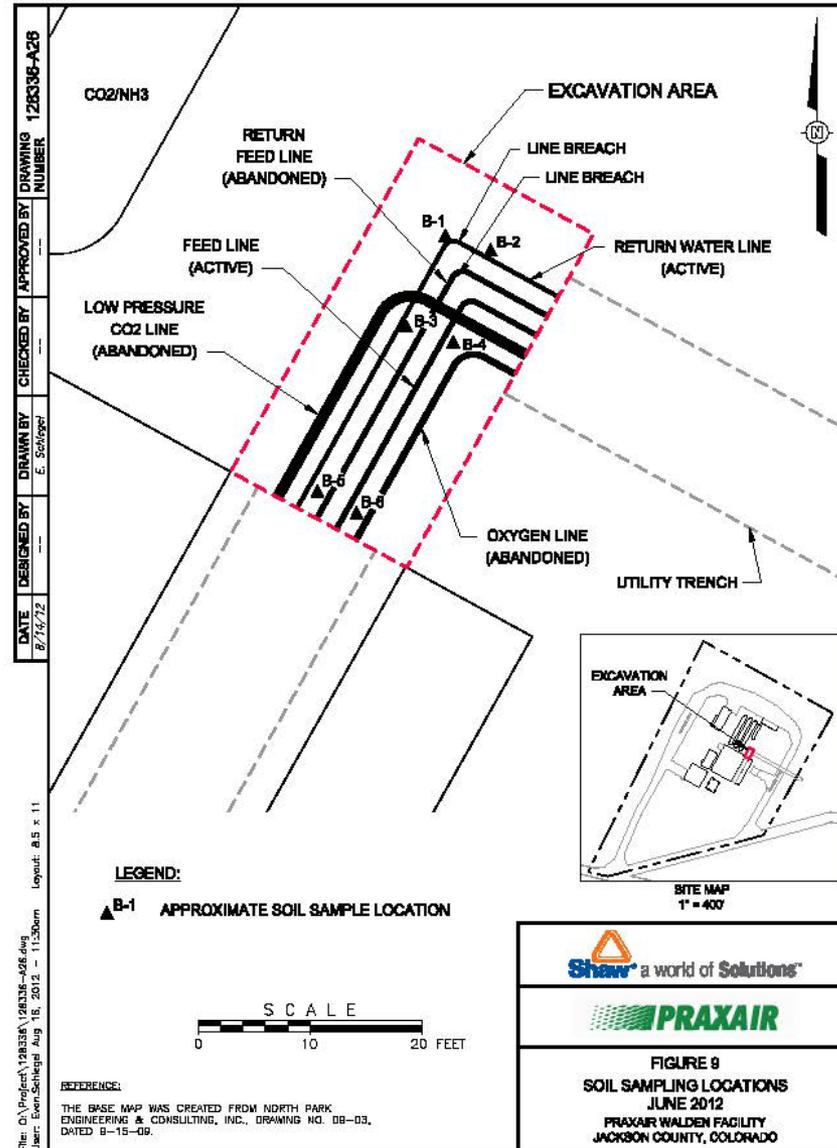
- June 2012 pressure line test
- Breaches occurred in return water and return gas lines at elbow NW of plant
- Excavated impacted soils and determined limited area of impact
- Impacted soils to a depth of 6' bgs
- Release did not impact groundwater
- Concluded that breaches from pressure test were not the source of MW-4 nor MW-11 which is up gradient
