SPILL/RELEASE REPORT

Date of Incident: 16-Aug-11	Facility Name & No: Rangely Weber Sand Unit	County: Rio Blanco
Type of Facility (well, tank battery, flow line, pit): Injection Well		QtrQtr: SWNW Section: 29
Well Name and N Fee 114X		Township: 2N Range: 102
API Number: 05-103-080311		Meridian: 6PM
Specify volume spilled and recovered (in bbls) for the following materials:		
Oil spilled: 0	Oil recov'd: 0	Water spilled: 105.65
Water recov'd: 104	Other spilled: 0	Other recov'd: 0
Ground Water impacted? <input type="checkbox"/> Yes <input checked="" type="checkbox"/> No	Surface Water impacted? <input type="checkbox"/> Yes <input checked="" type="checkbox"/> No	
Contained within berm? <input type="checkbox"/> Yes <input checked="" type="checkbox"/> No	Area and vertical extent of spill: 596.2 X 2.5	
Current land use: Non Crop Land	Weather conditions: 60 Degrees Cloudy	
Soil/geology description: Silty Clay		
IF LESS THAN A MILE, report distance IN FEET to nearest ... Surface water: N/A wetlands: N/A buildings: N/A

CHEVRON –FEE 114X

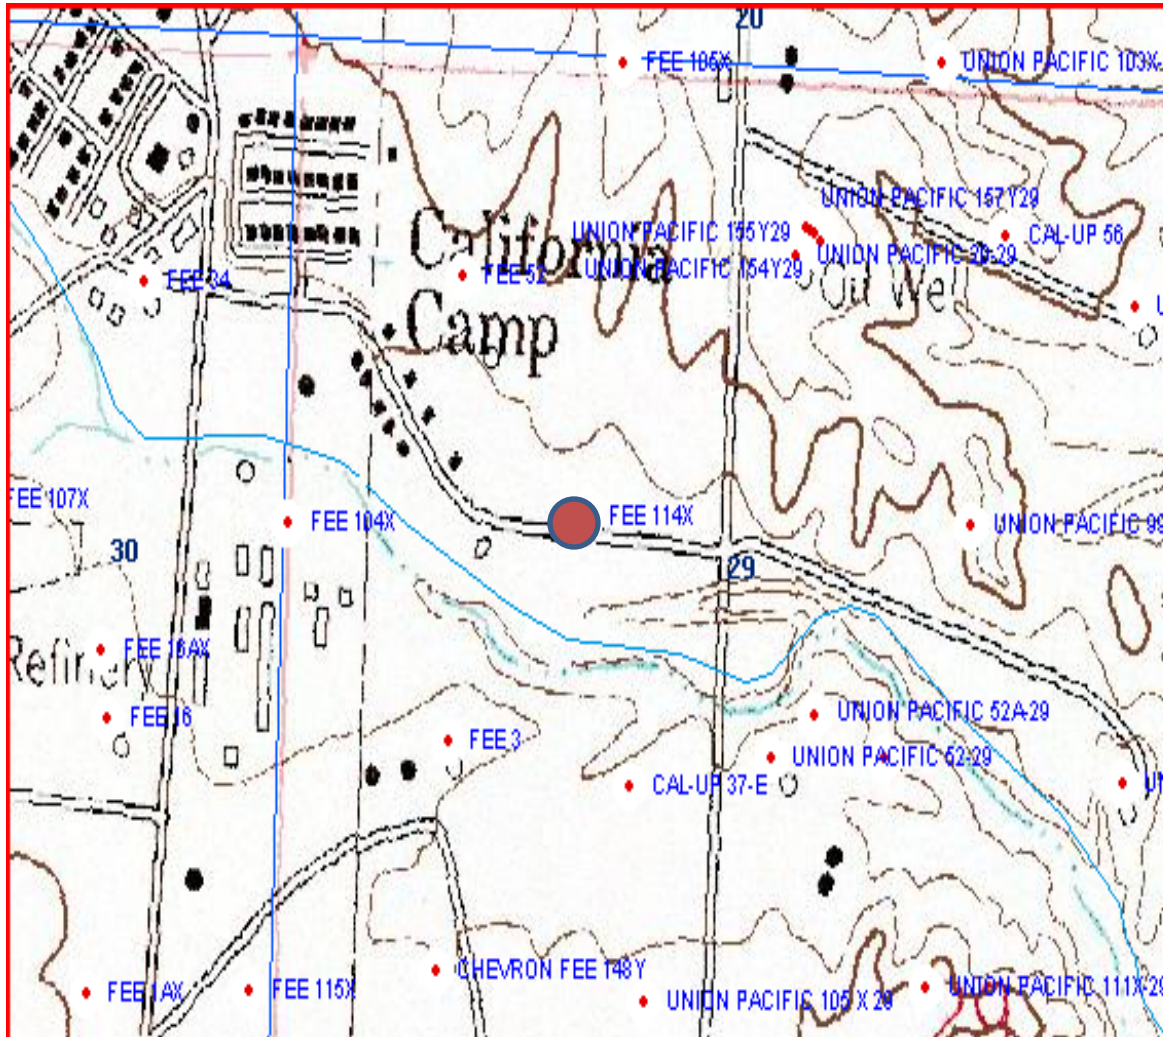
Livestock: N/A Water wells: N/A Depth to shallowest ground water: N/A		
Cause of spill (e.g. equipment failure, human error, etc.): Internal Corrosion		
Detailed description of the spill/release incident: A leak occurred on a 10 inch steel pipe approximately 450 feet west of Well Fee 114X. Approximately 105.65 bbls of brine water were released.

WELL HEAD

Describe measures taken to prevent problem from reoccurring: The damaged section of pipe (270 feet) will be replaced.
