**SENSITIVE AREA DETERMINATION
RICE LEASE - SITE SPECIFIC
SUBSURFACE INVESTIGATION REPORT
REMEDATION #8461**

**CM PRODUCTION, LLC
CLIFF UNIT— RICE LEASE PRODUCED WATER PITS
SECTION 33, T12N, R54W, 6TH P.M.
LOGAN COUNTY, COLORADO**

JANUARY 2015

OLSSON PROJECT No. 014-0704

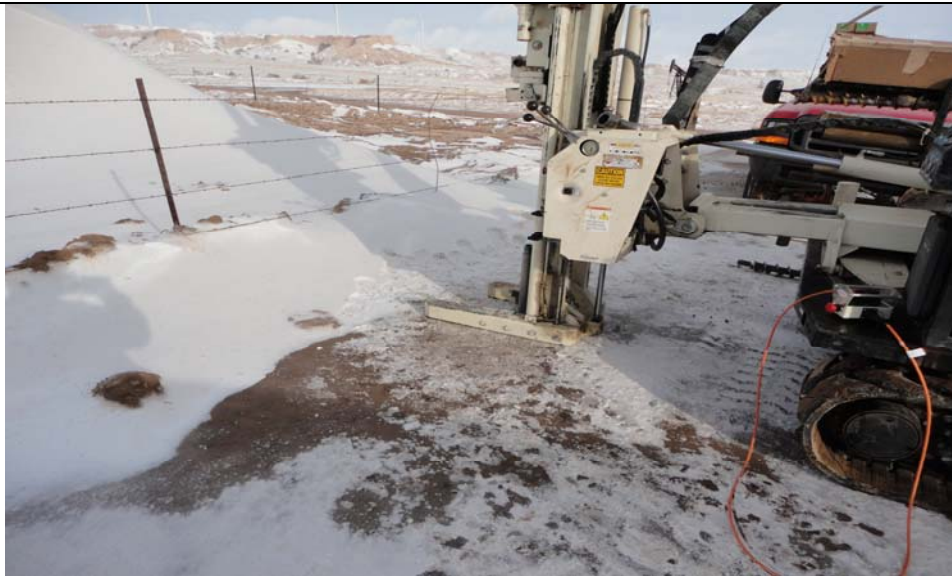
Subject: Site Services setting up to begin drilling the MW-1 location on the southeast corner of the south pit.

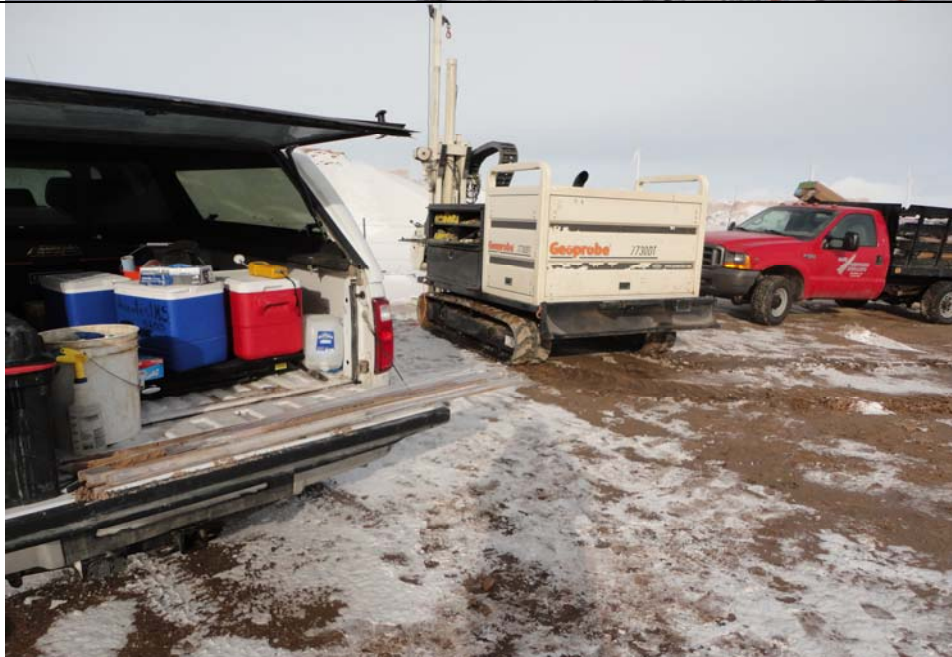
Subject: Site Services used a 7730 DT track-mounted Geoprobe® to collect soil samples in Macro-core® barrels containing polyacetate soil sample sleeves.

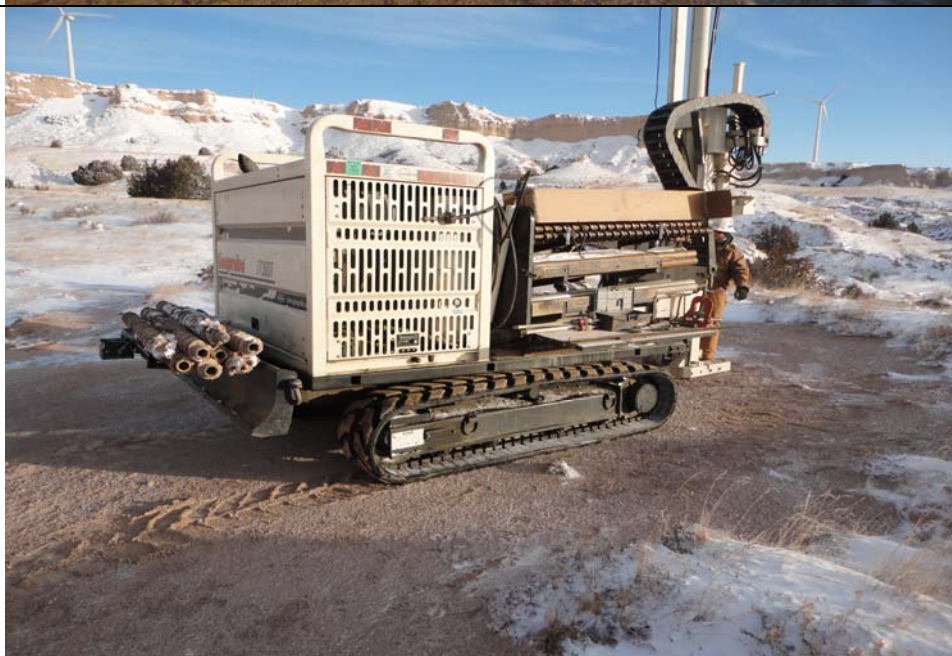
Subject: Site Services sets up to probe/drill the test hole for MW-2 using a rubber track mounted 7730 DT Geoprobe® rig.

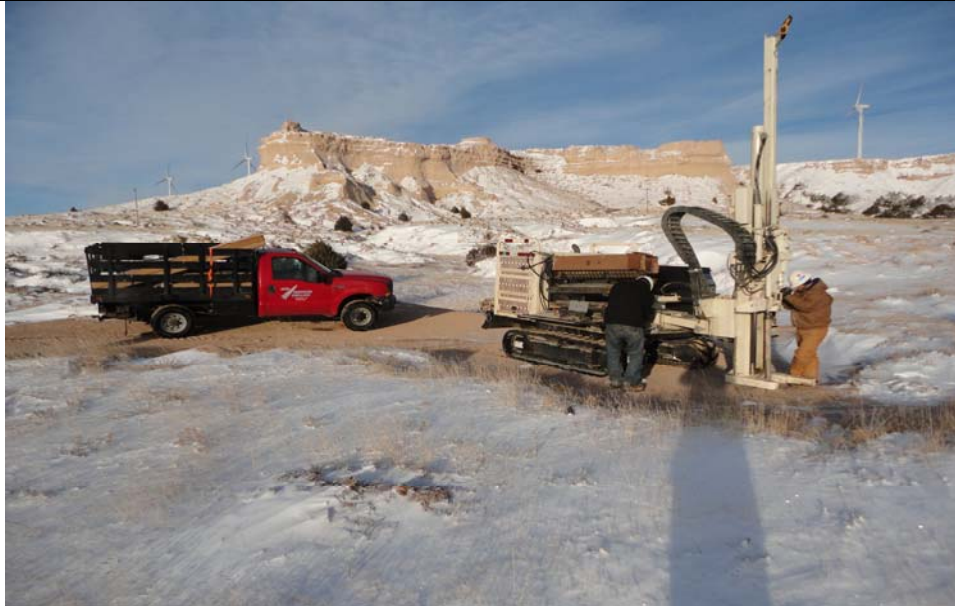
Subject: Site Services direct-push boring for collection of soil samples at the MW-2 location (up gradient) of the site.

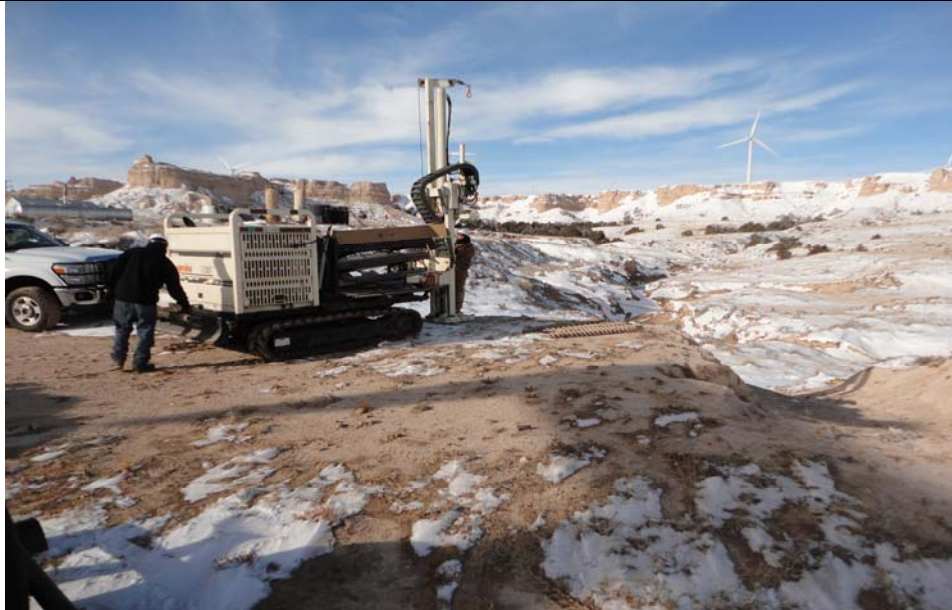
Subject: Site Services set up to advance the direct-push soil test hole for monitoring well, MW-3, on the north side of the Rice #2 well pad.
