September, 2015 COGCC Environmental field inspection of CM Productions LLC Pit Complex Facility
(Location ID: 324634, Pit Facility IDs 112265, 112266, 112267, 112268, 112269, and 115241)

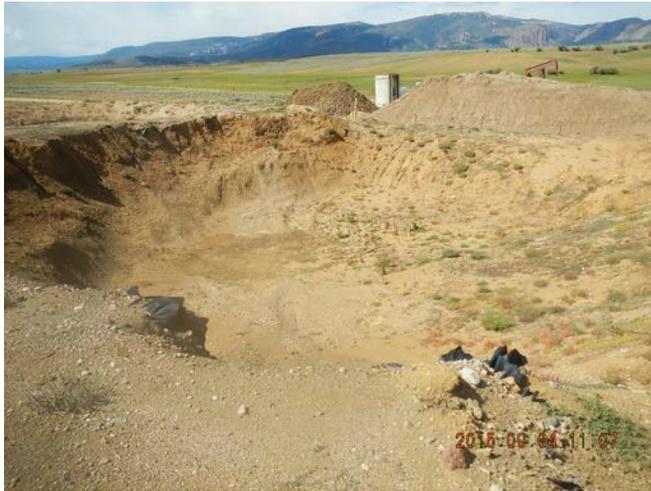
Pit Facility 115241- Pit bottom appeared to be moist with some vegetation growth. Material has sloughed from the sides or upper portion of the pit. Surface water runoff from the main Facility is controlled via a ditch was constructed along the north side of the Pit Complex. Pit not netted.
