**Photo 2:** Photo of PR well Murphy # 11-5, API # 005-07112

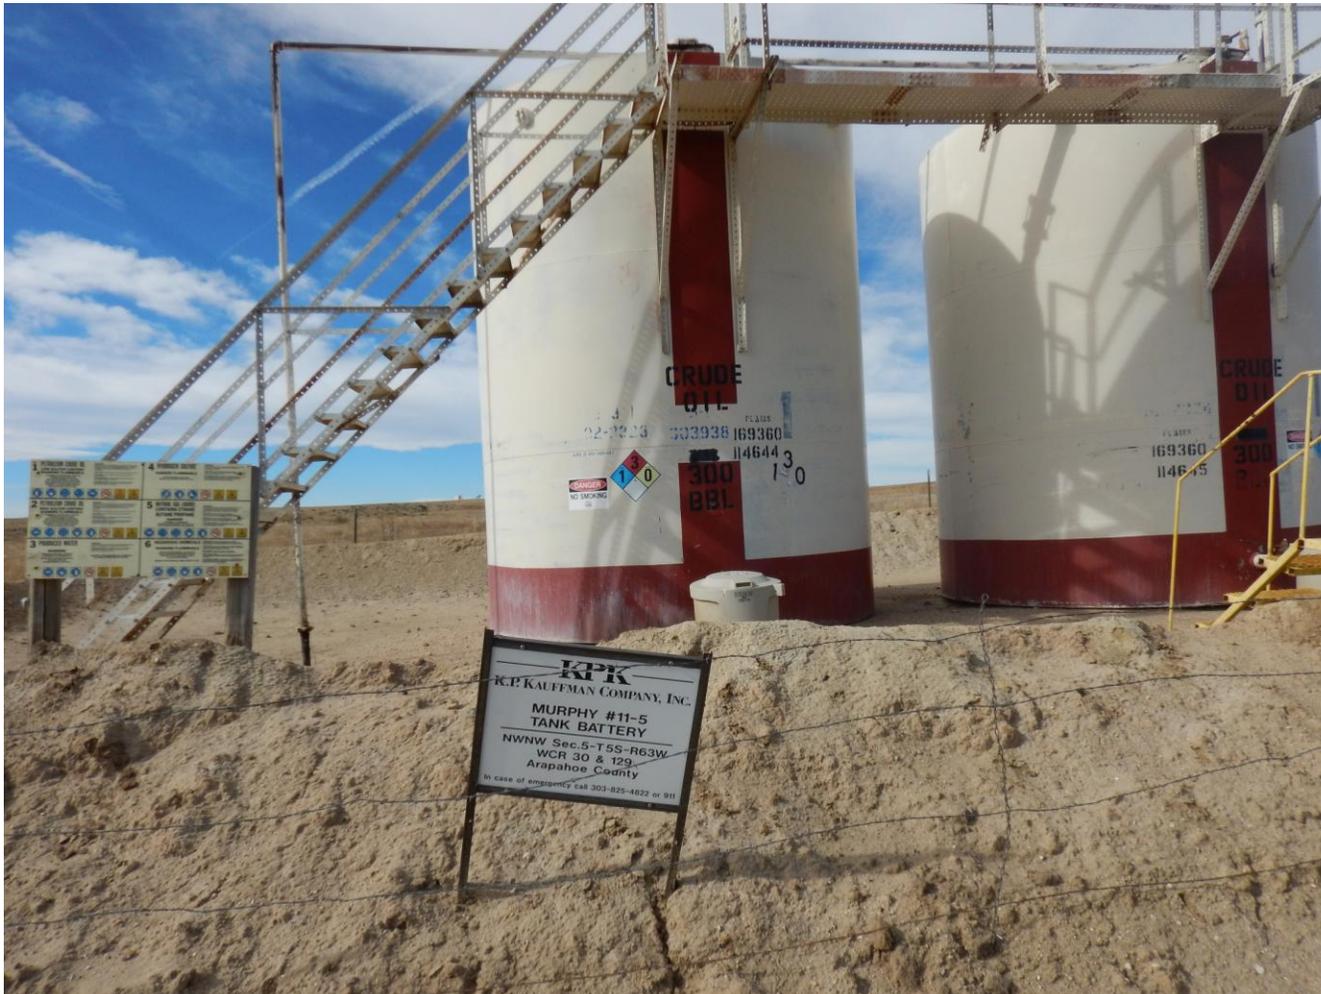
Photo 6: Photo of Murphy # 11-5 tank batteries. Battery location is approximately one quarter (1/4) of a mile east of well location.
