HRM- Stormwater and Erosion Overview Map

**#3-Mandy
Lease Road
API 123-10604**

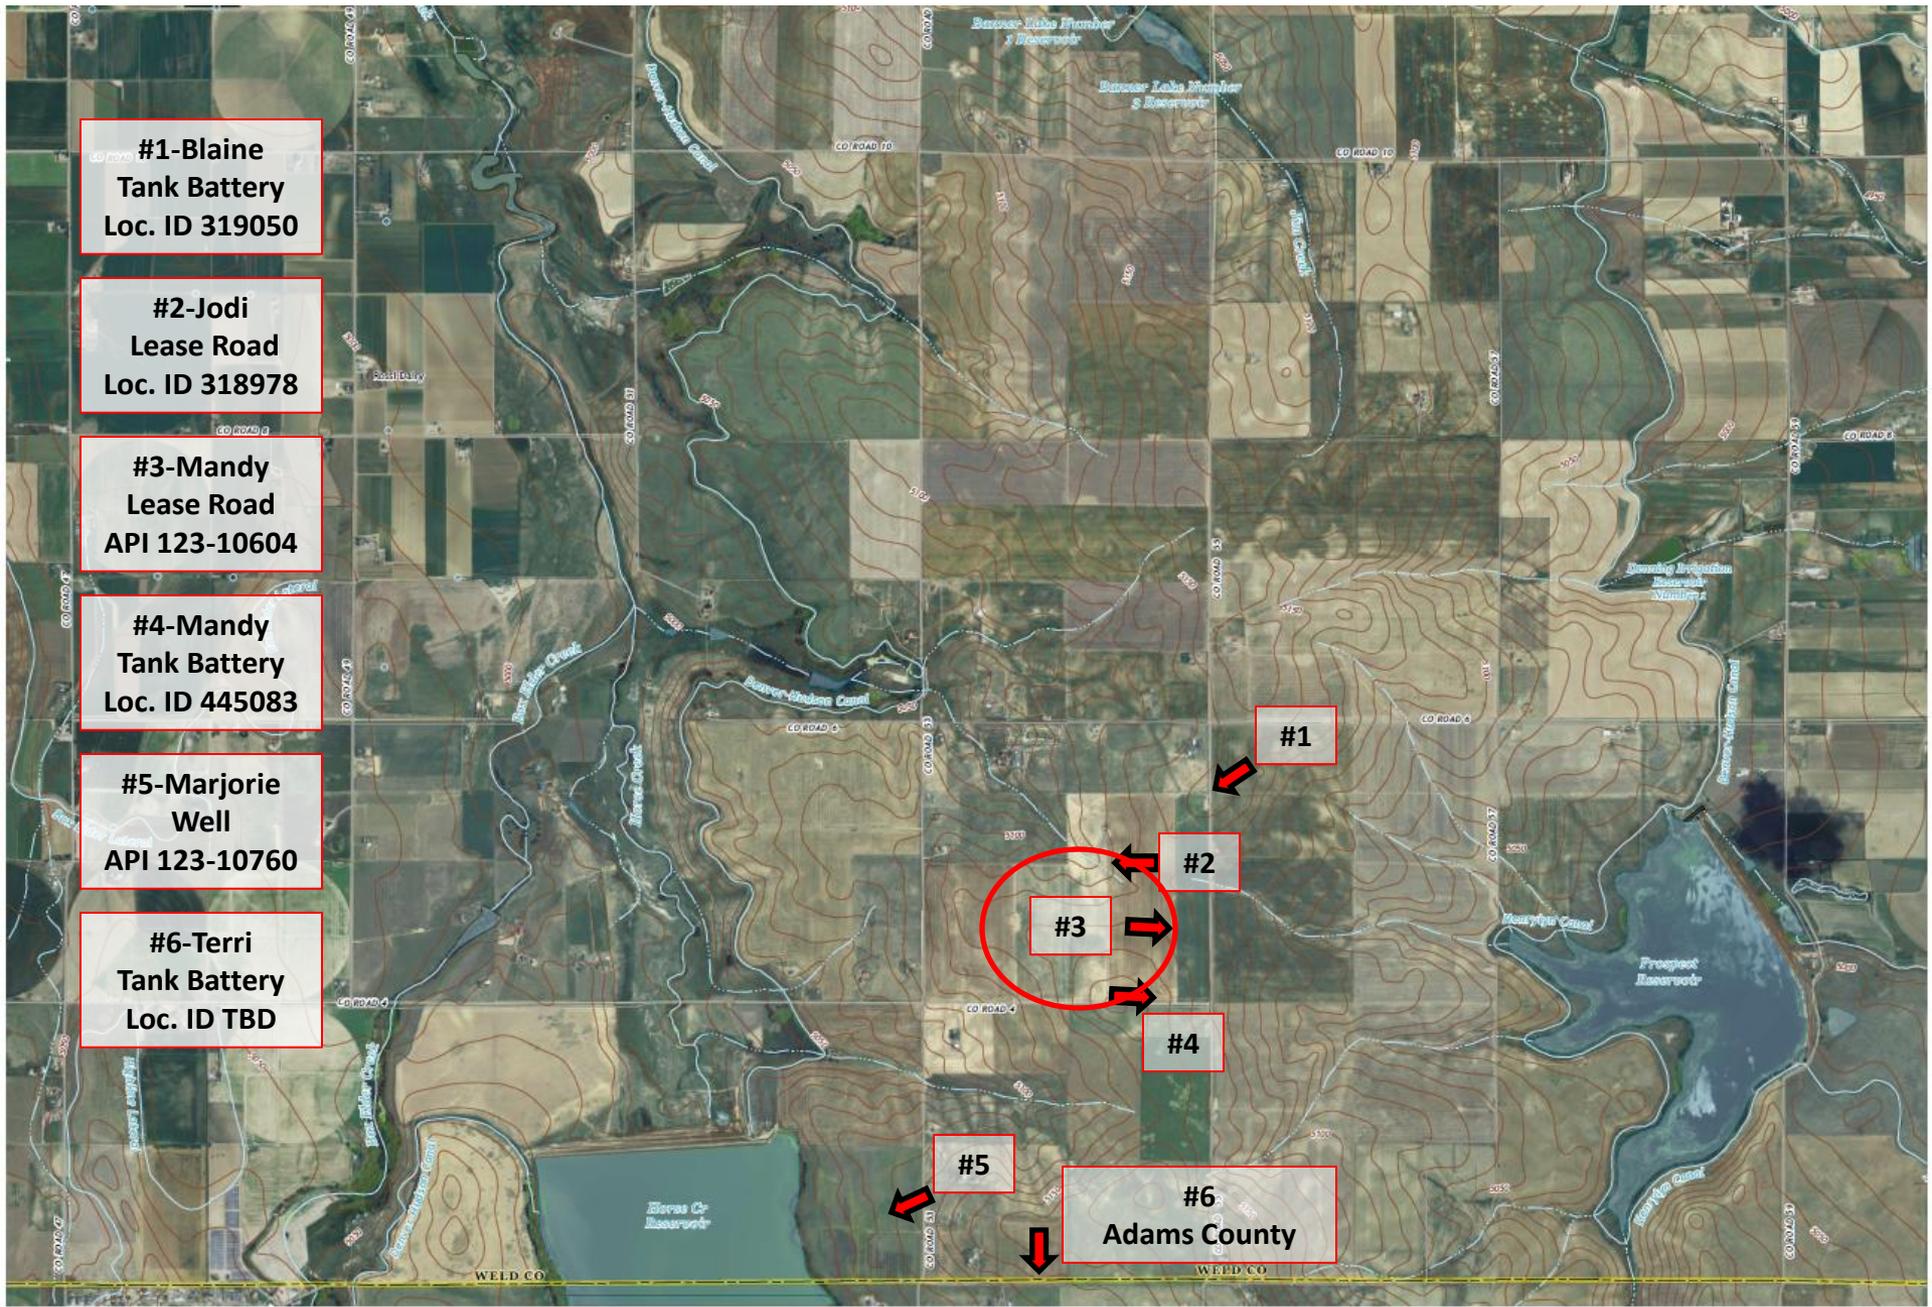
**#1-Blaine
Tank Battery
Loc. ID 319050**

**#2-Jodi
Lease Road
Loc. ID 318978**

**#4-Mandy
Tank Battery
Loc. ID 445083**

**#5-Marjorie
Well
API 123-10760**

**#6-Terri
Tank Battery
Loc. ID TBD**
