Final Reclamation Inspection

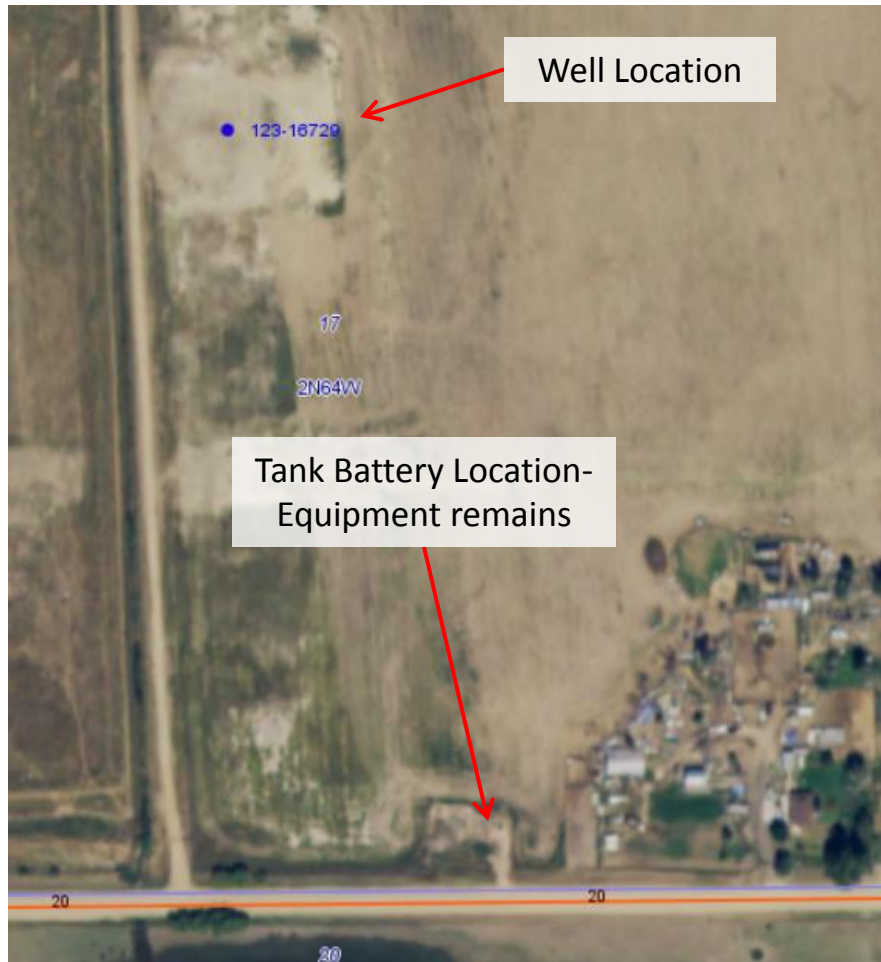
Photo 1. 2015 aerial imagery using COGCC GISOnline database, illustrating the well location and tank battery location where equipment remains.
