Foundation Overview- Diffuse knapweed (*Centarea diffusa*)

Sooner Unit- Location ID 447525

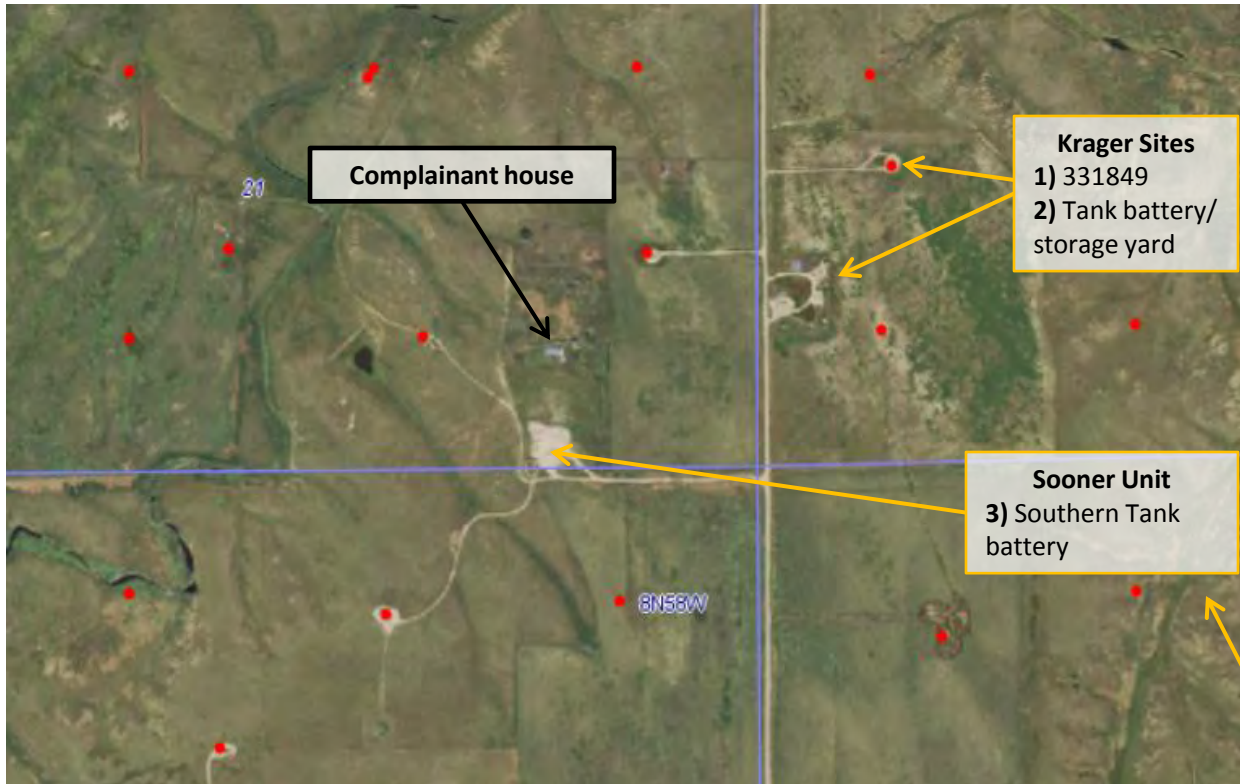
Sooner Unit- Southern Tank battery (Location ID 447525)

- 3) Southern Tank battery was mowed. Knapweed was observed in the cuttings and only a handful of individual knapweeds left behind. Foundation instructed on 8/25/16 to pull and bag remaining plants. Foundation instructed on 8/30/16 to collect, remove, and dispose weed debris and seed heads properly from areas that were mowed.
