Report

SUBJECT: Spaur Well Flash Fire
Injured: [REDACTED]
Location: Spaur Well Pad, Weld Co, CO.

REFERENCE: Our File Number: 16-227

DATED: October 7, 2016

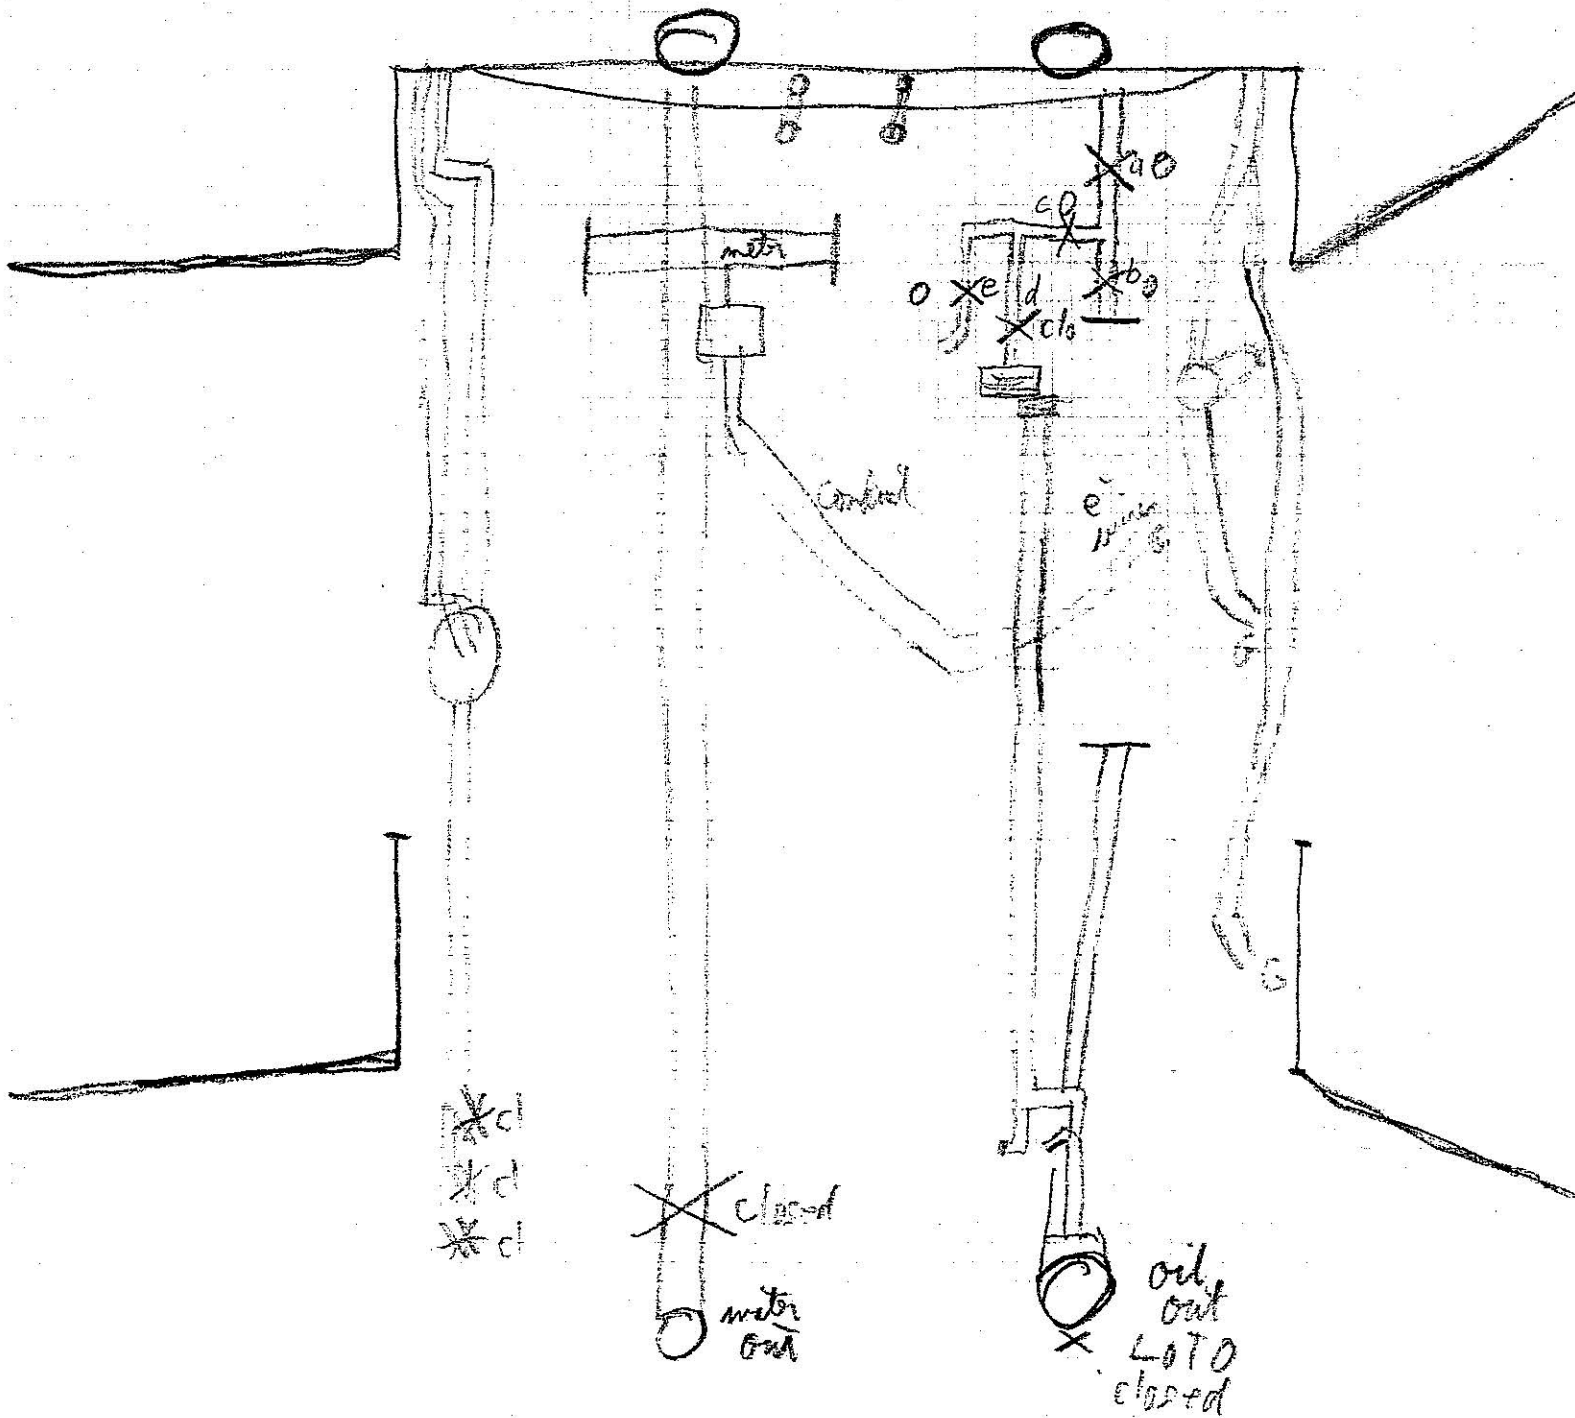
2

3. The fire occurred in this east end metal enclosure. The worst damage was to the west, near the end of the separator. The damage lessened, moving east. J.D. showed the position [REDACTED] was in, when the flash fire occurred. (See photo two in appendix).

4. Inside the enclosure, the end of the separator showed fire damage, as well as above and below. Two buckets were still present under the lower valves. Under the left bucket was a partially burned plastic drip pan. This plastic drip pan was secured as evidence. (See photos three - six in appendix).

Separator Enclosure

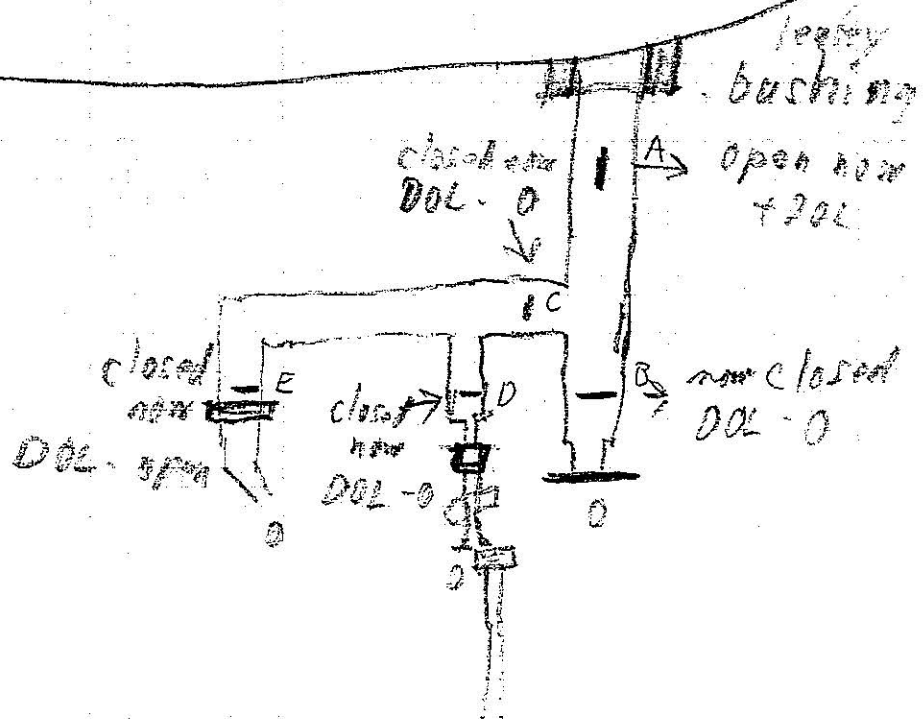
5. The position of the valves was documented. As found, vapors and liquid would flow out of all three openings. This valve manifold and the buckets were secured as evidence. (See photo seven in appendix).

DESCRIPTION
 Manifold - Condensate/Oil
