Construction and Stormwater Inspection

[Location ID 447778]

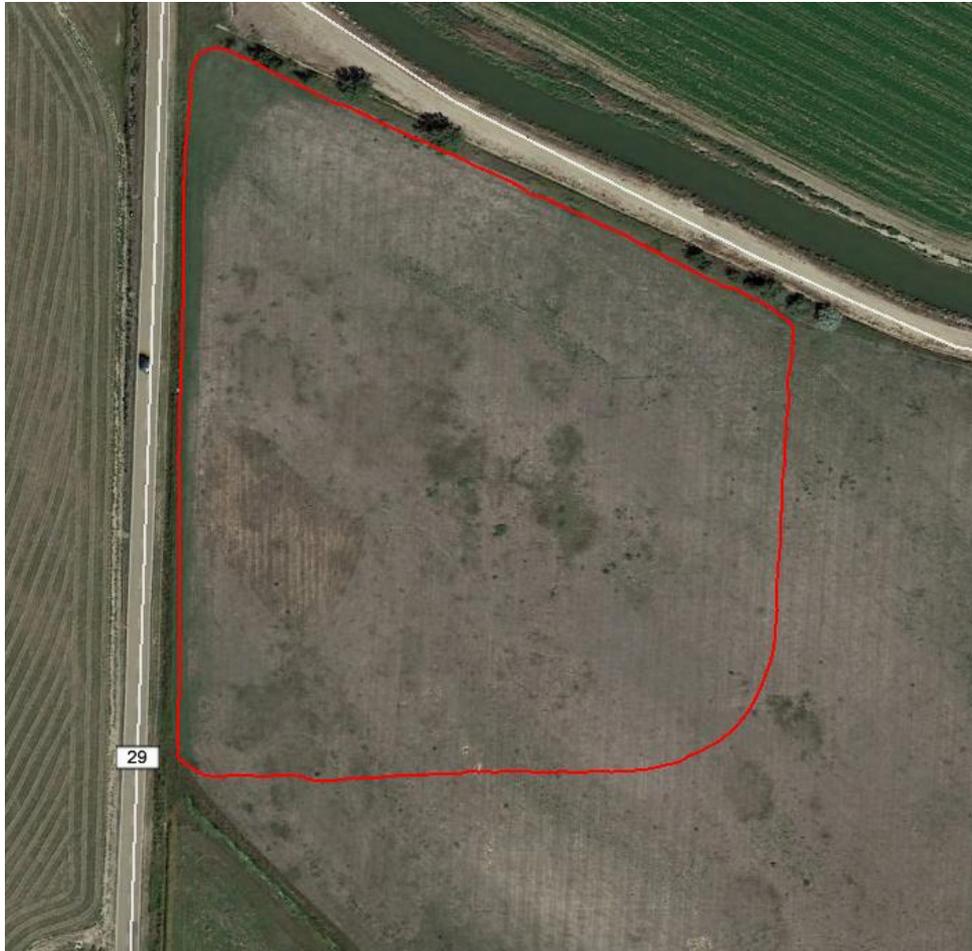
Google Earth aerial photo taken 9/7/2016 illustrating total extent of the Thornton/28-H Pad location. Total area of 8.05 acres was mapped on 11/29/16 using a Trimble Juno 3B handheld device. Perimeter of location was mapped and highlighted in red.
