Reclamation Inspection

10/28/2016

Operator: Markus Production Inc.

Location ID: 406198

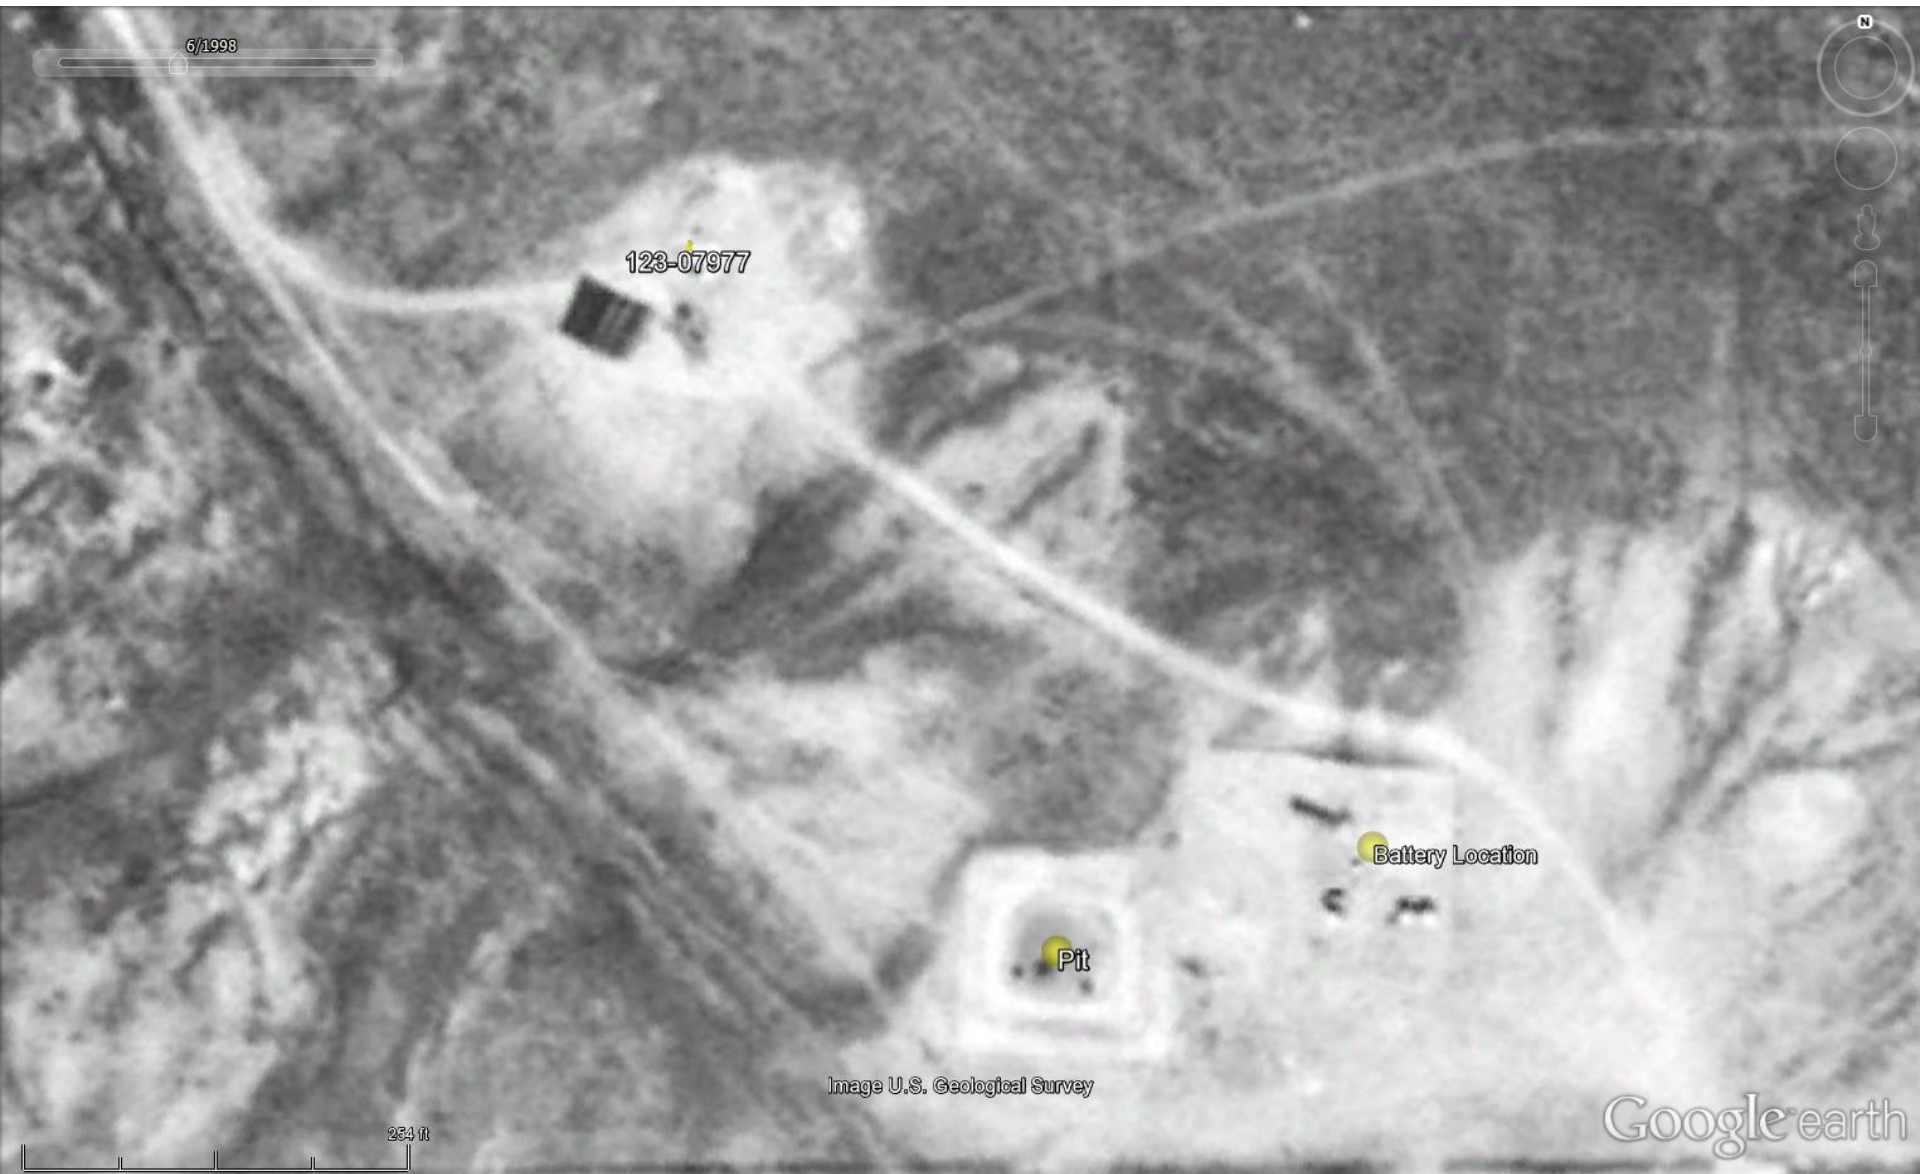
Figure 1: 1998 Aerial image of the location. Image shows areas of the well location, as well as the battery and pit location.

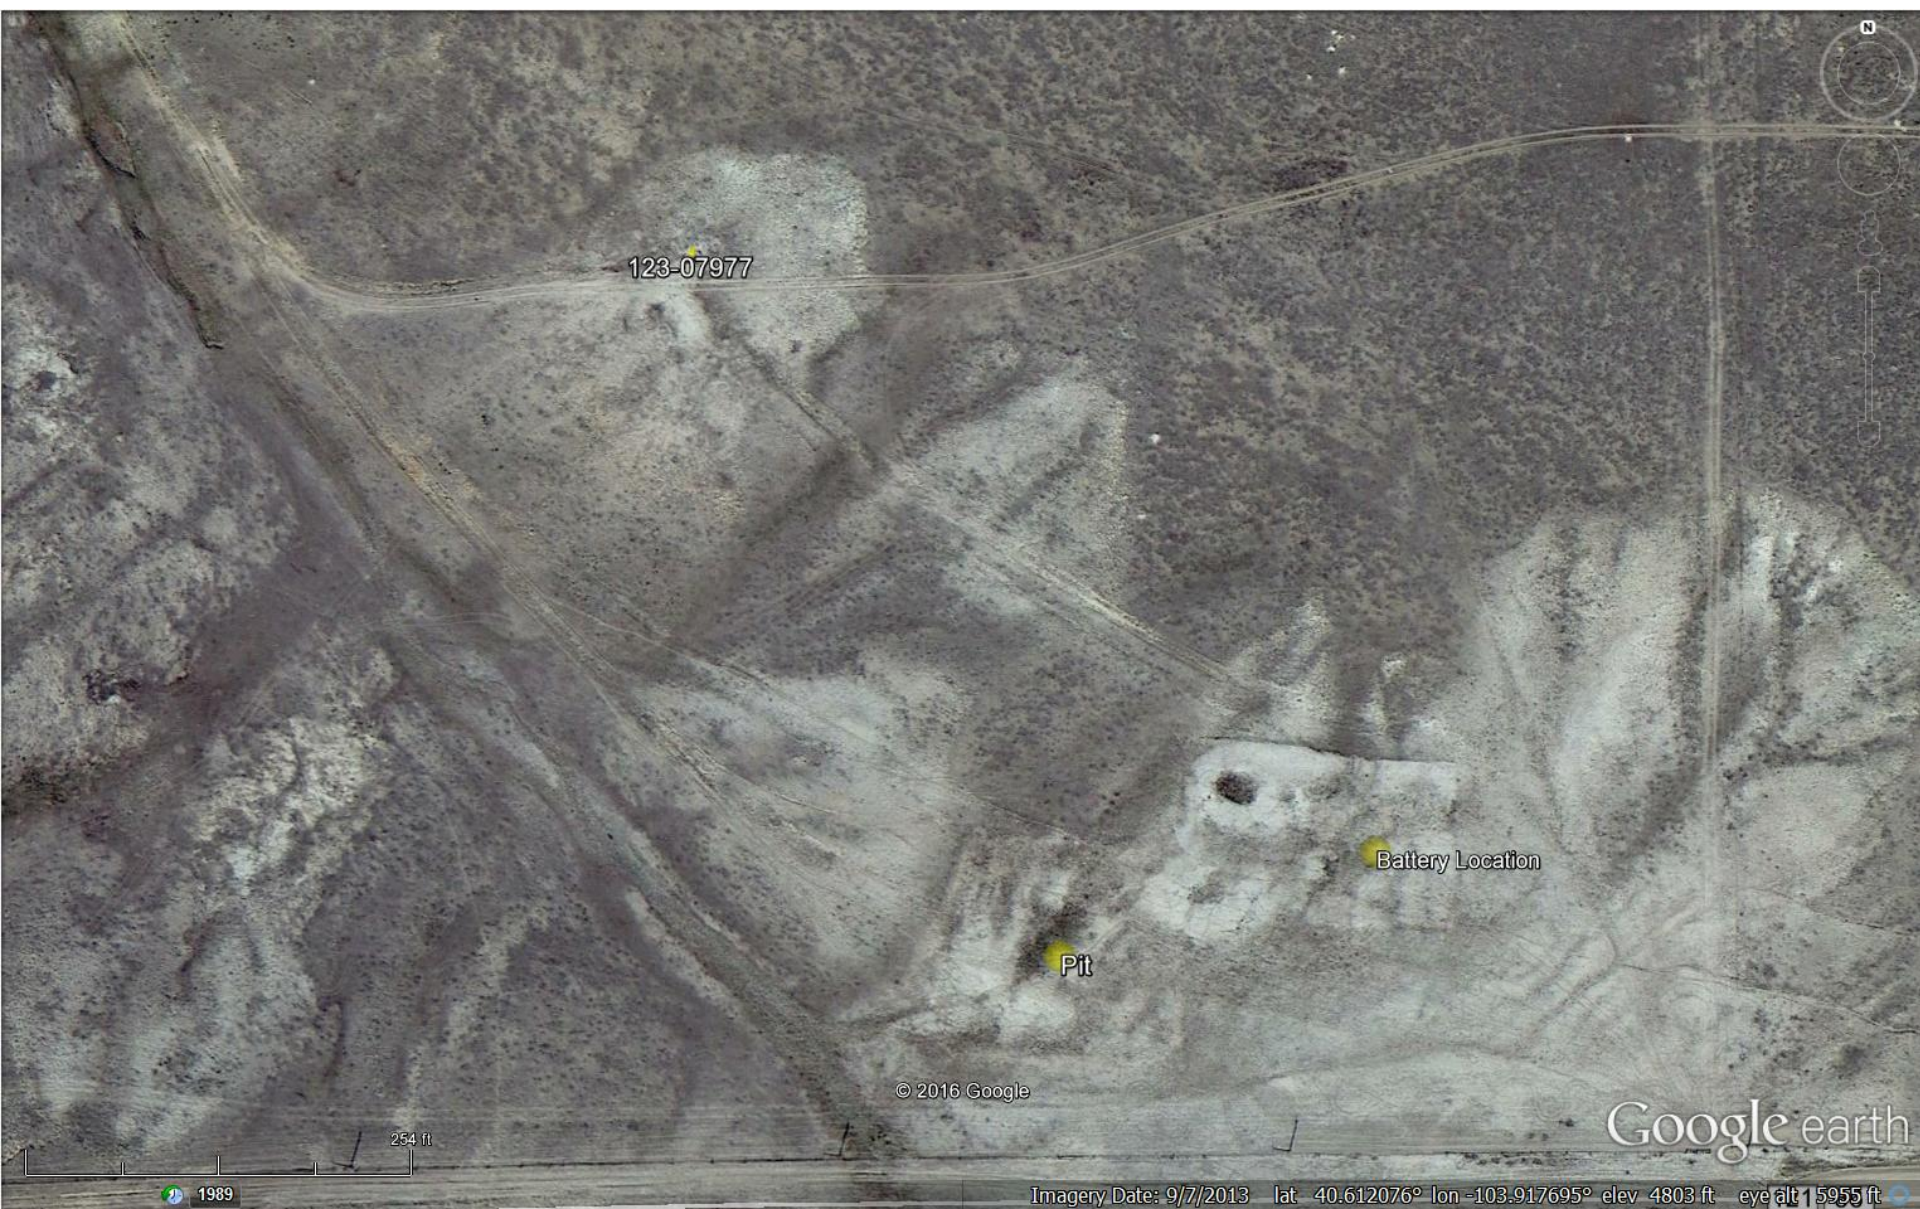
Figure 2: Most current aerial image available (2013) of the location. Image shows areas of the well location, as well as the battery and pit location.

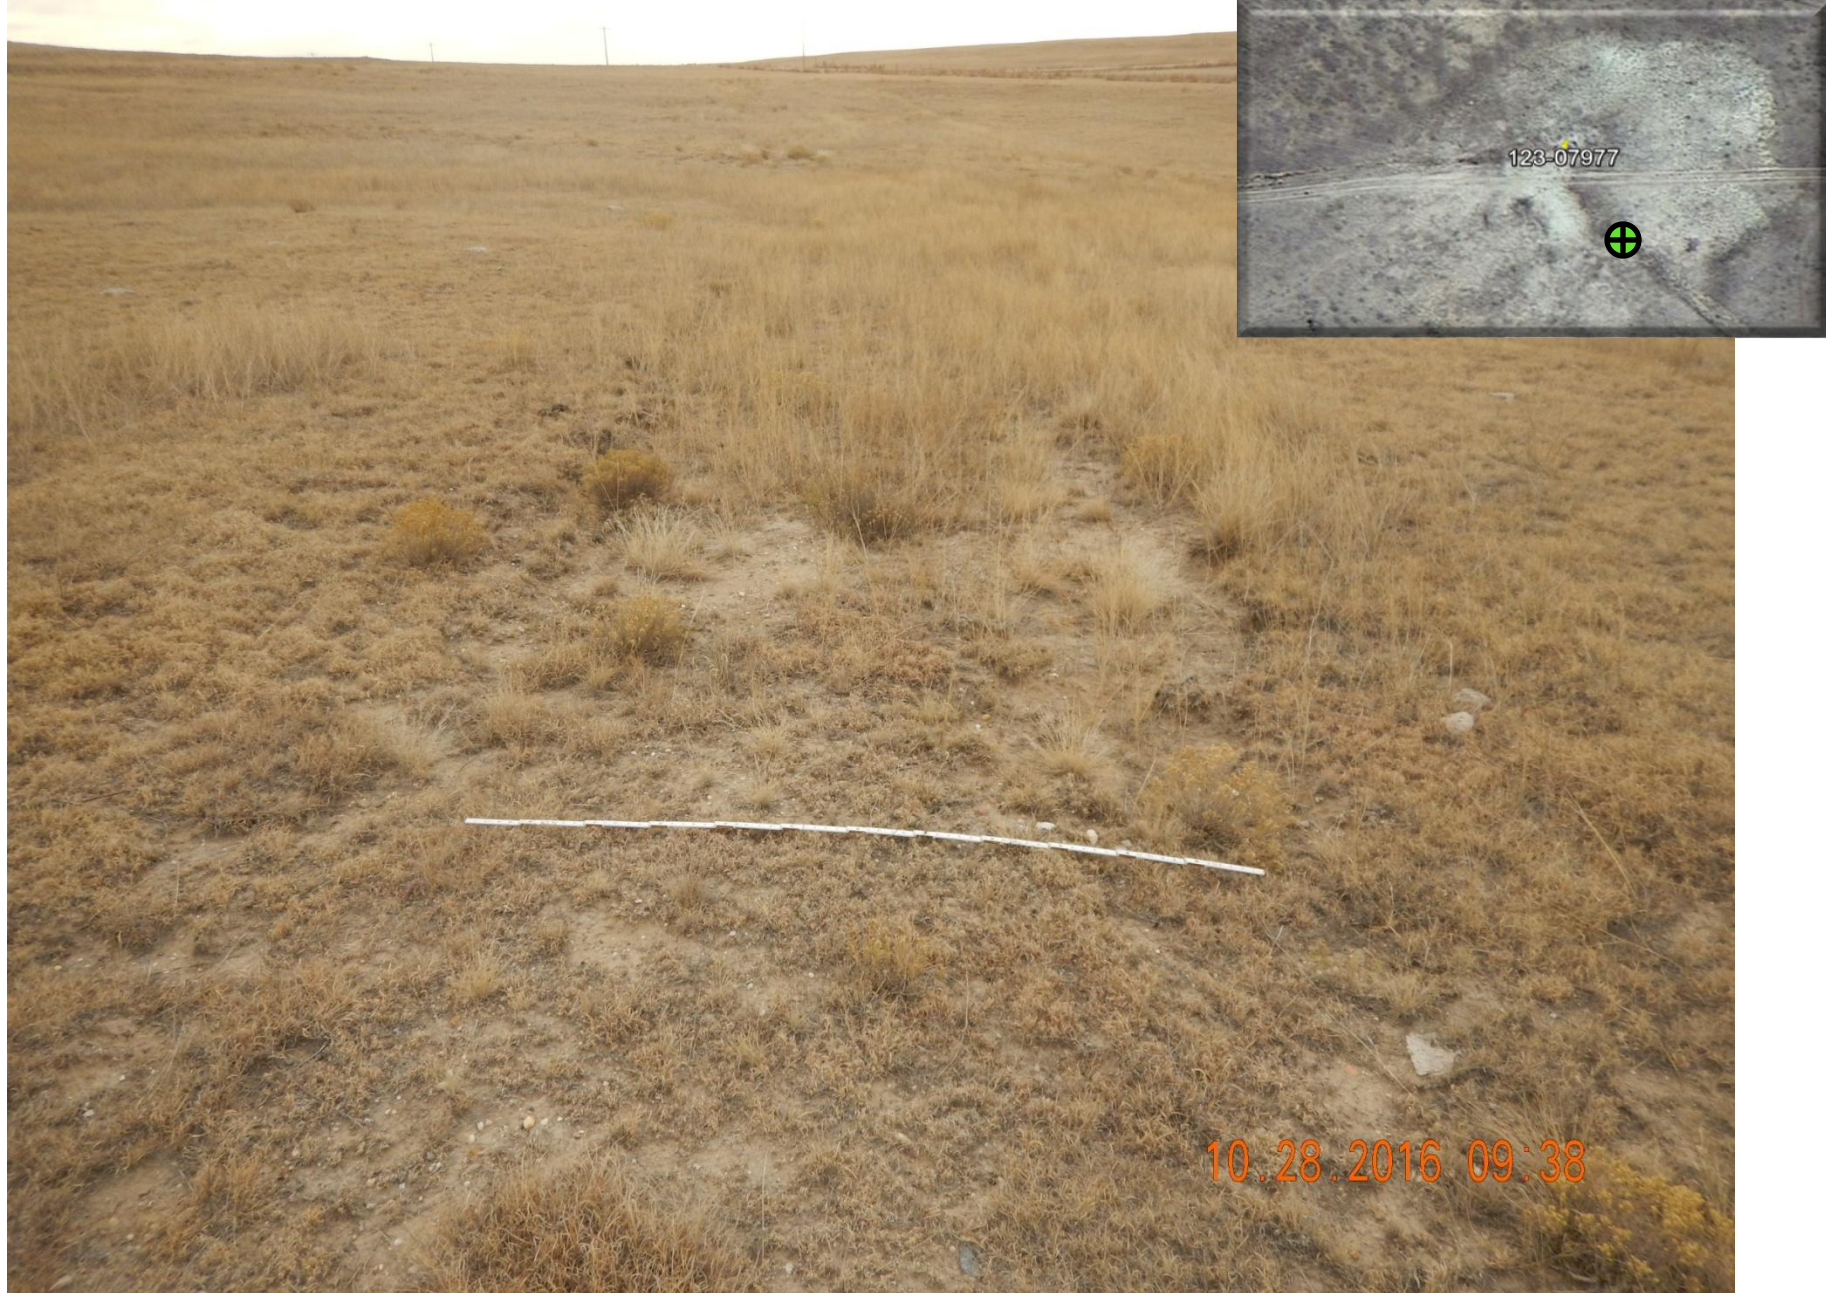
Figure 22: Photo taken from the south end of the location, facing southeast. Photo shows access road leading from the well location, to the pit/battery location.

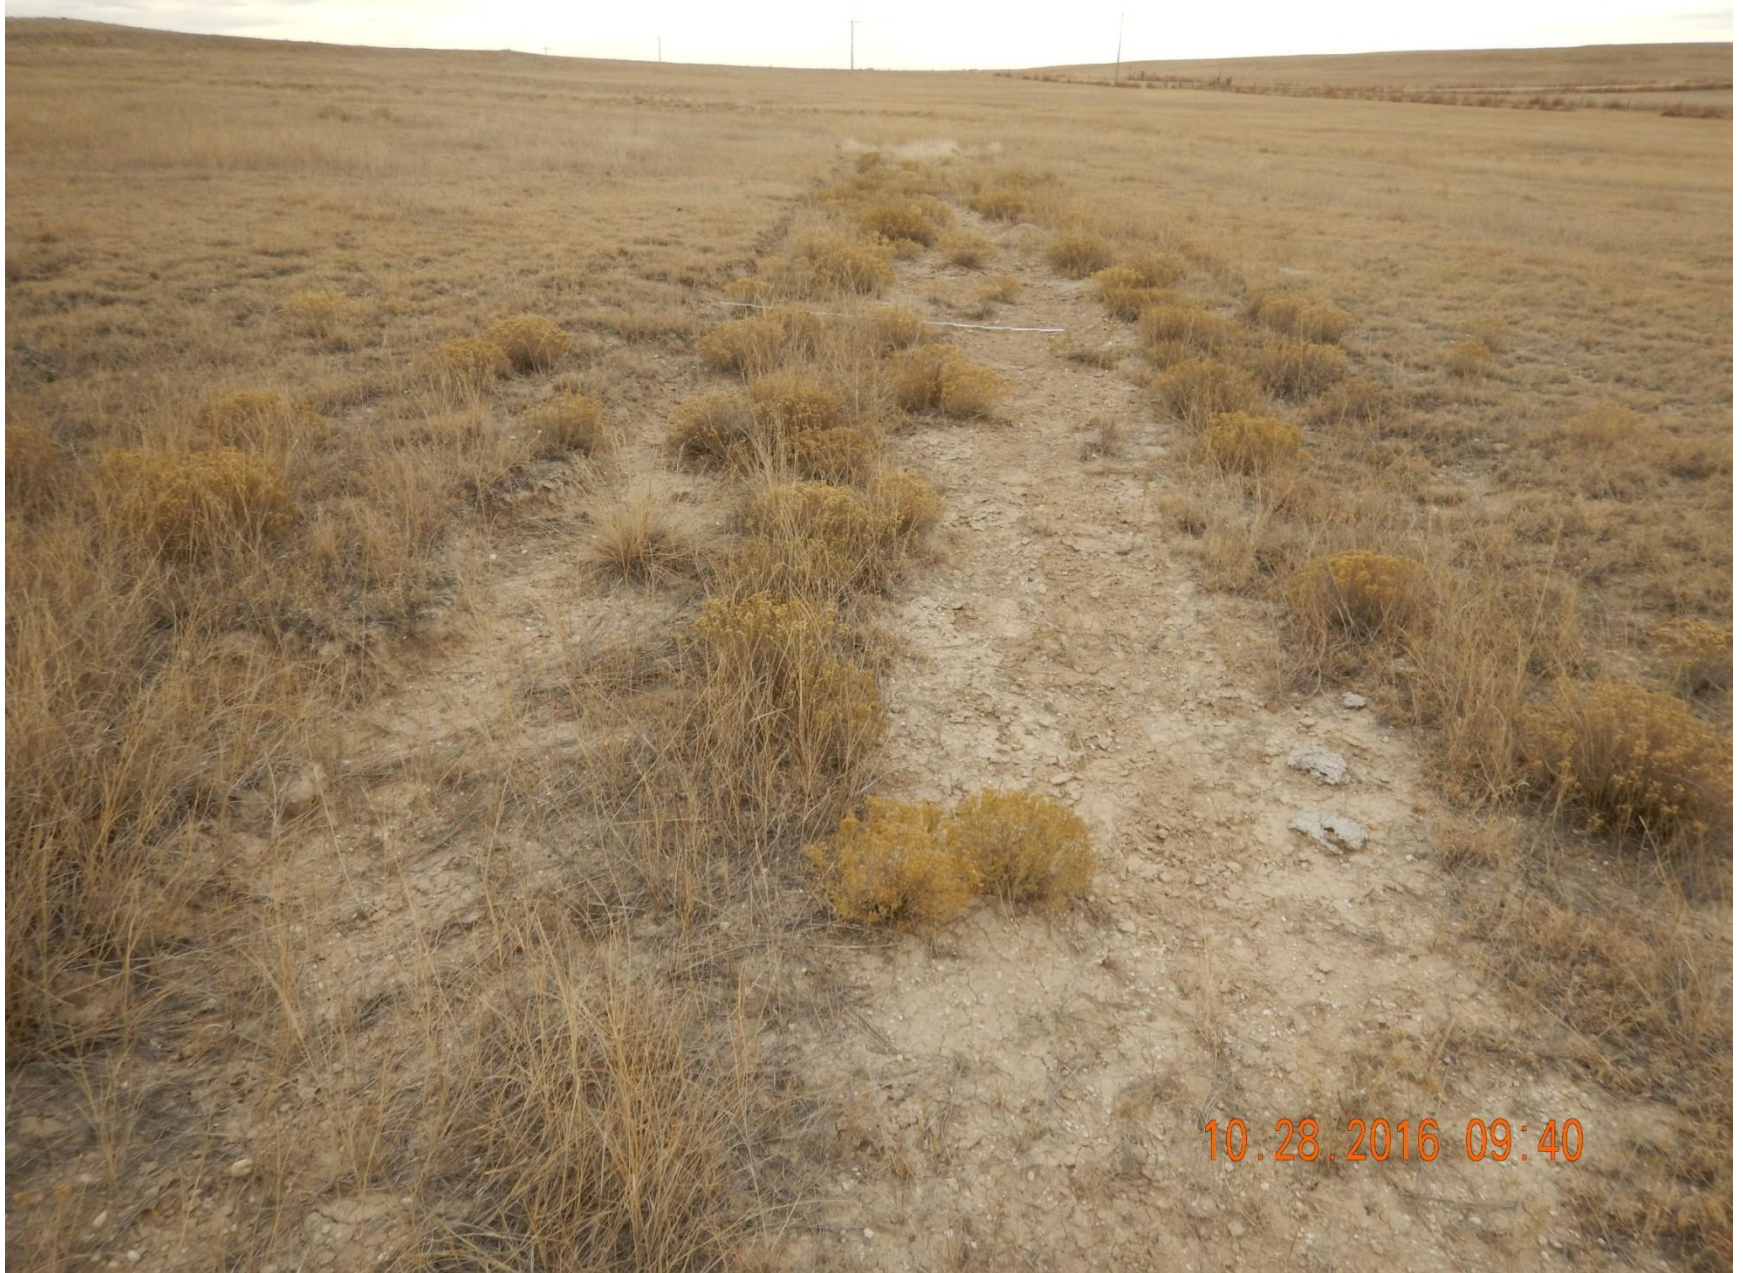
Figure 23: Photo taken from the access road leading from the well location, to the pit/battery location, facing southeast.

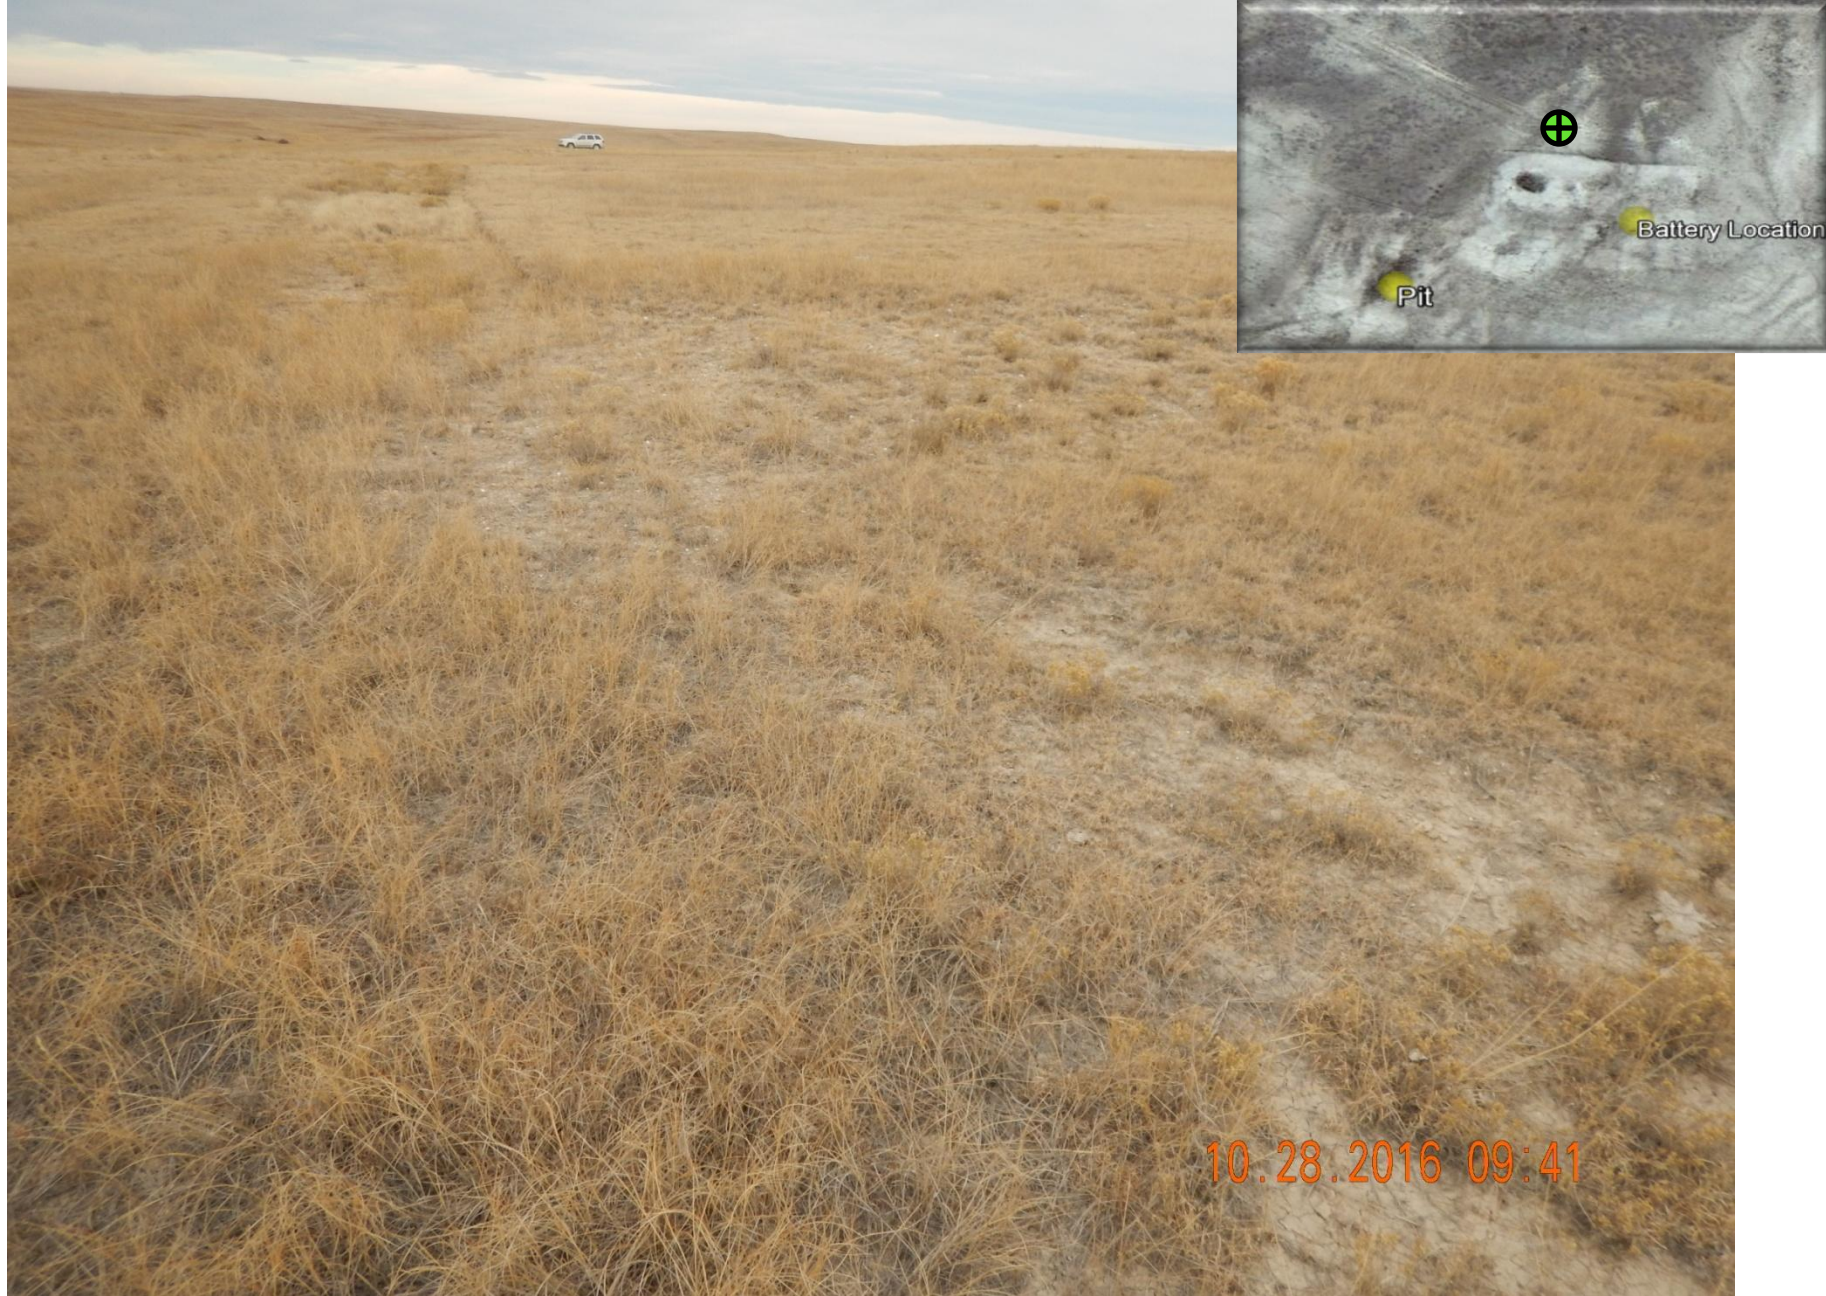
Figure 24: Photo taken from the access road, on the north end of the pit/battery location, facing northwest.

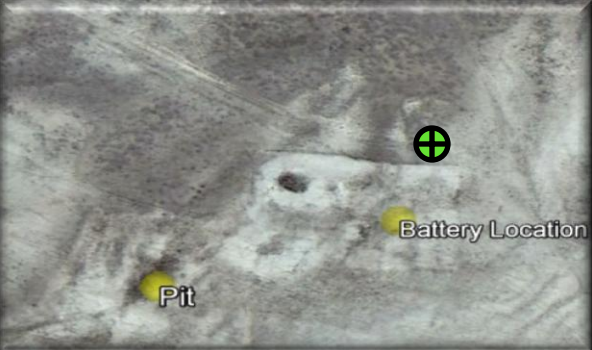
Figure 28: Photo taken from the access road, on the northeast end of the pit/battery location, facing northwest. Photo shows areas that remain unvegetated.

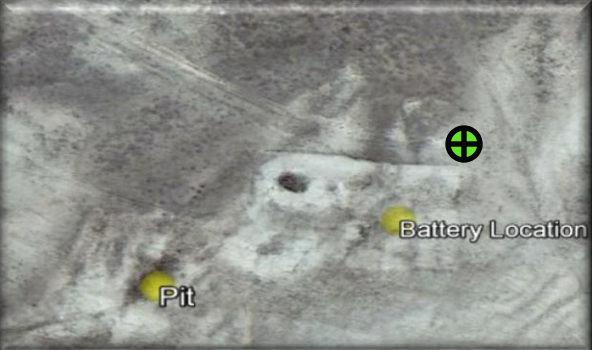
Figure 31: Photo taken from the access road, on the northeast end of the pit/battery location, facing north. Photo shows areas that remain unvegetated and experiencing degradation due to erosion. 6' measuring stick for reference.

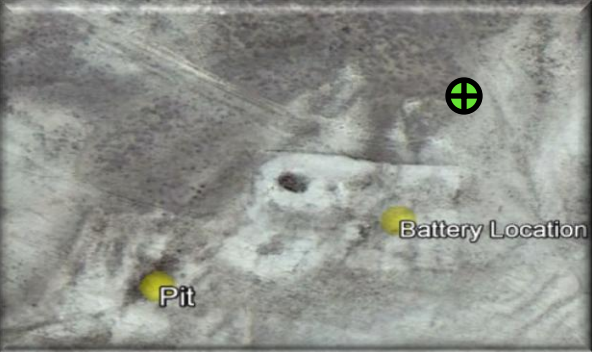
Figure 32: Photo taken from area north of the pit/battery location, facing west. Photo shows area that has either not been recontoured, or has experience erosion degradation.

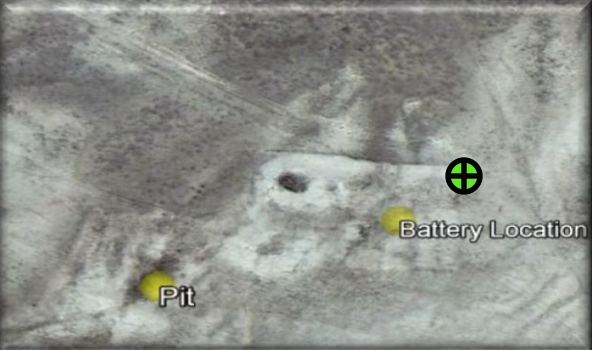
Figure 34: Photo taken from the northeast corner of the battery location, facing west. Photo shows areas pit/battery location has not achieved uniform vegetative cover and large areas remain unvegetated. 6' measuring stick for reference.

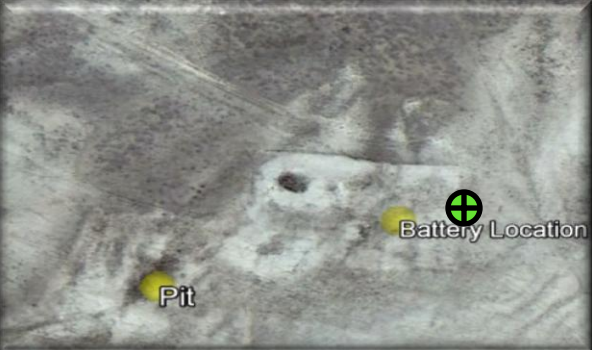
Figure 37: Photo taken from east end of the battery location, facing west. Photo shows areas pit/battery location has not achieved uniform vegetative cover and large areas remain unvegetated. 6' measuring stick for reference.

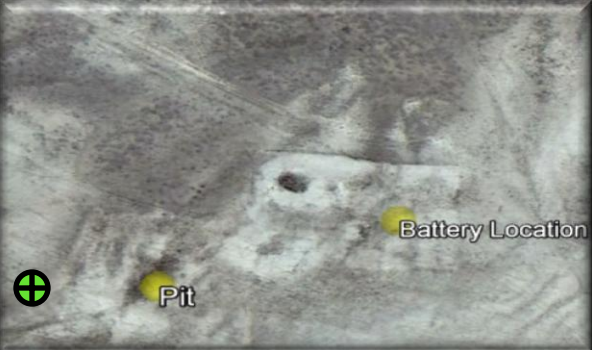
Figure 52: Photo taken from southwest end of the pit location, facing northeast. Photo shows areas pit/battery location has not achieved uniform vegetative cover and large areas remain unvegetated. 6' measuring stick for reference.
