# Final Reclamation & Stormwater Inspection

12/13/2016

Operator: Petro-Canada #72085

Location ID: 311664

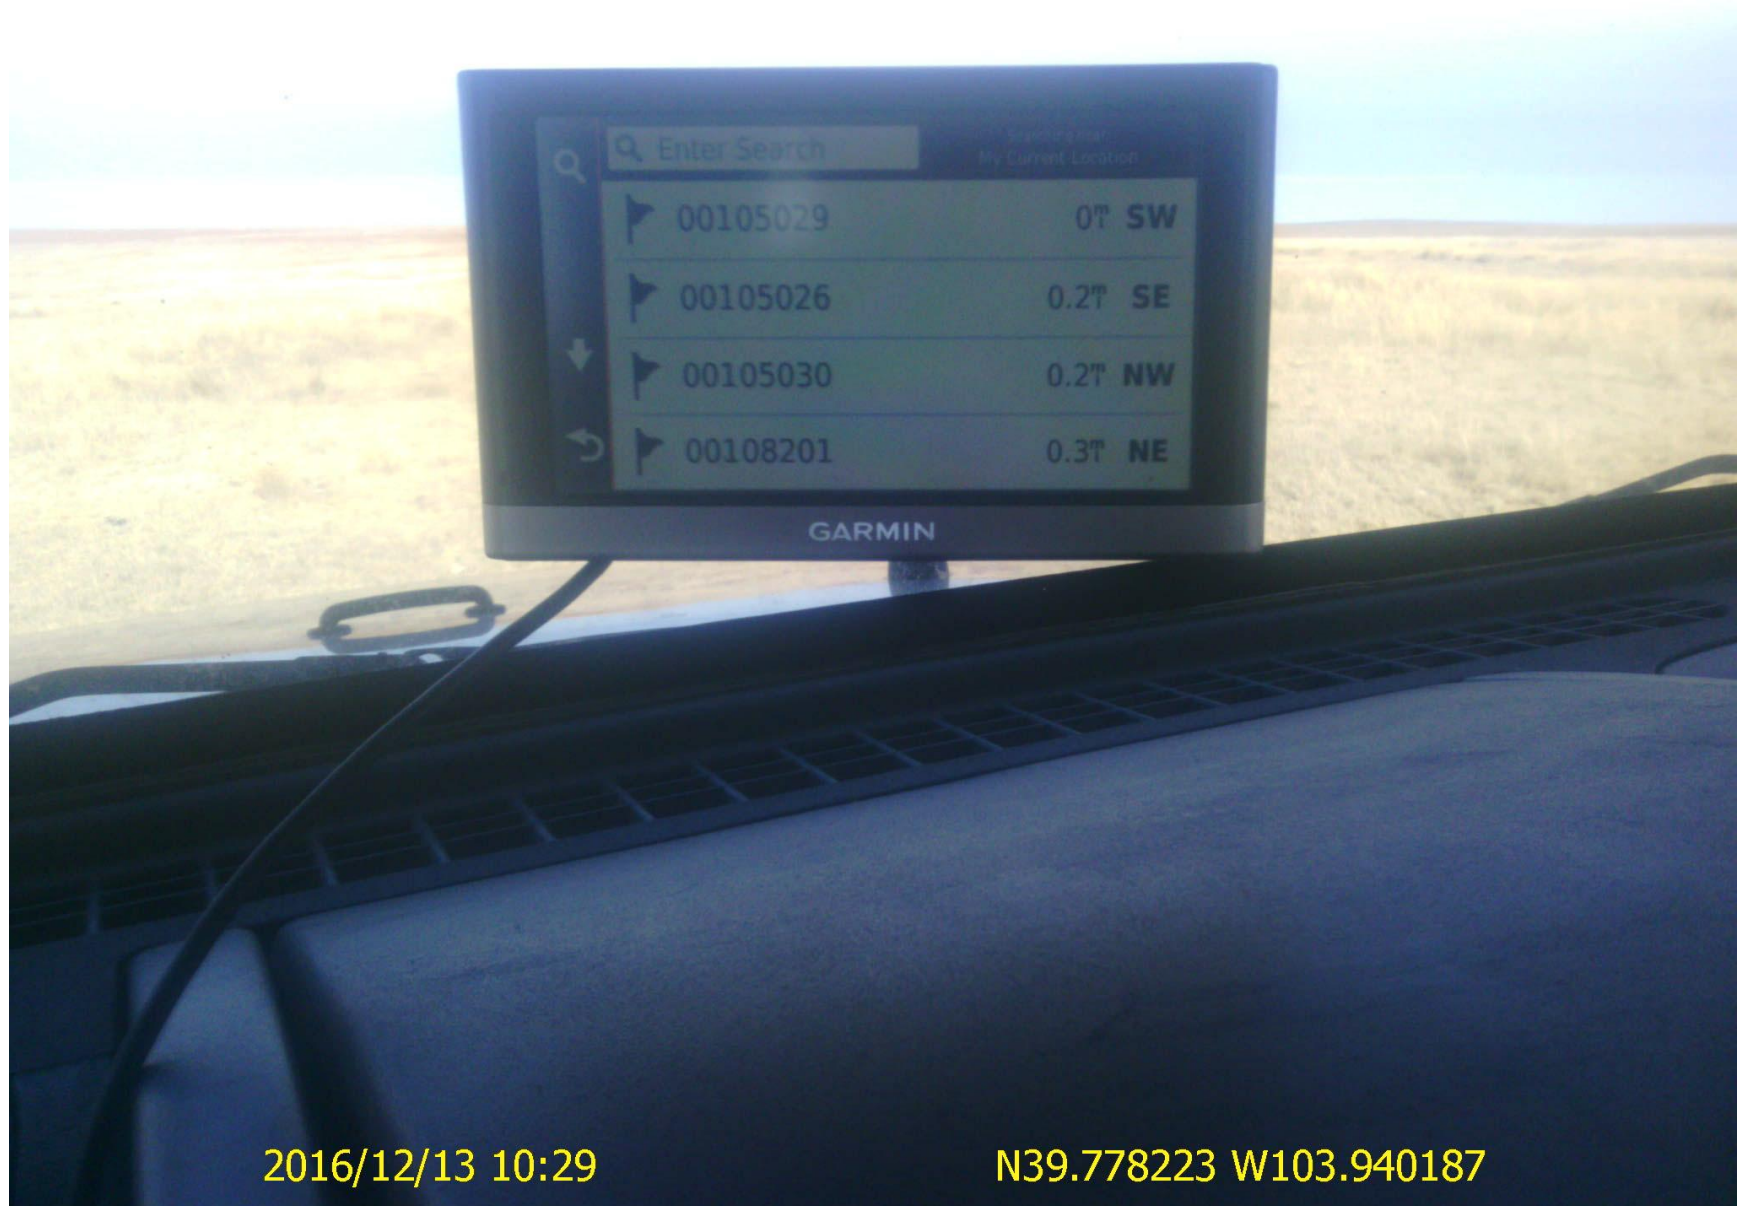
**Figure 1:** Photo of GPS confirming location. See photos from inspection Doc. # 682500938 for additional information and details
