# Reclamation and Stormwater Inspection

March 14, 2017

Operator: CRESTONE PEAK RESOURCES  
OPERATING LLC

Location ID: 434375

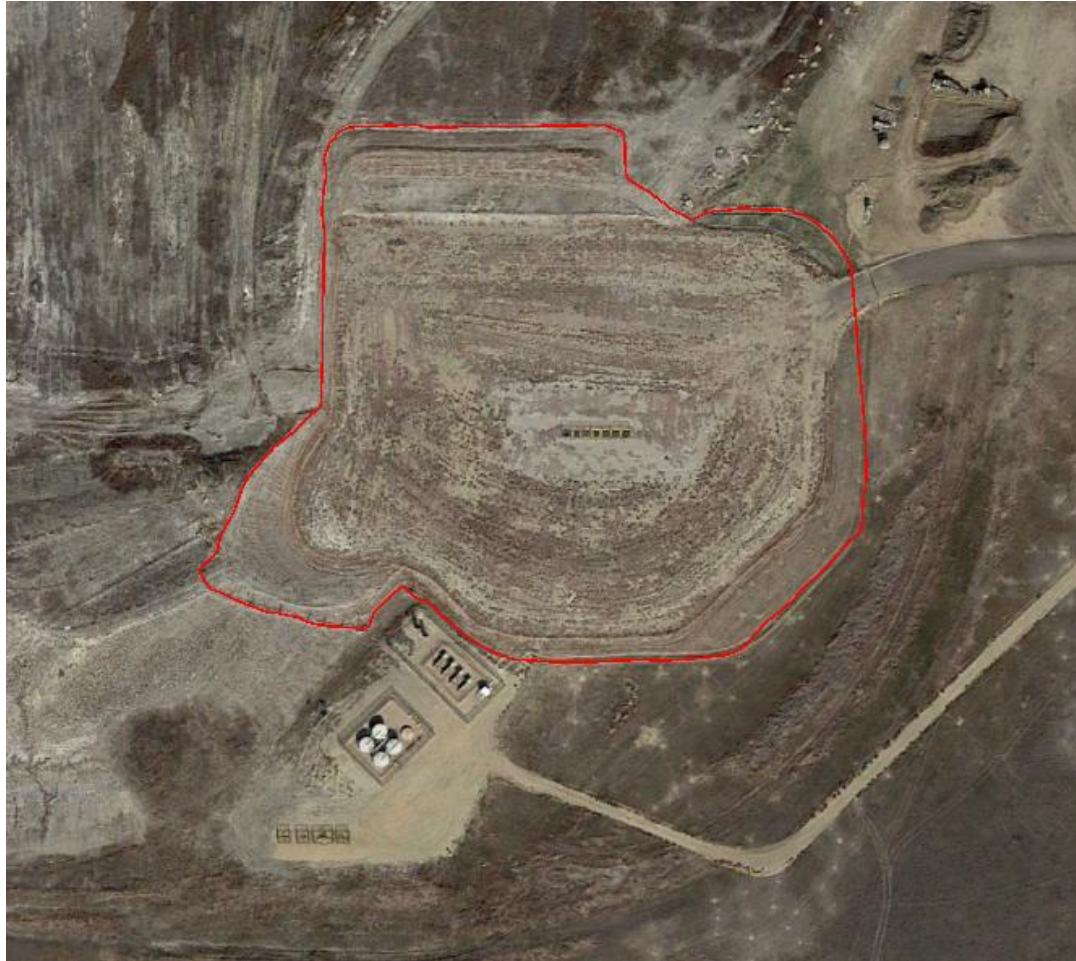
Google Earth aerial imagery taken October 9, 2015, and overlaid with field collected data on March 14, 2017 using a Trimble handheld GPS. Total construction disturbance of 6.20 acres was collected using the Trimble handheld GPS.
