Reclamation Inspection

May 15, 2017

Operator: LONGS PEAK RESOURCES LLC- #10611

Location ID: 440192

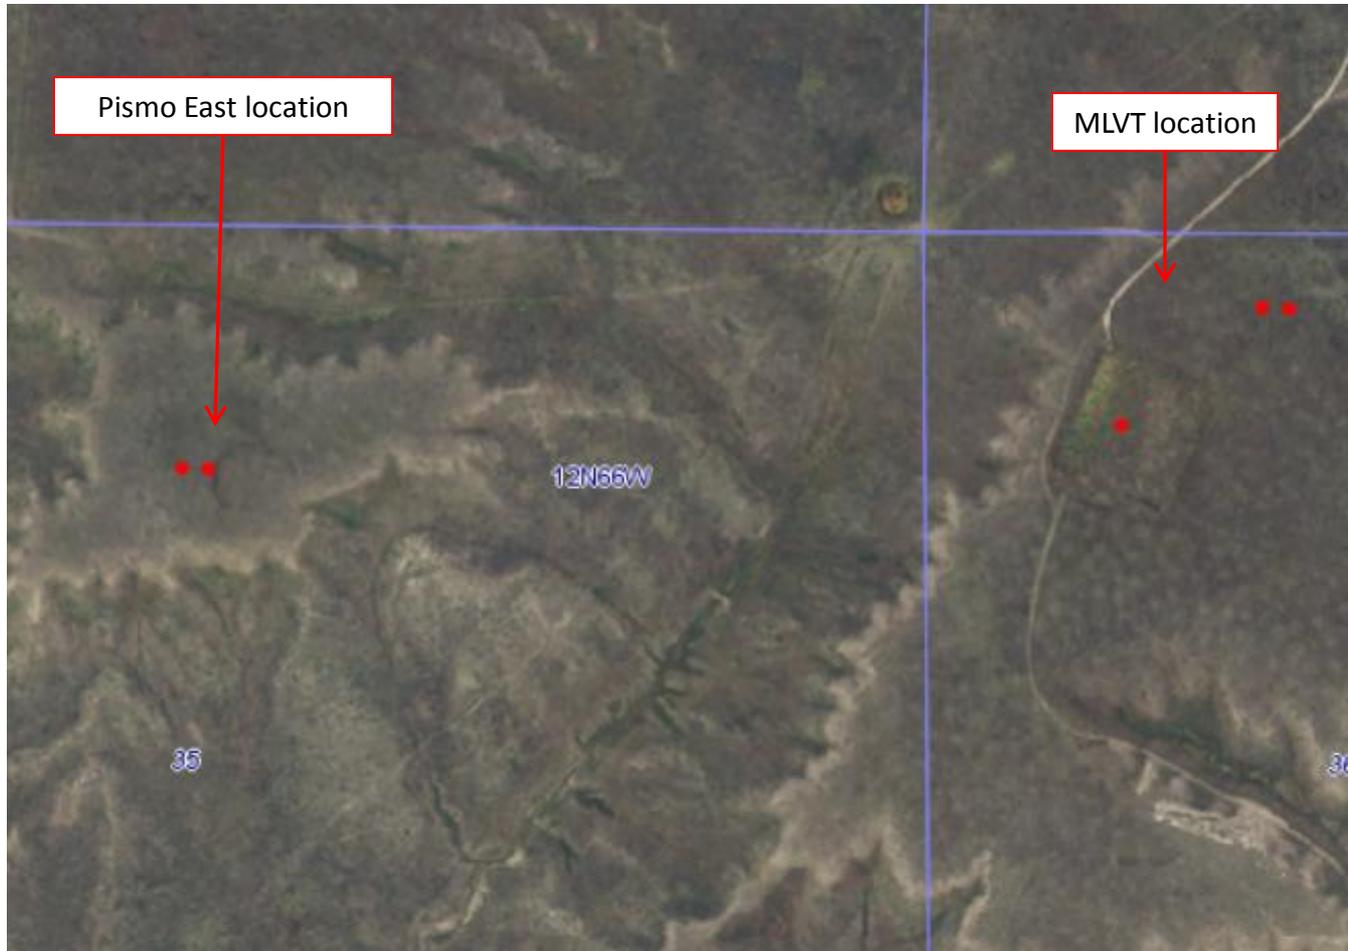
2015 aerial imagery using COGCC GISOnline database illustrating the Pismo East location in relation to the MLVT location approximately 0.54 miles to the east.

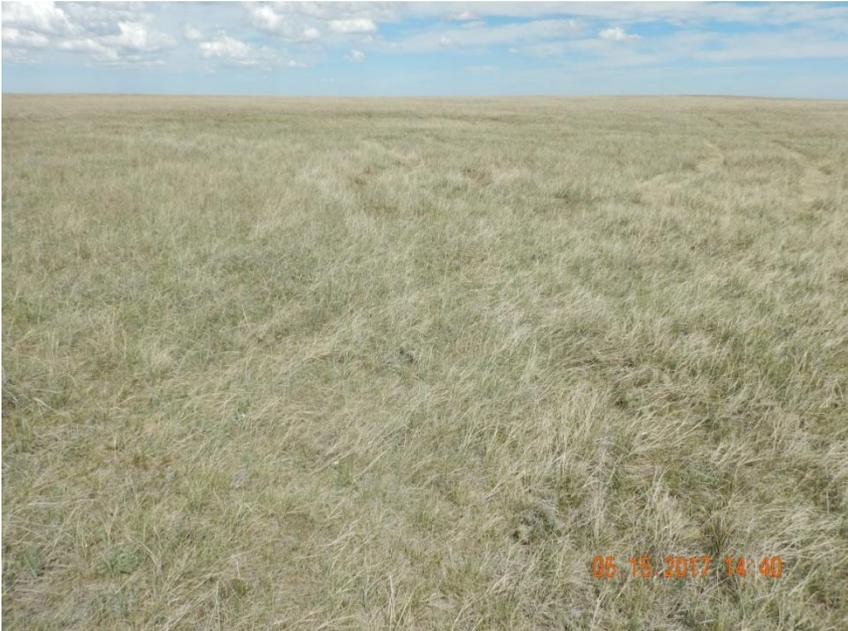
Photo 9. Reference photo taken east of the MLVT location area, facing North.
