Petroglyph Energy, Inc.
Well Pad Final Reclamation Evaluation

Well Name: State 36-05

Evaluation Date: July 15, 2015

Evaluated by: Lindsey Brandt; Senior Environmental Scientist; Habitat Management, Inc.

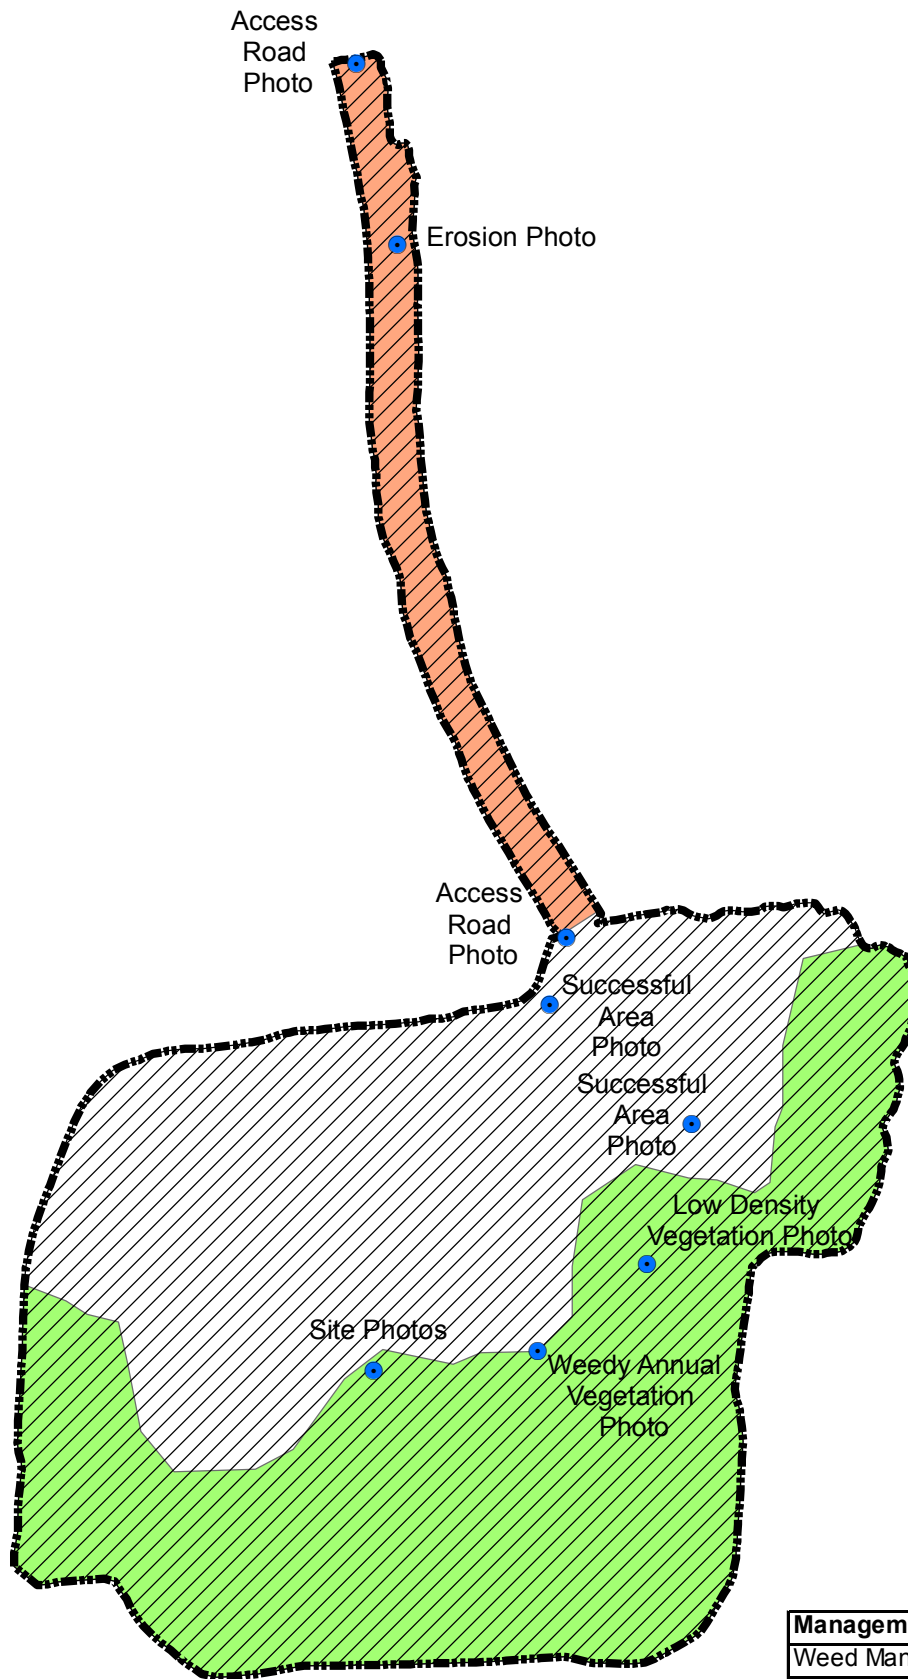
Portions of the State 36-05 well pad are establishing satisfactorily as shown in the attached photos and map. The rest of the pad is dominated by weedy annuals including tall tumblemustard (*Sisymbrium altissimum*), however, often desirable vegetation is establishing underneath. Cheatgrass (*Bromus tectorum*) is dispersed throughout the site, however currently not abundant. Scotch thistle (*Onopordum acanthoides*) is abundant throughout the pad and diffuse knapweed (*Centaurea diffusa*) occurs scattered along the access road, as well as one plant on the southeast corner of the pad.

Tire ruts along the access road are causing water to channelize and erosion to occur. It appears that the road was driven on when wet which caused the tire ruts.

Many years of noxious weed management are likely required to effectively control weed infestations on this site. The entire well pad should be treated in the fall of 2015 to minimize the cheatgrass infestation. Prior to herbicide application the site should be mowed to remove the standing dead annual vegetation and allow for effective soil contact of herbicides. A pre-emergent herbicide should be applied to prevent germination of this winter annual.

Thistle and knapweed rosettes should be spot-sprayed with appropriate broadleaf selective herbicides in fall 2015 and spring 2016 ideally before bolting occurs. Pre-emergent herbicide application around the thistle infestation may also be beneficial to reducing this species.

The access road should be cross-rippled or harrowed to alleviate compaction, and BMPs should be installed to manage drainage. The access road and areas indicated on the attached map should be reseeded with the approved seed mix, and mulched with Woodstraw at a target rate of 60% cover.
