# Flowline and Final Reclamation Inspection

June 6, 2017

Operator: TOP OPERATING COMPANY- #39560

API: 05-013-06096

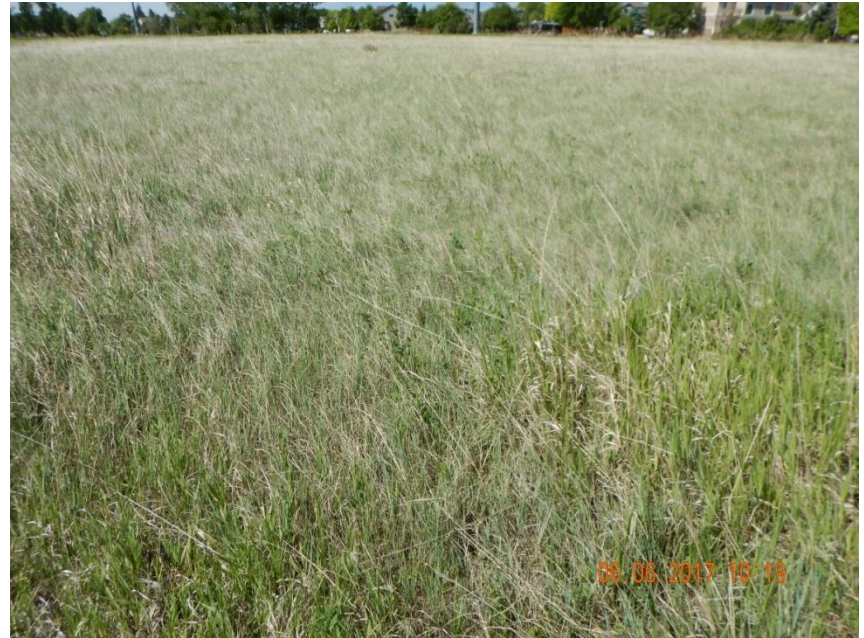
**Photo 8.** Reference photo taken south of the well location illustrating Smooth Brome (*Bromus inermis*) and Western wheatgrass (*Pascopyrum smithii*).
