Interim Reclamation Inspection

Operator: KERR MCGEE OIL & GAS ONSHORE LP #47120

Location ID: 438023

Location Name: DEJANE STATE TANK BATTERY /2N-36HZ

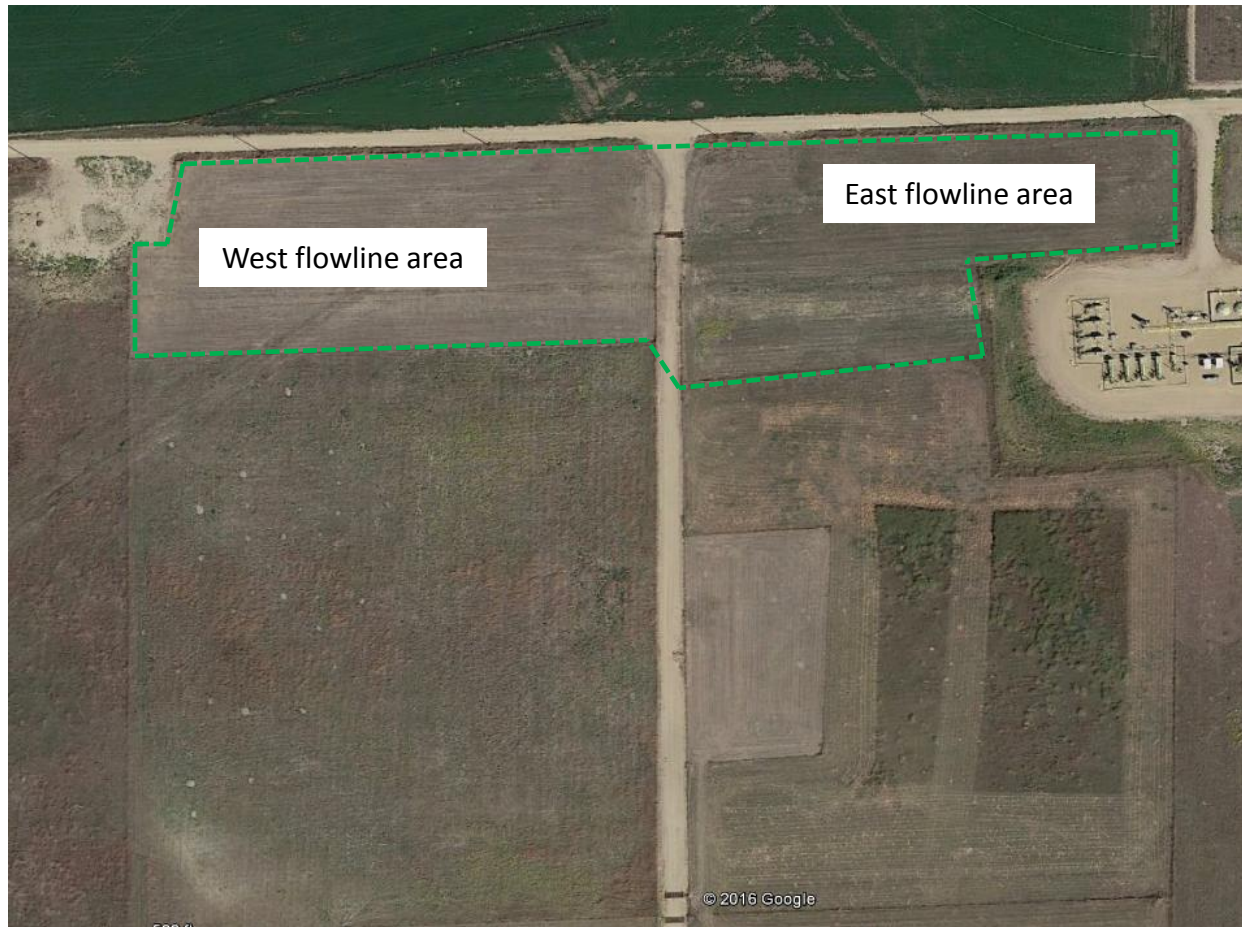
Google Earth aerial imagery taken September 7, 2016 illustrating the flowline area and well pad that are the subject areas for this follow up interim reclamation inspection (outlined in the green dashed line).
