Interim Reclamation and Stormwater Inspection

November 22, 2017

Operator: CONFLUENCE DJ LLC- #10518

Location ID: 452048

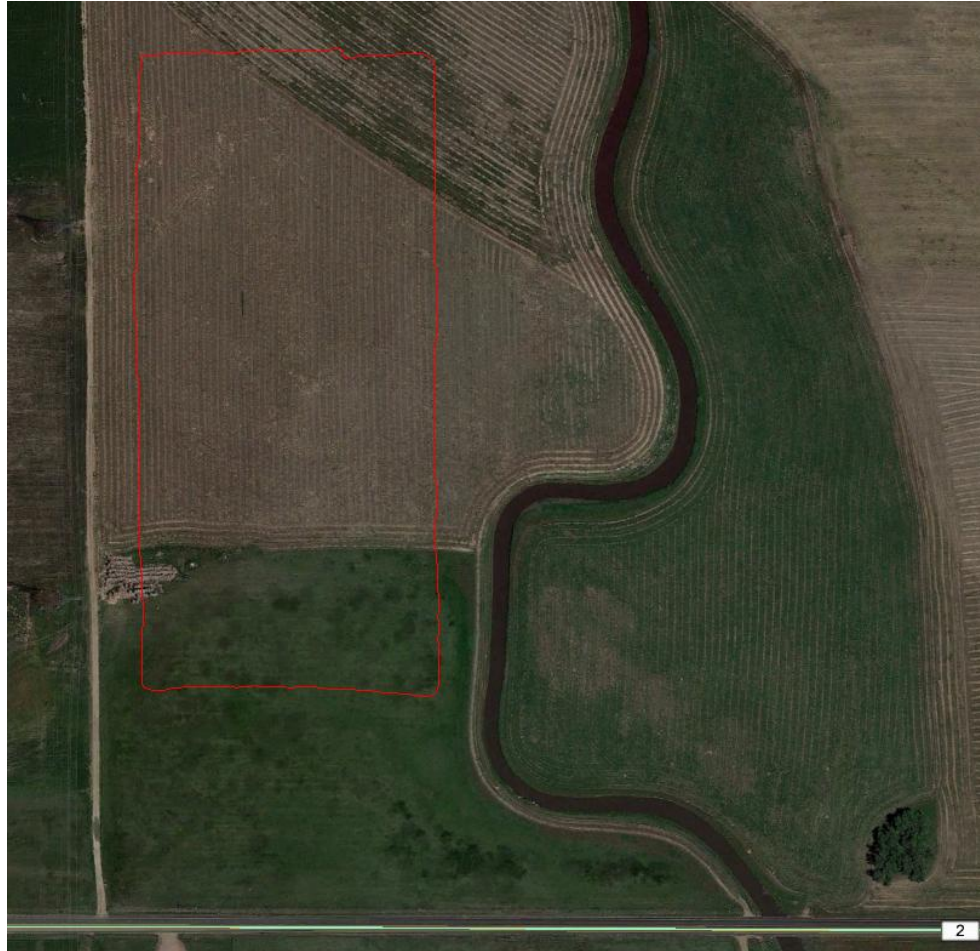
Inspection Photos
Location Name: Freedom /33
Location ID: 452048

Google Earth imagery taken on June 2, 2014 illustrating the location that was mapped on November 22, 2017 using a Trimble Juno 3B handheld device that indicated a total disturbance of 17.20 acres.
