Interim Reclamation and Stormwater Inspection

January 9, 2018

Operator: NOBLE ENERGY INC- #100322

Location ID: 433936

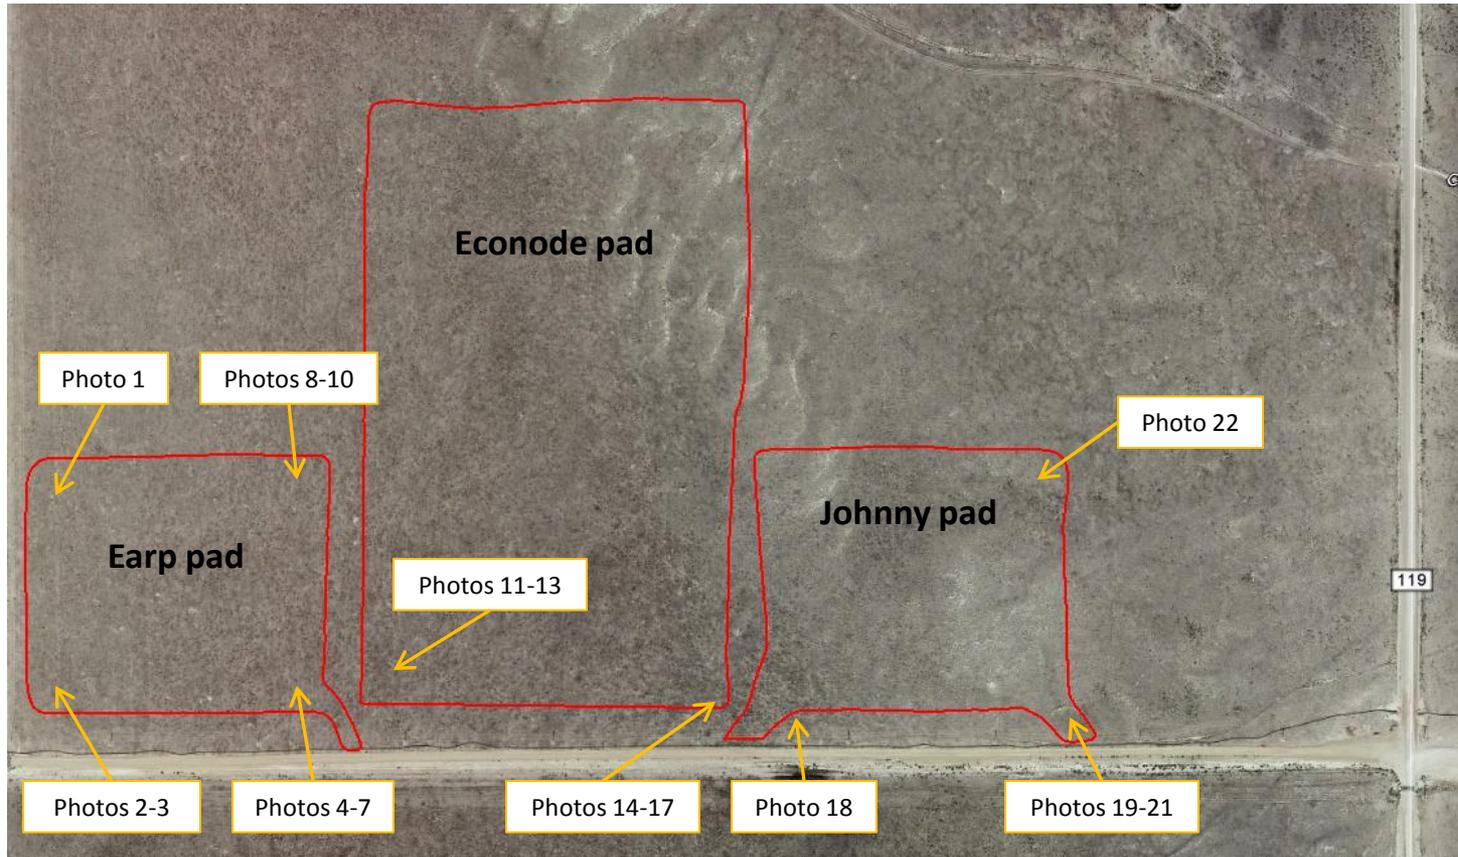
Photo reference points to help illustrate approximate locations of the subject photo during the January 9, 2018 inspection.
