Final Reclamation Inspection

February 6, 2018

Replugging Operator: BARRETT CORPORATION* BILL (BBC)- 10071

API: 05-123-09893

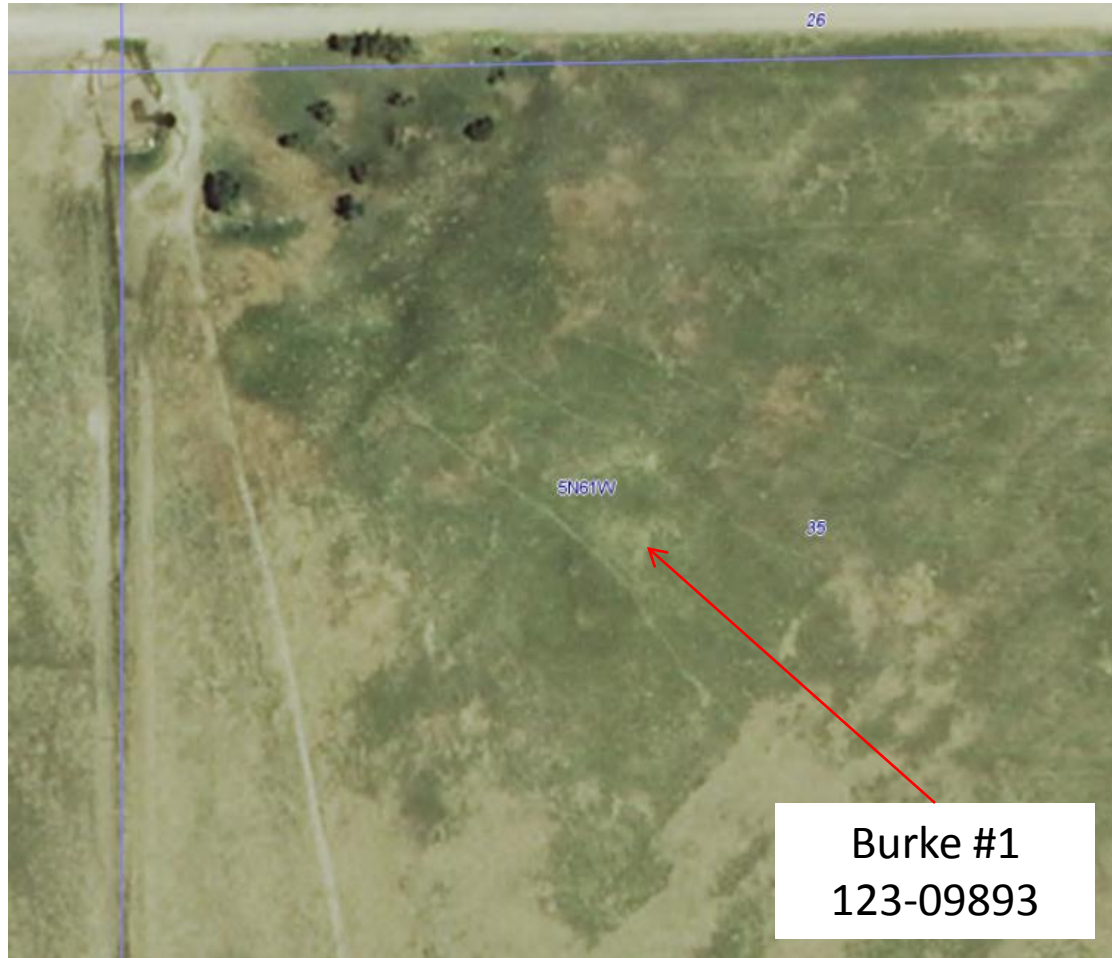
Aerial imagery take in 2013, post plugging and abandonment operations.

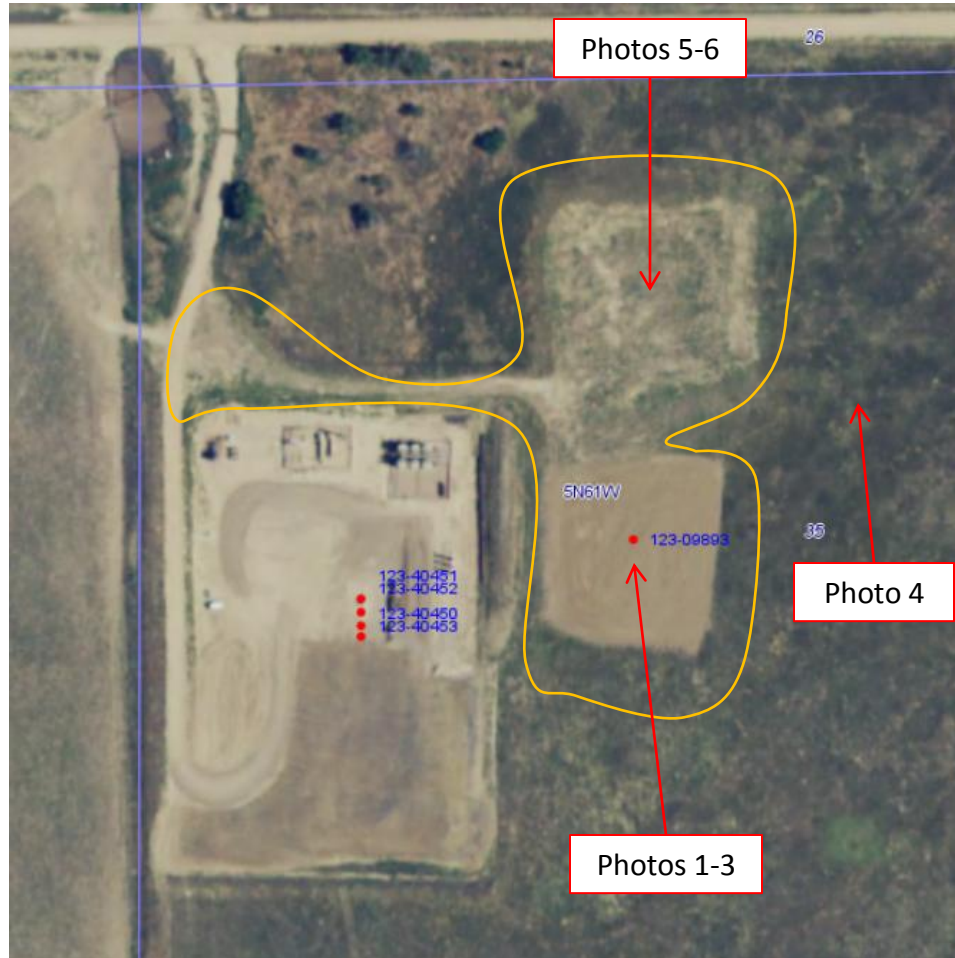
Photo reference points to help illustrate approximate locations of the subject photo during the February 6, 2018 inspection.
