Interim Reclamation and Stormwater Inspection

April 5, 2018

Operator: CUB CREEK ENERGY- #10542

Location ID: 446104

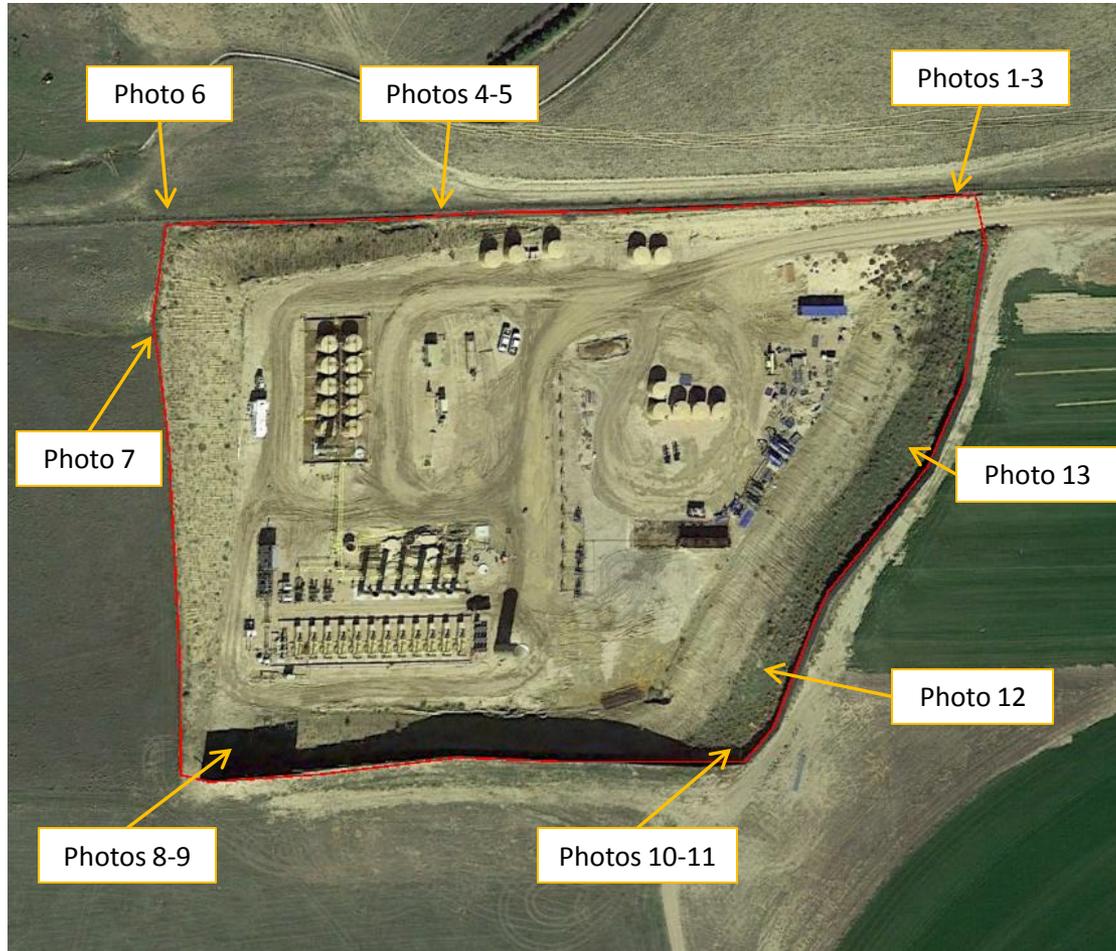
Photo reference points to help illustrate approximate locations of the subject photo during the April 5, 2018 inspection.
