Final Reclamation and Stormwater Inspection

April 11, 2018

Operator: SRC ENERGY INC- #10311

Location ID: 333286

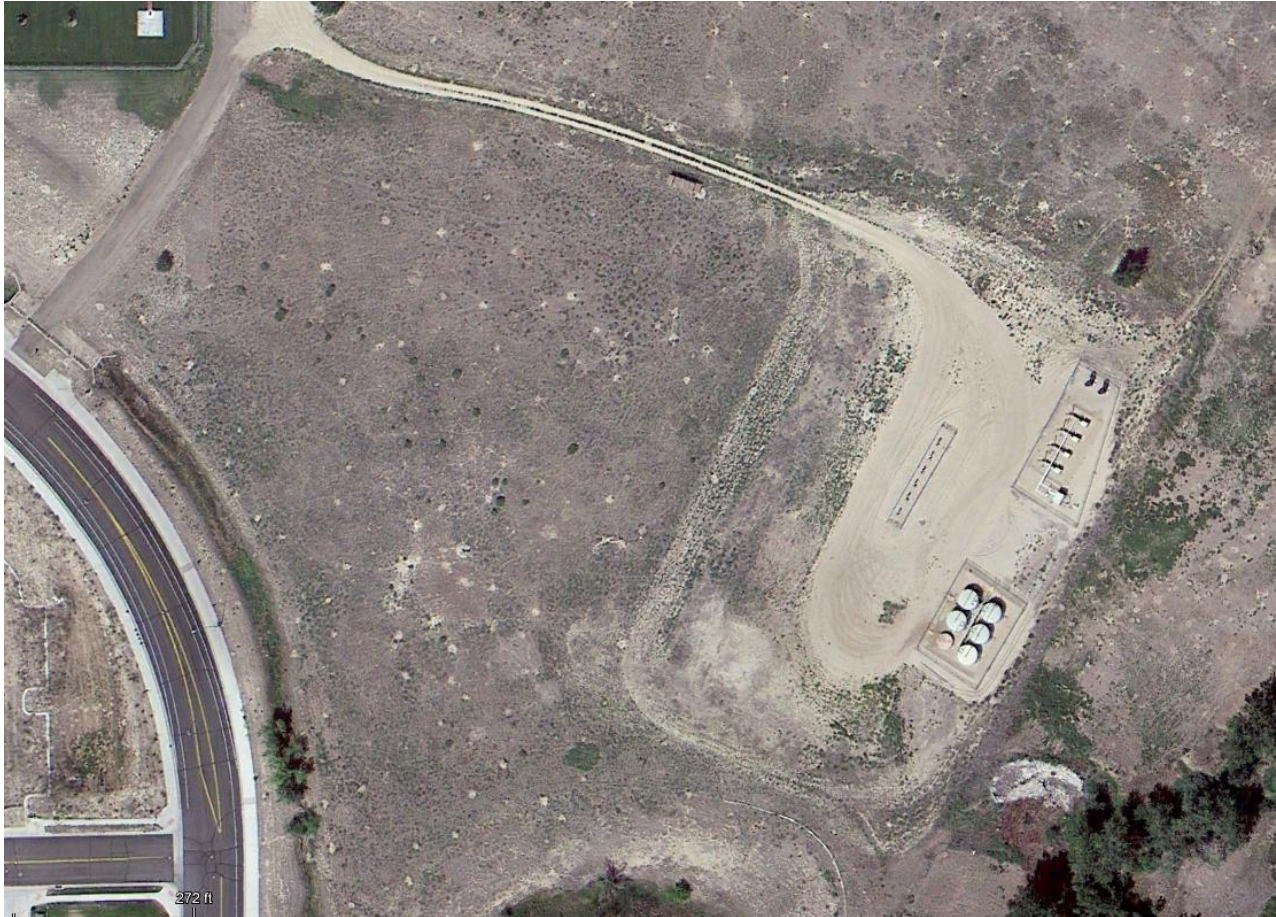
Google Earth aerial imagery taken August 18, 2012. Photo illustrates the SRC Northridge location during active operations before the Kelly Farms location was built.

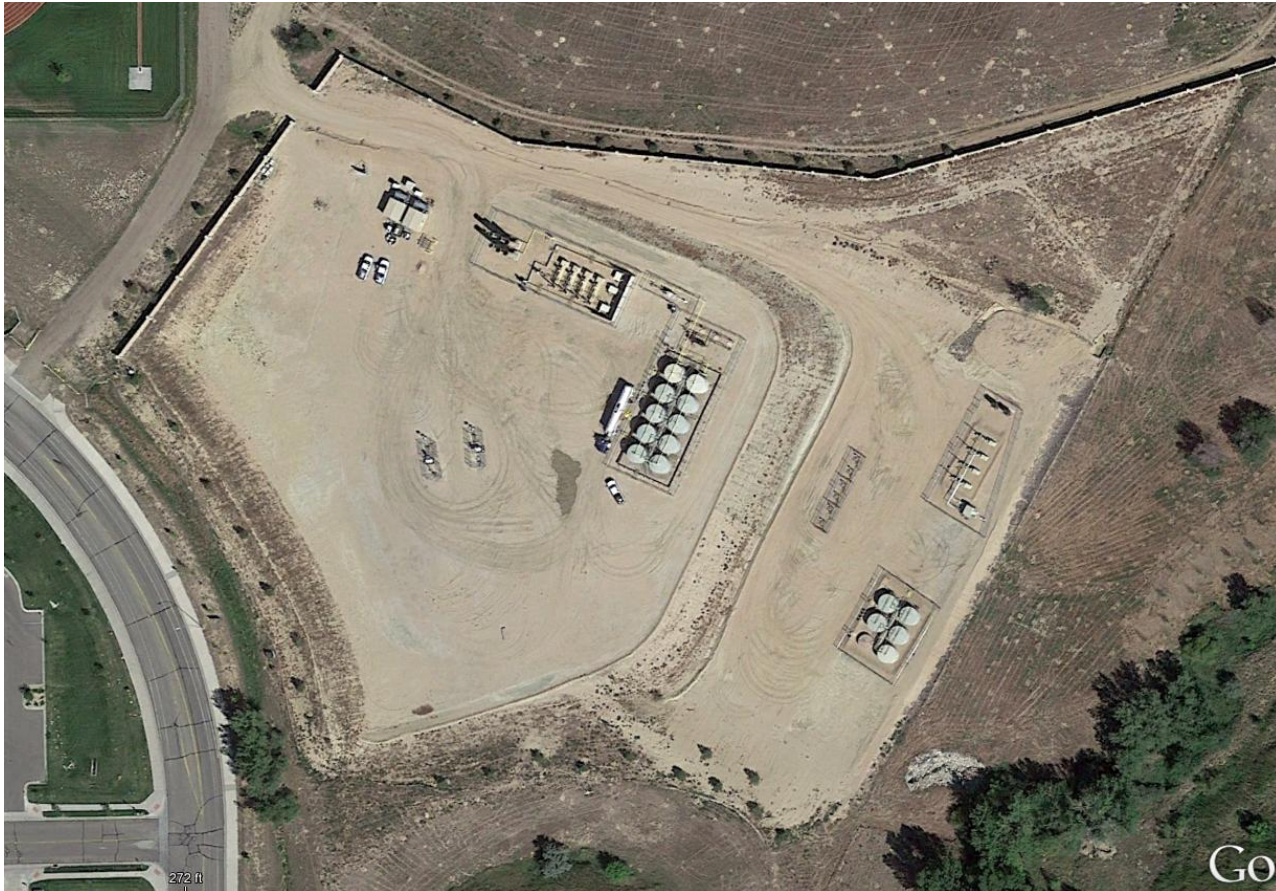
Google Earth aerial imagery taken September 7, 2016. Photo illustrates both the SRC Northridge and Kelly Farms locations during active operations.

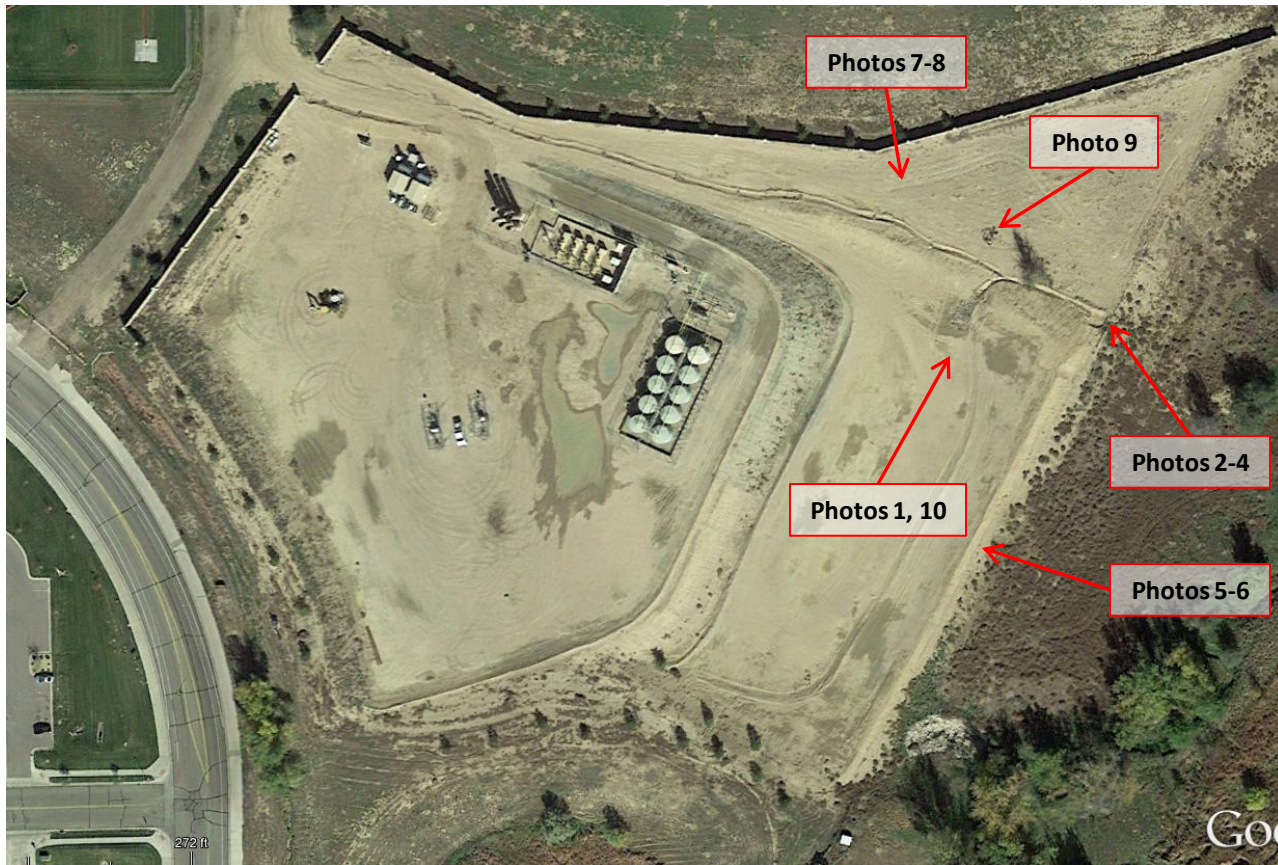
Photo reference points to help illustrate approximate locations of the subject photo during the April 11, 2018 inspection.
