# Interim Reclamation and Stormwater Inspection

April 16, 2018

Operator: GADECO LLC- #10673

Location Name: Grynberg Stateline Federal /24-12-65-4 Pad

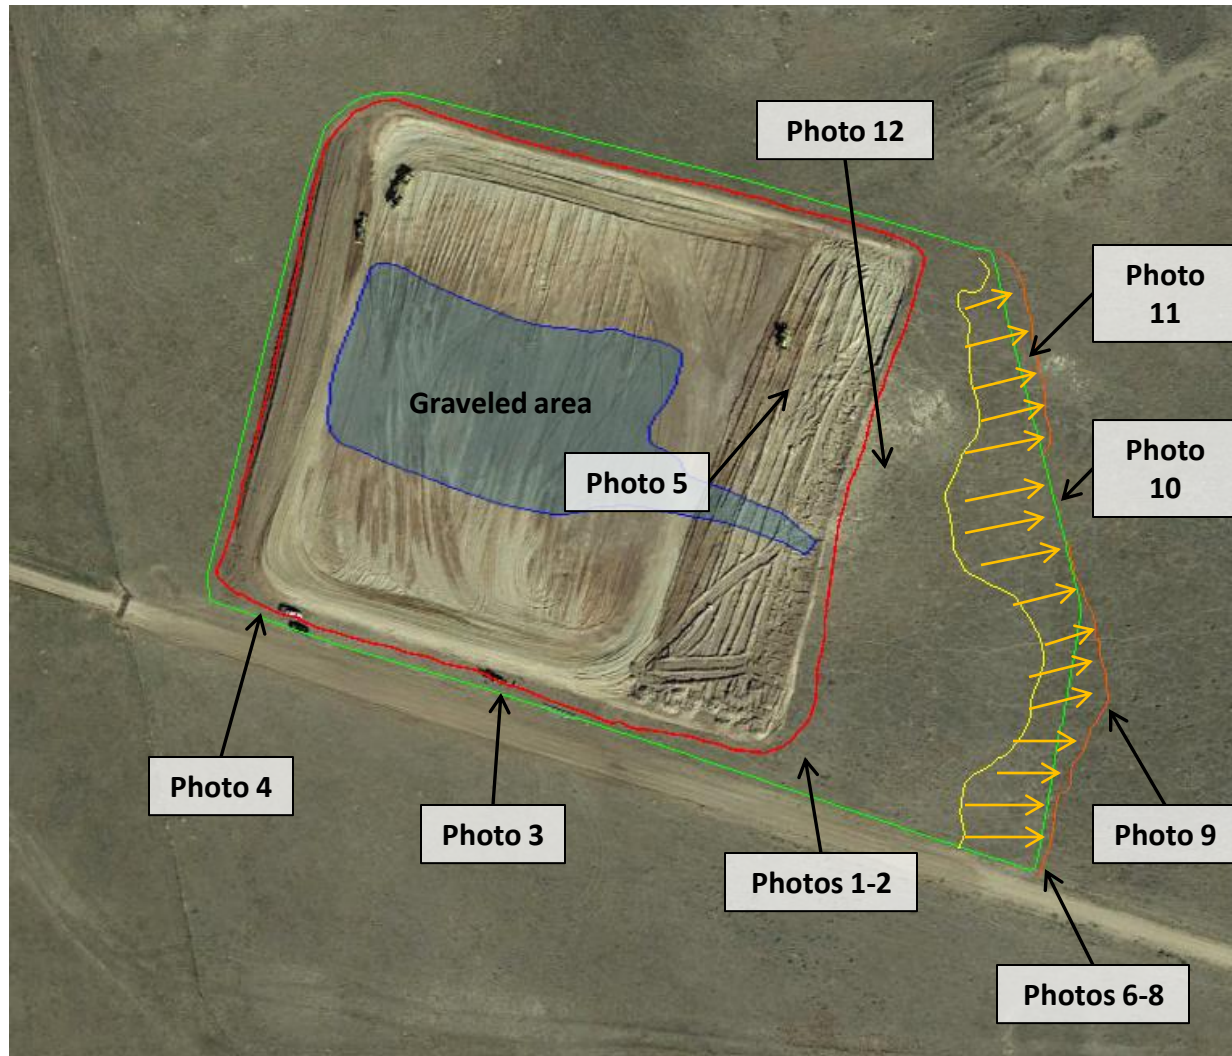
Photo reference points to help illustrate approximate locations of the subject photo during the April 16, 2018 inspection.
