Interim Reclamation and Stormwater Inspection

June 27, 2018

Operator: EXTRACTION OIL & GAS INC #10459

Location ID: 436824

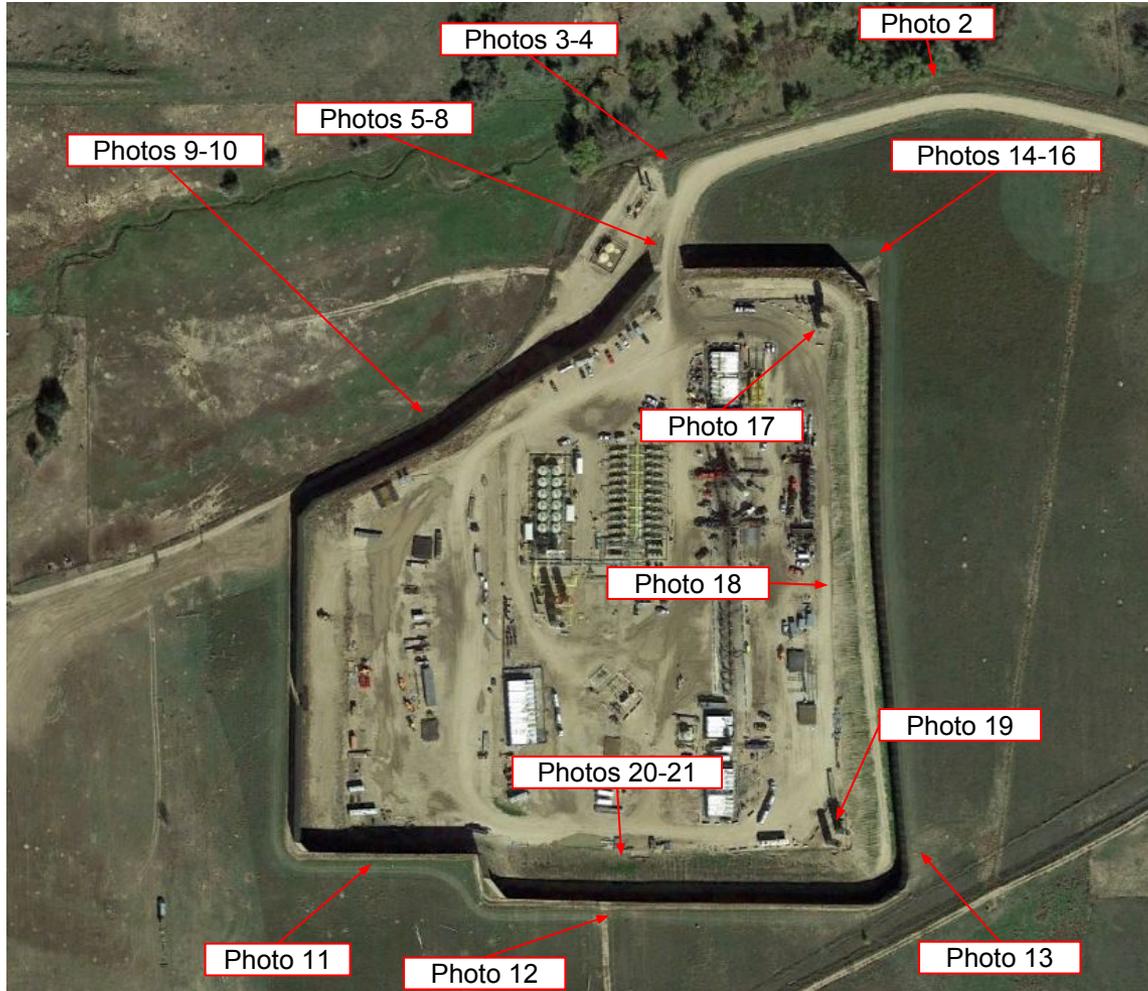
Google Earth aerial imagery taken on 10/14/2017. Photo reference points to help illustrate approximate locations of the subject photo during the June 27, 2018 inspection. Photo 1 not shown in this aerial image.
