Interim Reclamation and Stormwater Inspection

August 10, 2018

Operator: K P KAUFFMAN COMPANY INC - 46290

Location ID: 320780

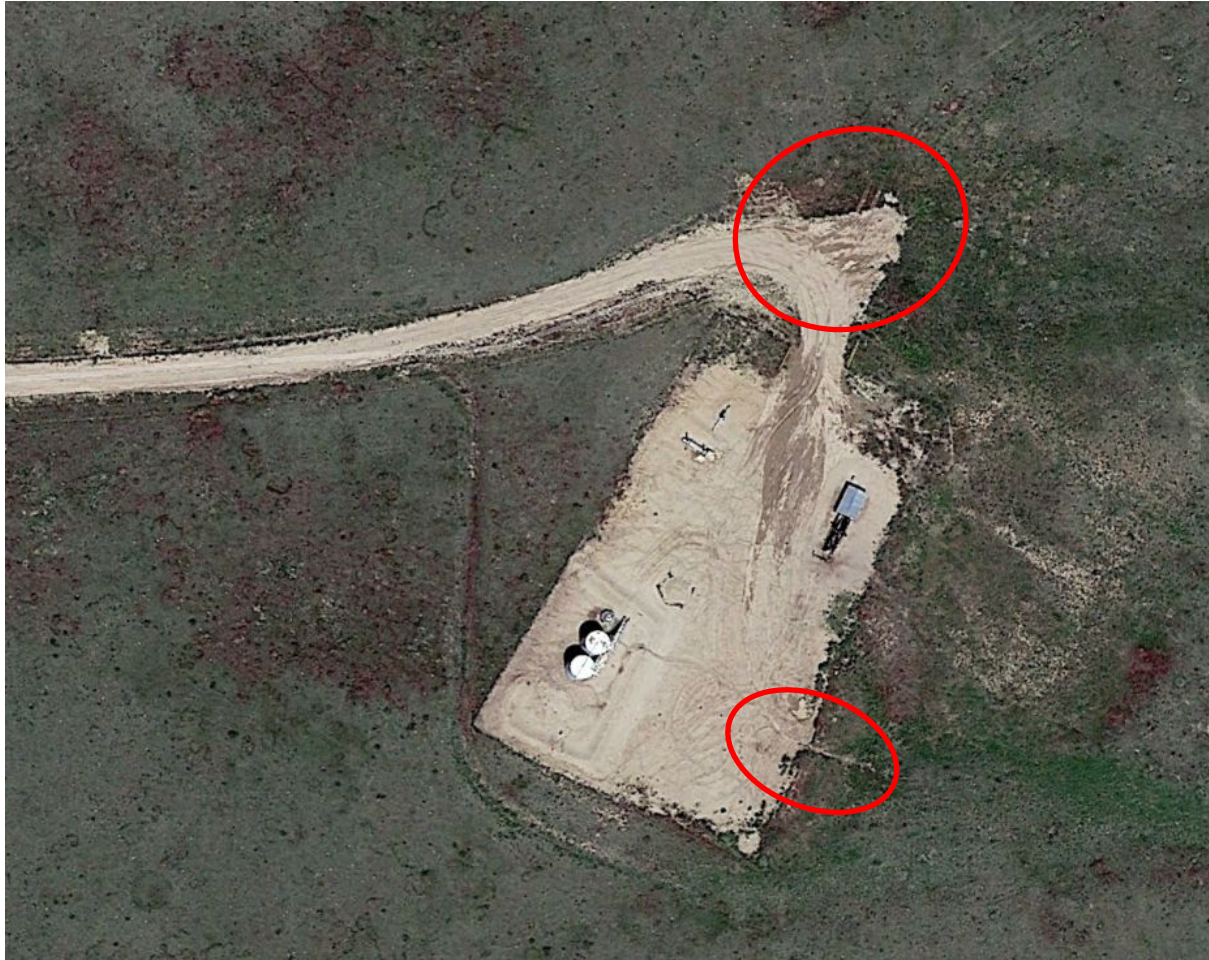
Google Earth aerial imagery taken 6/14/2016 illustrating well location during operations. Two points of discharge were observed during the August 10, 2018 inspection along a portion of the access road and along the southeastern well location (highlighted in the red circles). Erosion is channelizing along portions of the access road and needs repairs and BMPs.
