Inspection Photos

09/05/2018

Operator: FOUNDATION ENERGY
MANAGEMENT LLC - 10112

Inspection Doc. Number: 682503851
Weld County, CO

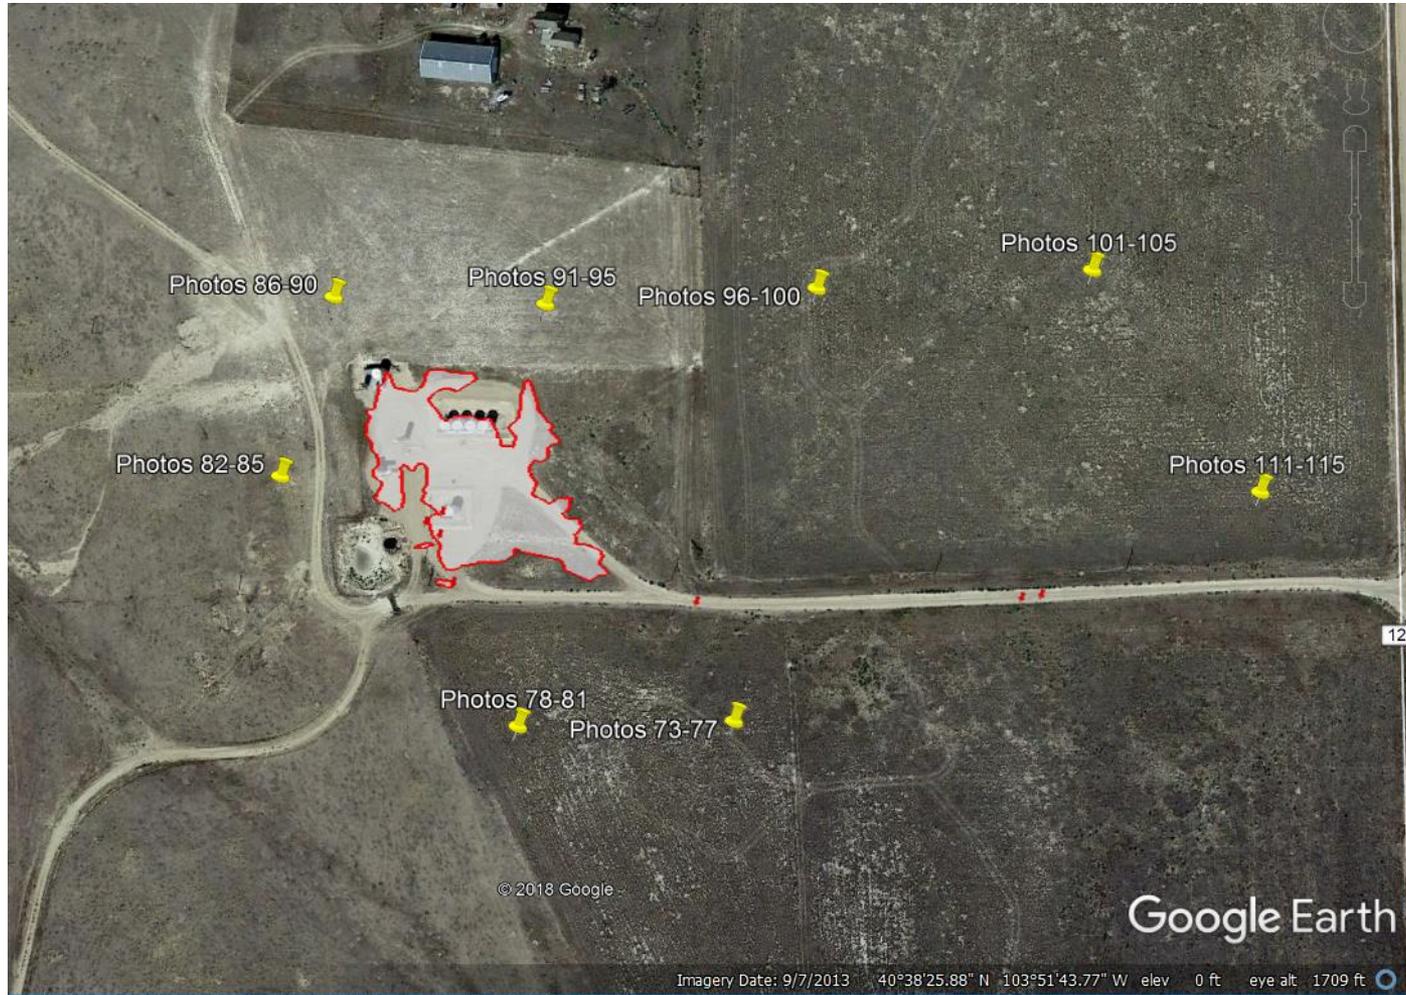
2013 aerial imagery. Photo shows overview of photos that will be included in this document.

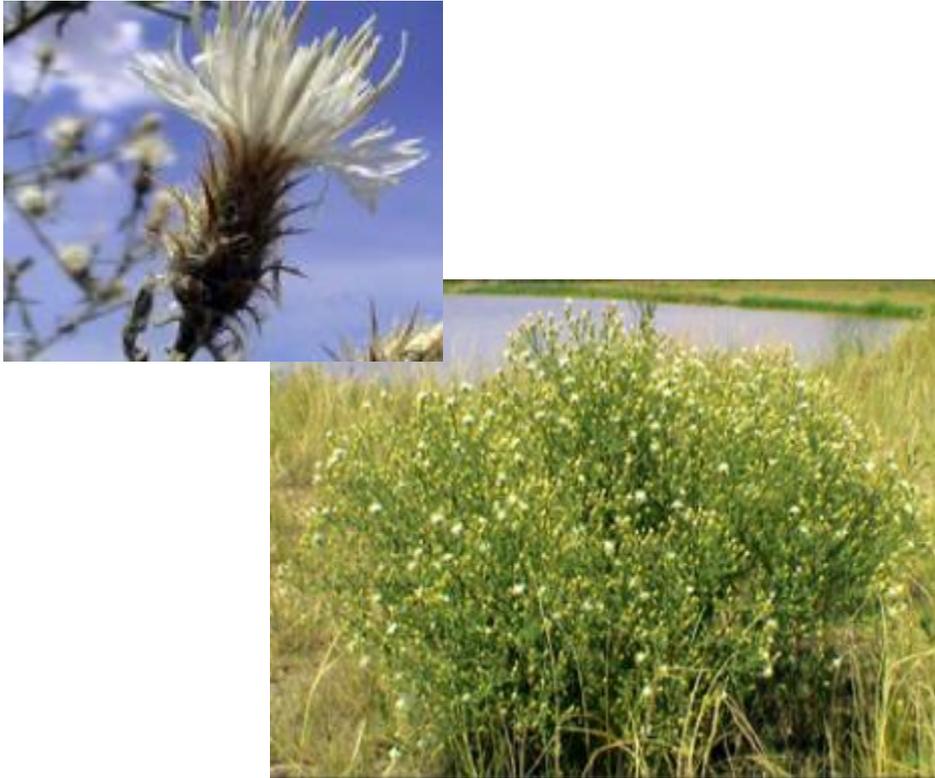
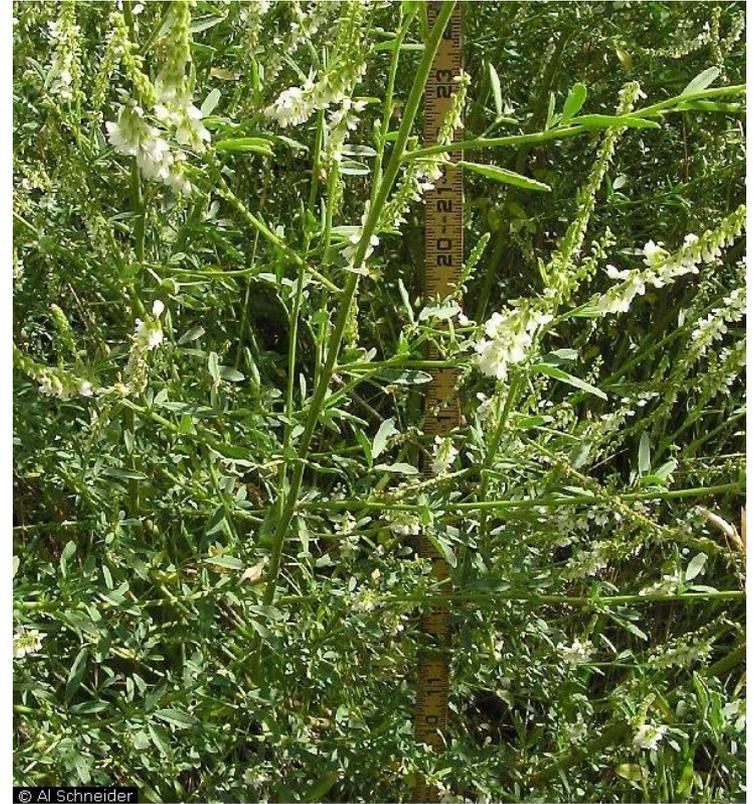
The photos within this document identify Yellow Sweet clover within the location and reference area, as well as Diffuse Knapweed. For documentation purposes as it may be difficult to distinguish between the two in the photo document, the above picture are to compare and contrast the visible differences between Diffuse Knapweed (Two photos to the left) and Yellow Sweet Clover (Single photo on the right). Photos curtesy of CO Department of Ag, and USDA Plants Database.

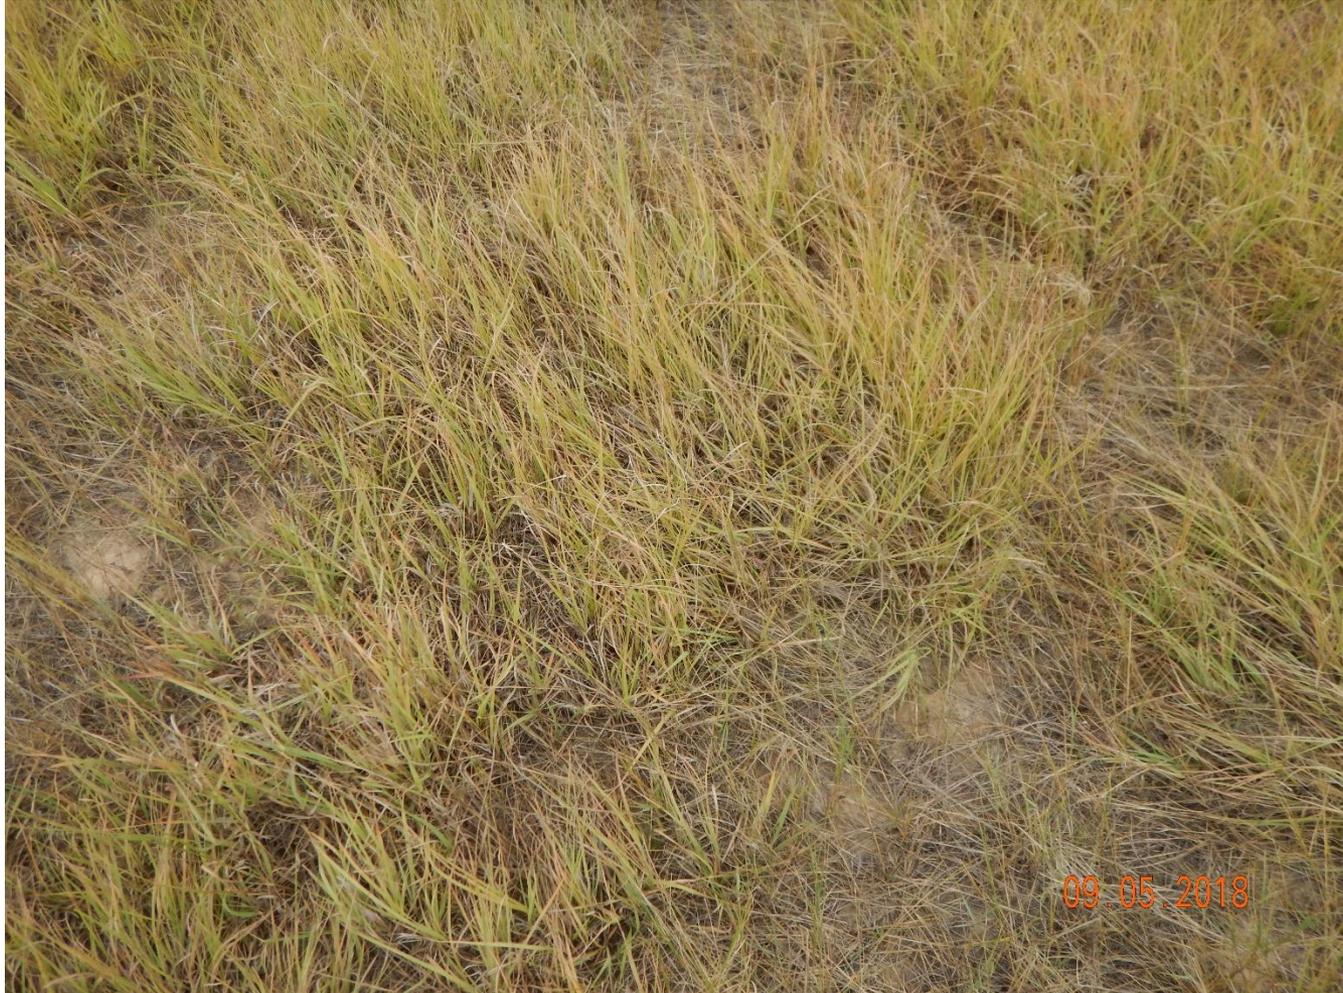
Photo 77: Photo taken from the adjacent lands. Photo shows dominant vegetation observed in this immediate area to be Sideoats Grama

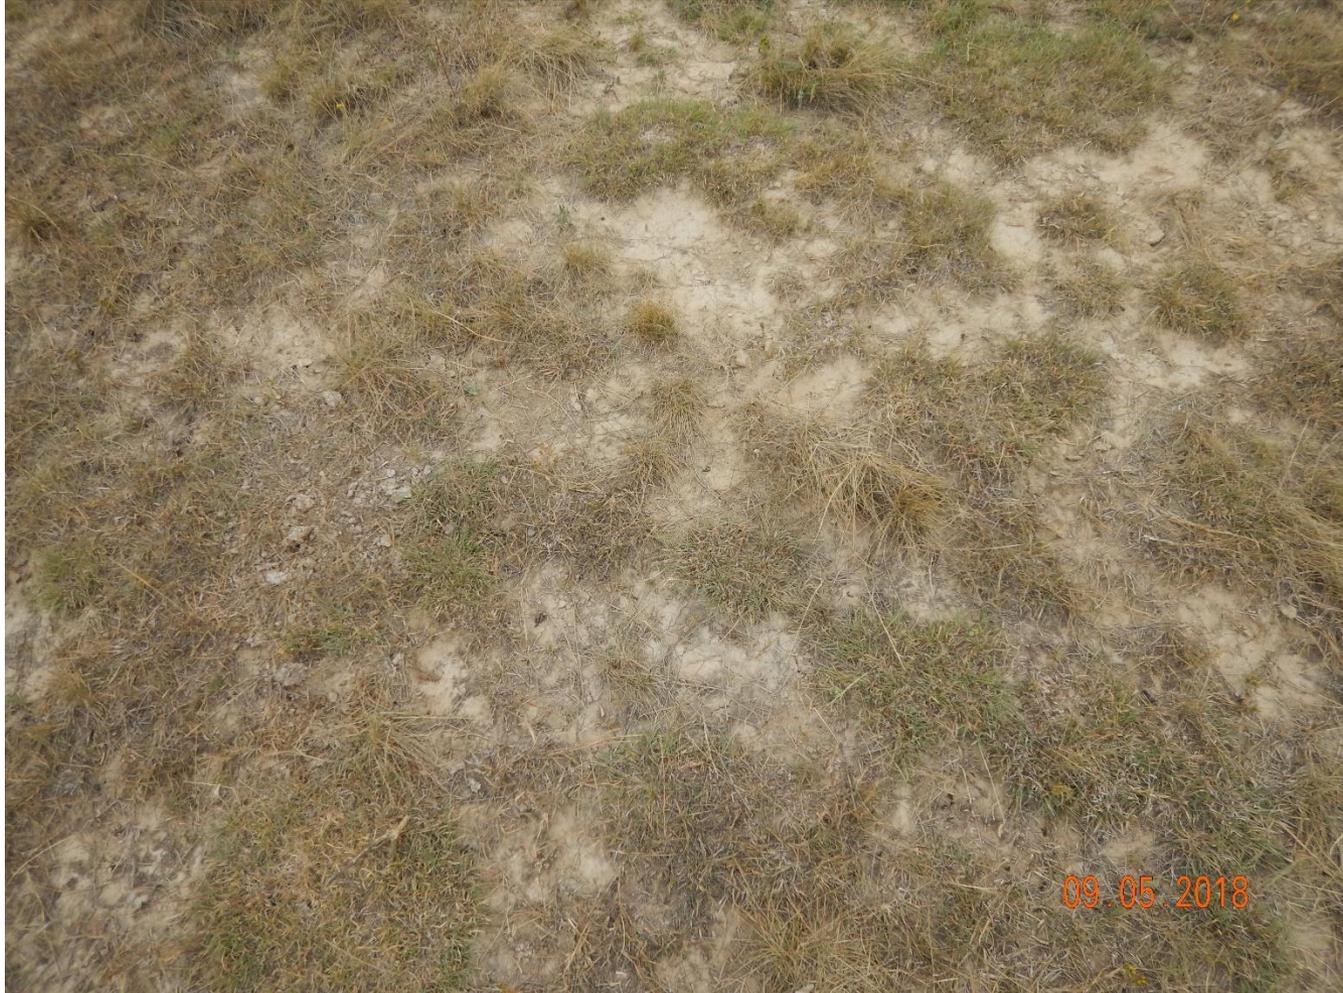
Photo 90: Photo taken from the adjacent lands. Photo shows dominant vegetation observed in this immediate area to be Blue Grama and Buffalo Grass

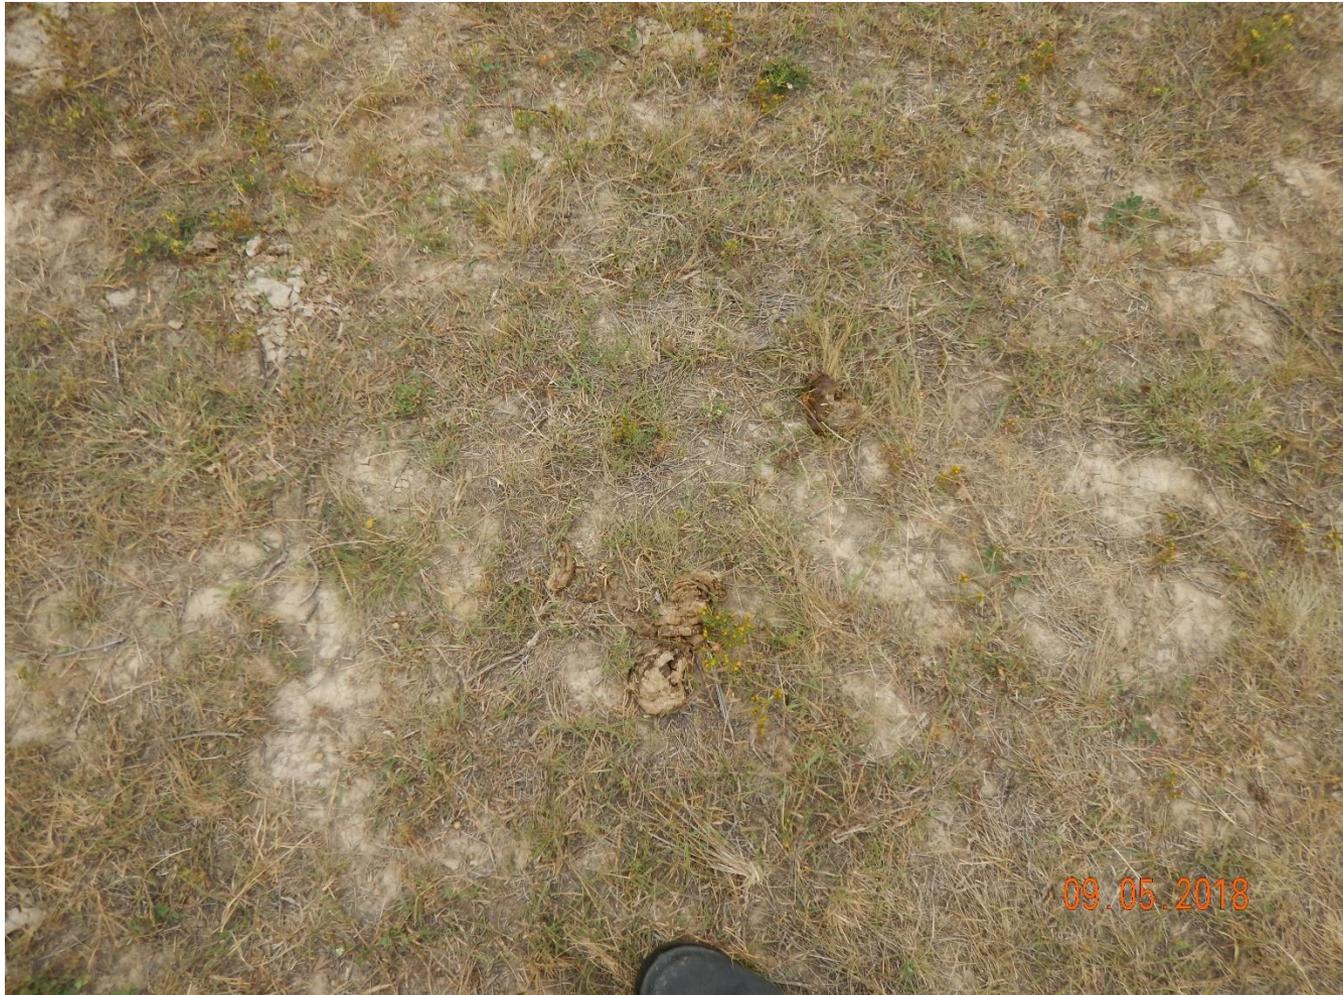
Photo 95: Photo taken from the adjacent lands. Photo shows dominant vegetation observed in this immediate area to be Blue Grama and Buffalo Grass

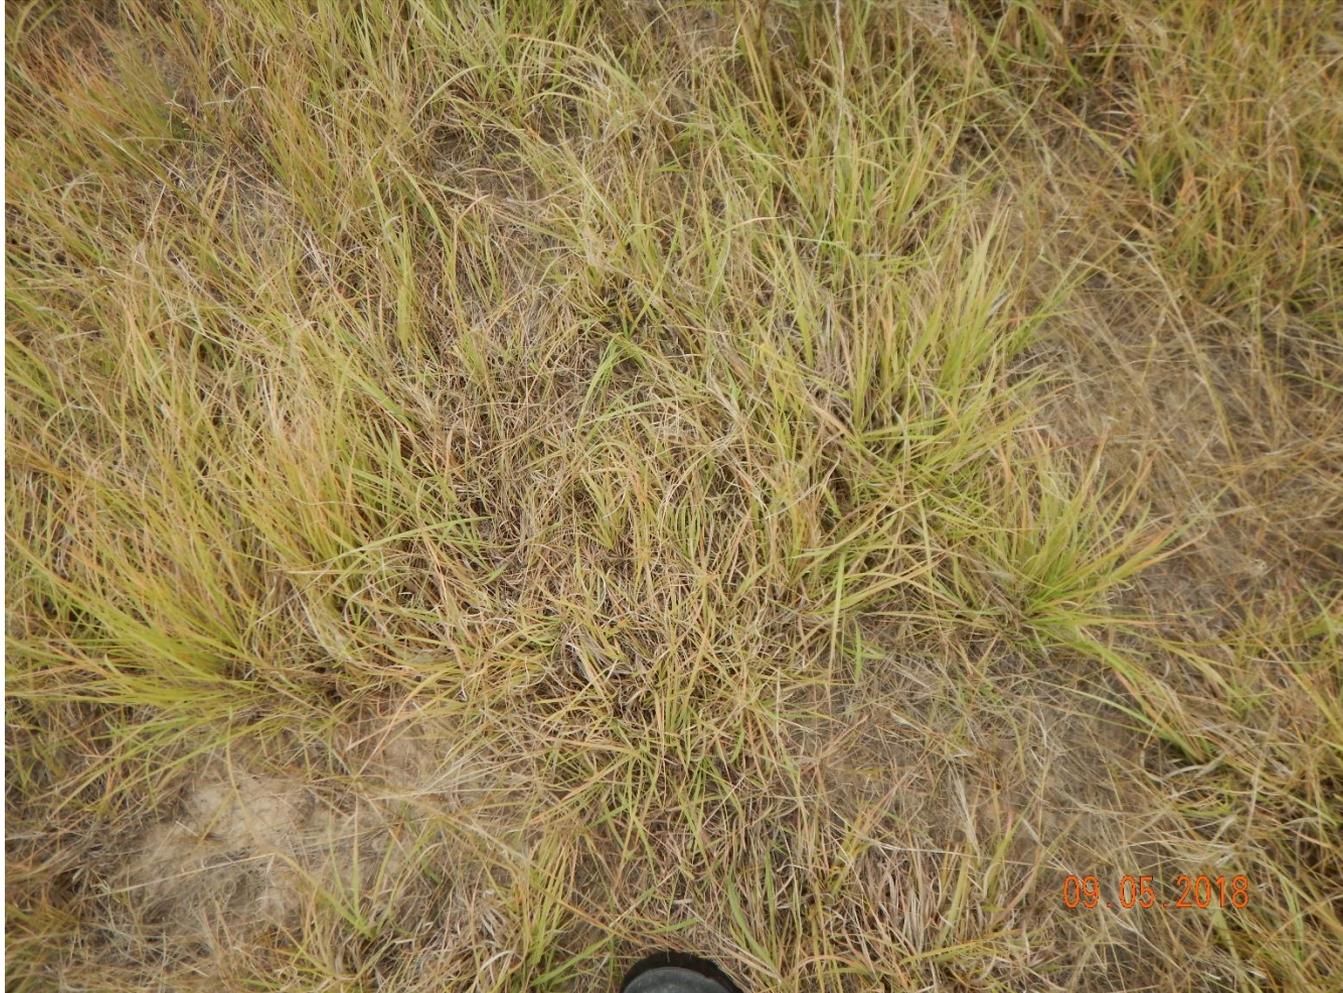
Photo 100: Photo taken from the adjacent lands. Photo shows dominant vegetation observed in this immediate area to be Sideoats Grama

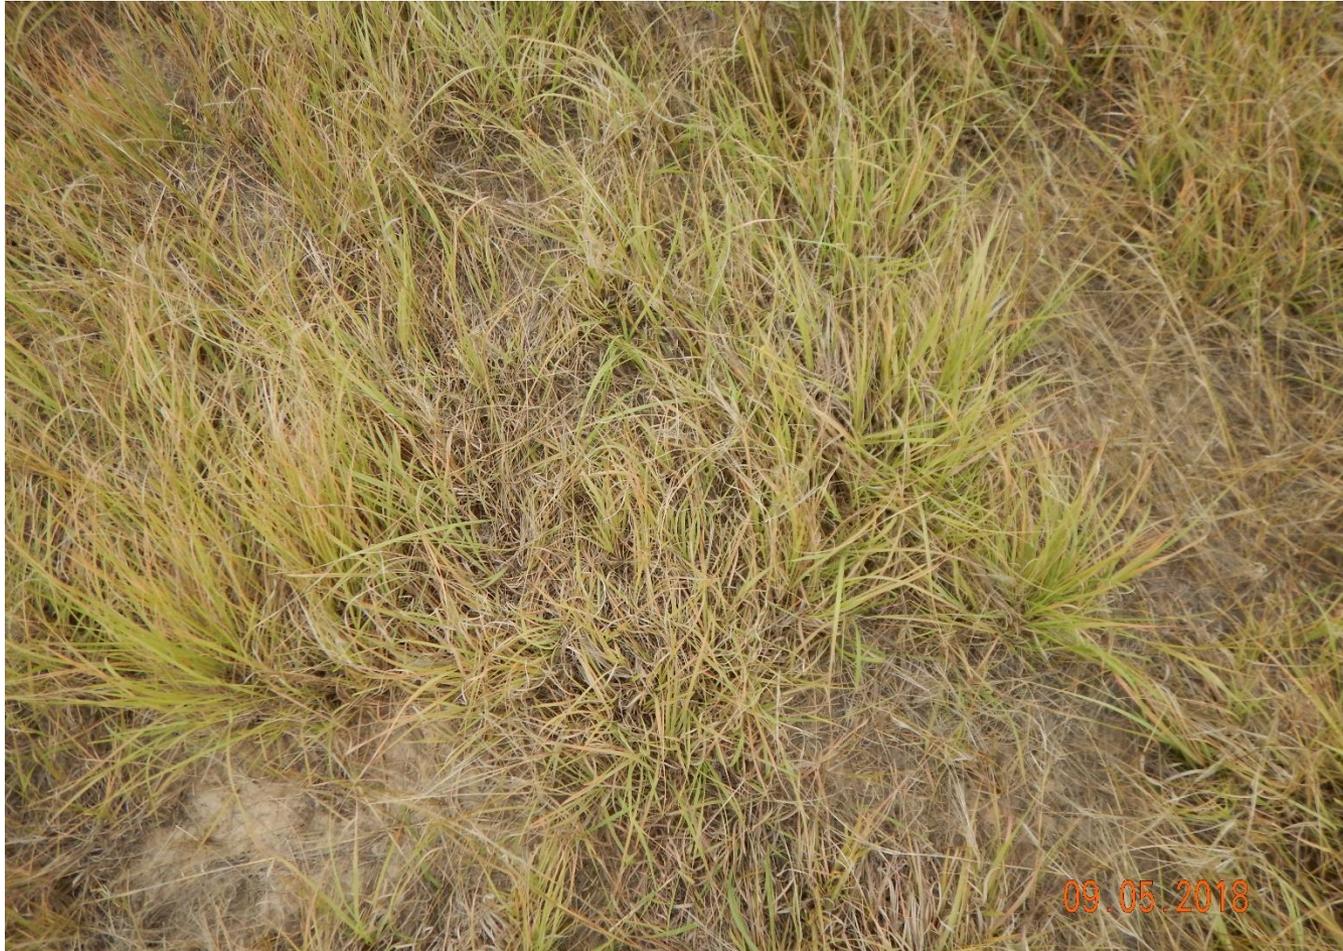
Photo 105: Photo taken from the adjacent lands. Photo shows dominant vegetation observed in this immediate area to be Sideoats Grama

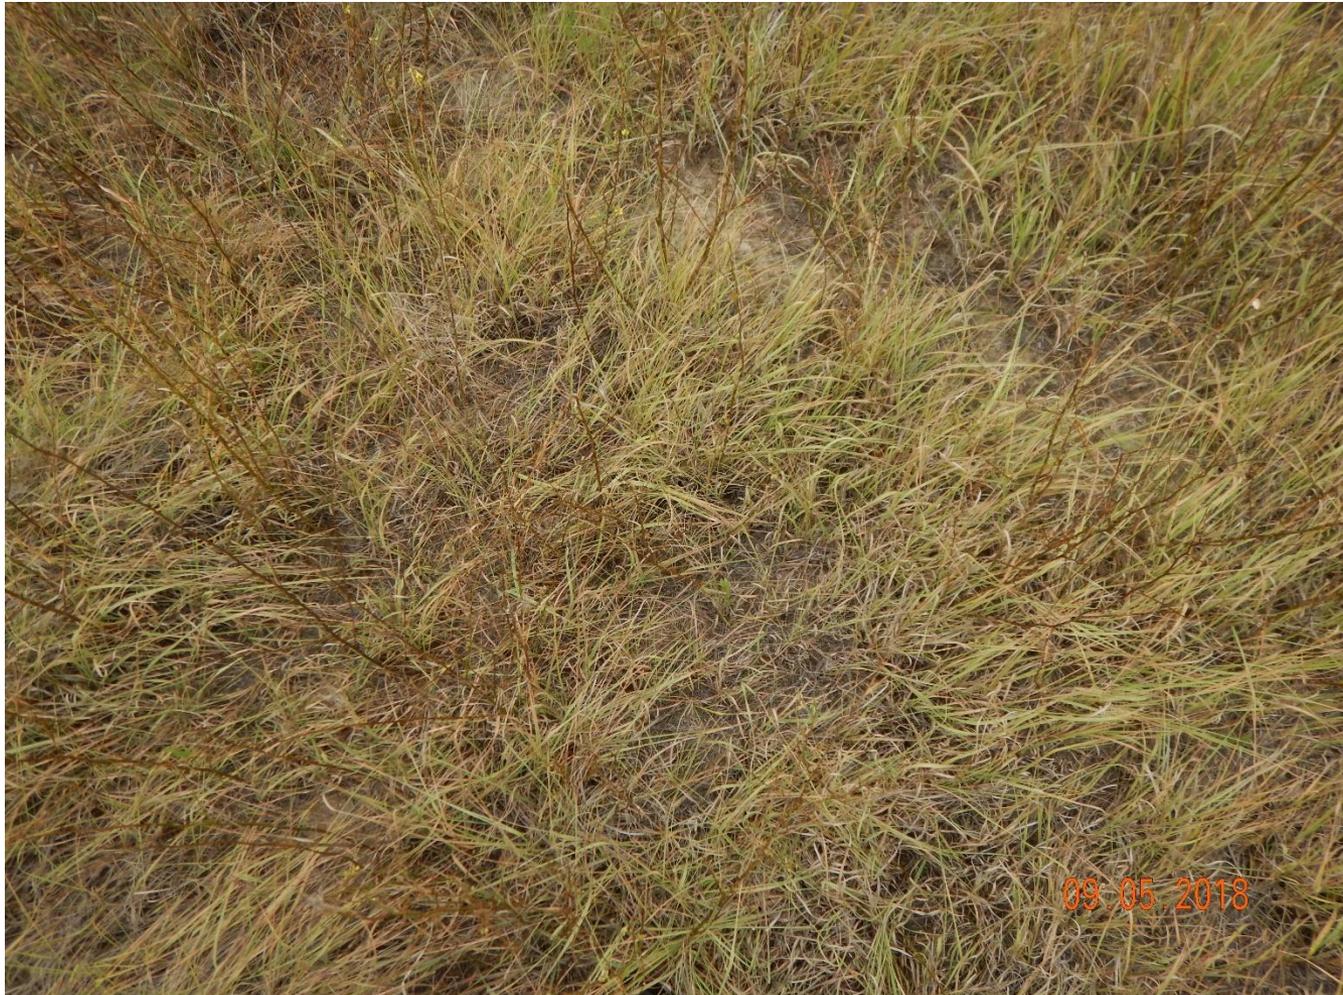
Photo 110: Photo taken from the adjacent lands. Photo shows dominant vegetation observed in this immediate area to be Sideoats Grama

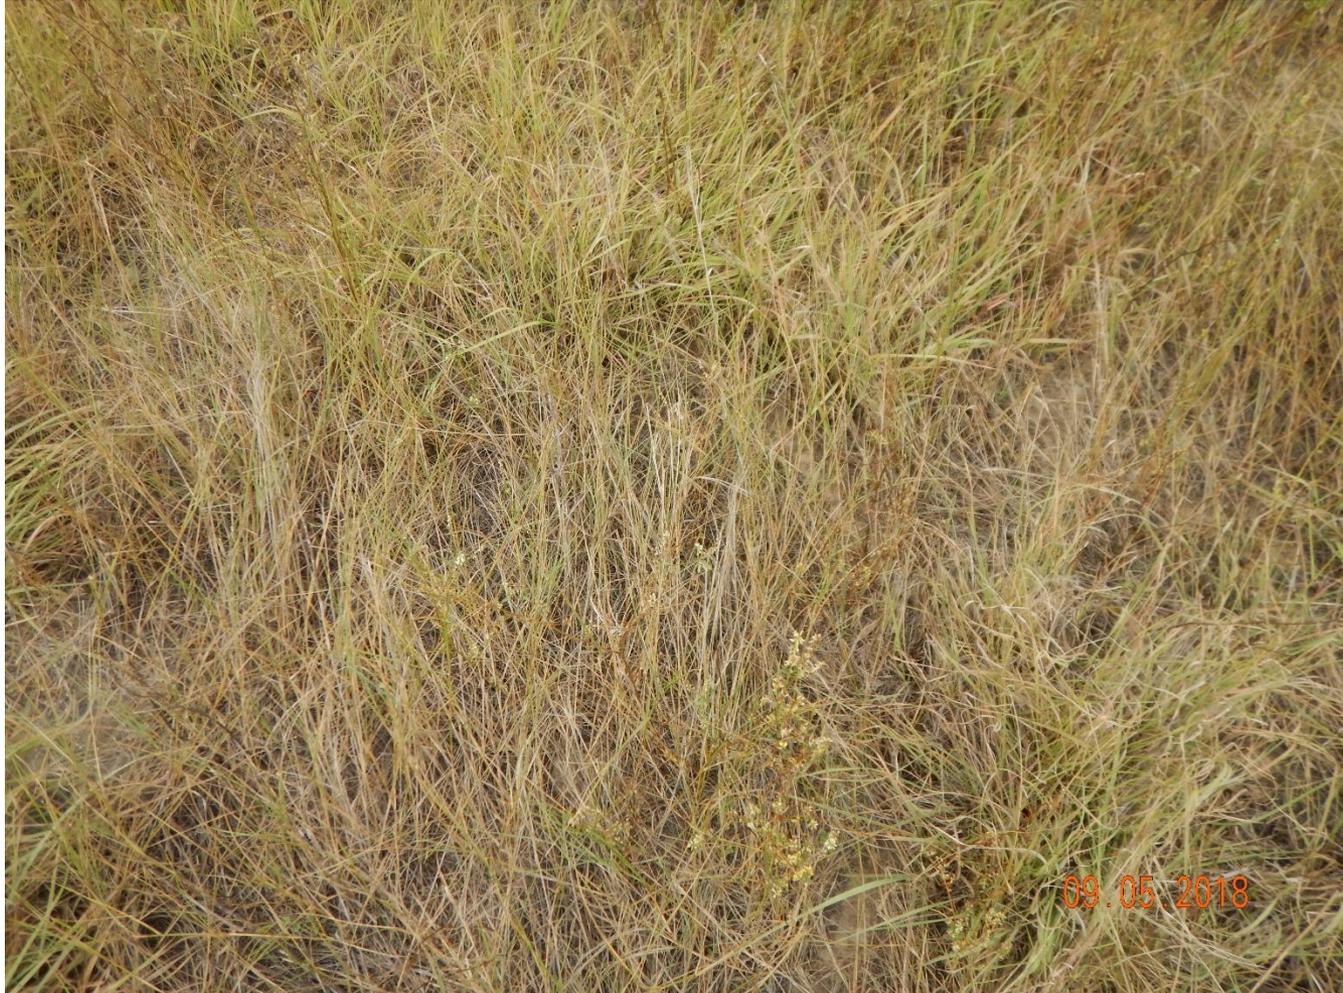
Photo 115: Photo taken from the adjacent lands. Photo shows dominant vegetation observed in this immediate area to be Sideoats Grama
