# Inspection Photos

09/20/2018

Operator: SMITH OIL PROPERTIES INC - 79905

Location ID: 313873

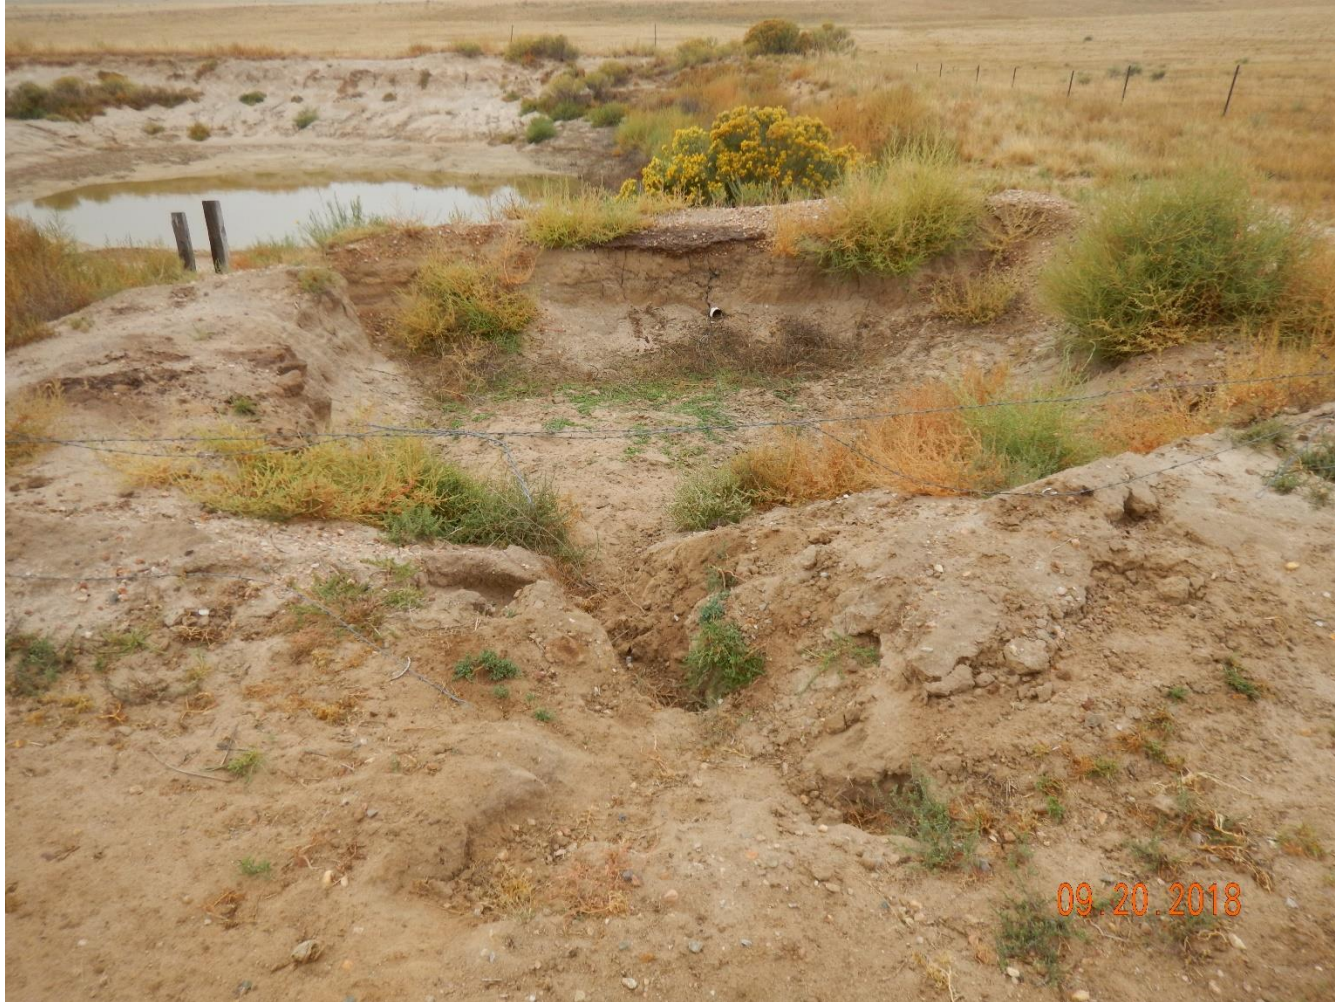
**Photo 16:** Photo taken from the east end of the skim pit, facing west.

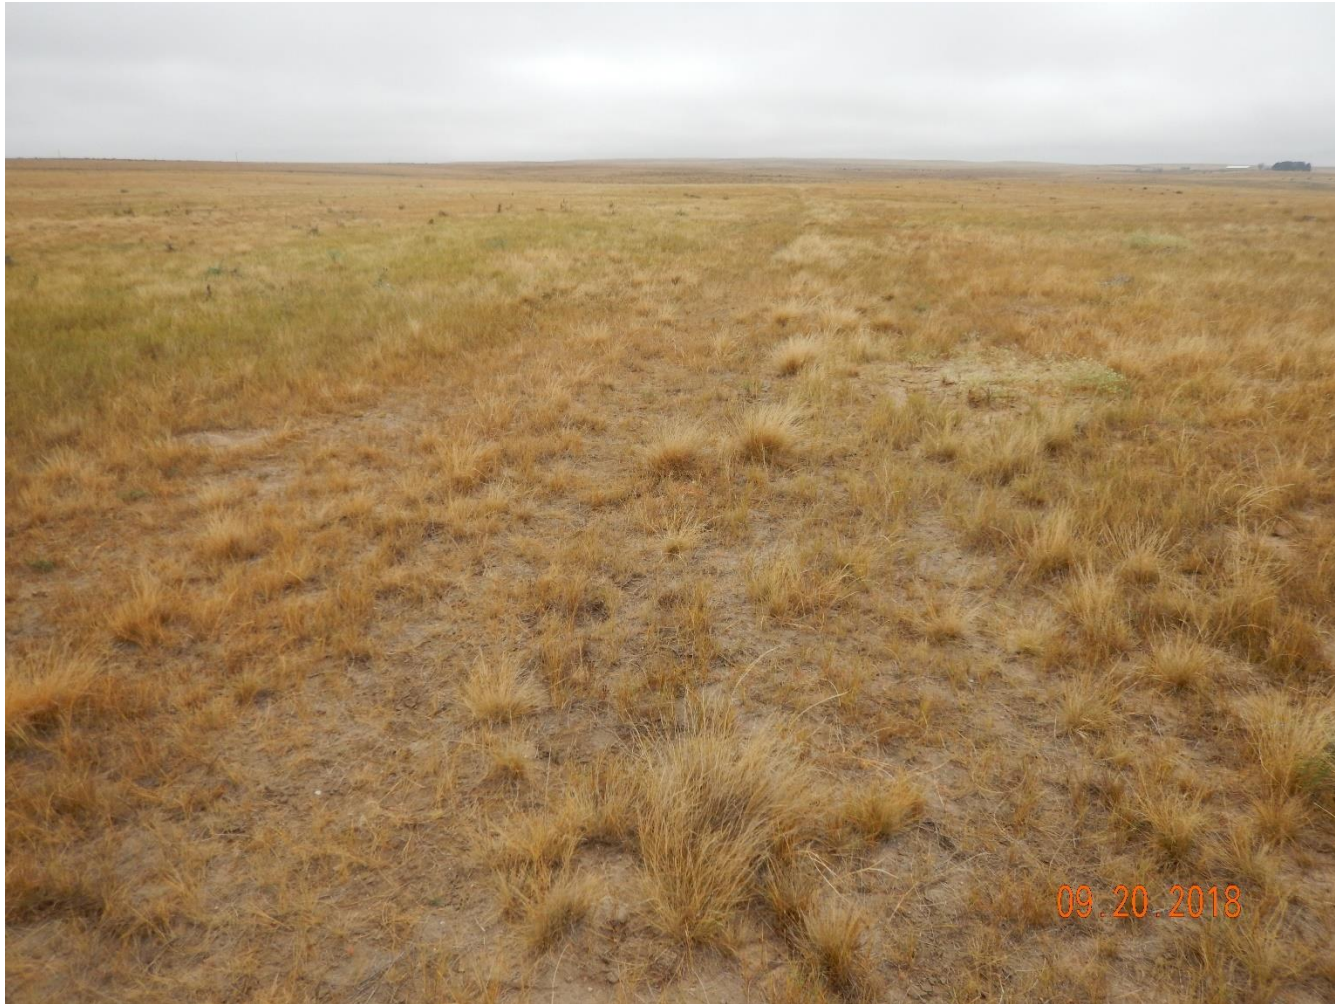
**Photo 29:** Photo taken from the east of the location. Photo shows area where a second access road to the location has been reclaimed.
