Inspection Photos

10/01/2018

Operator: SWN PRODUCTION COMPANY LLC -
10396

Inspection Doc. Number: 682504013
Adams County, CO

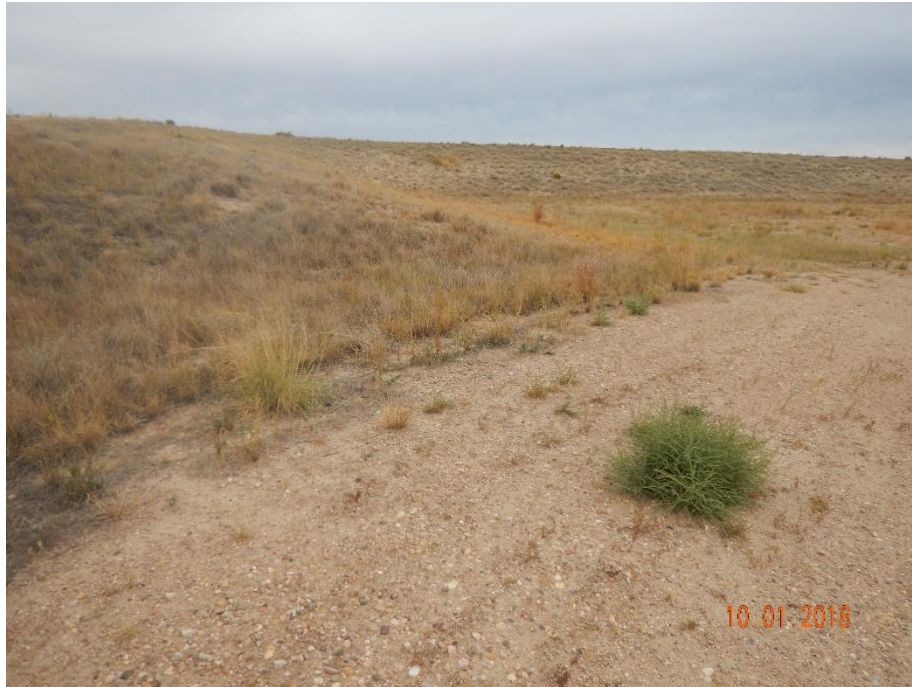
Photo 5: Photo taken from the north end of the location, facing east. Photos 5-8 provide an overview of the location from east, to south to west.

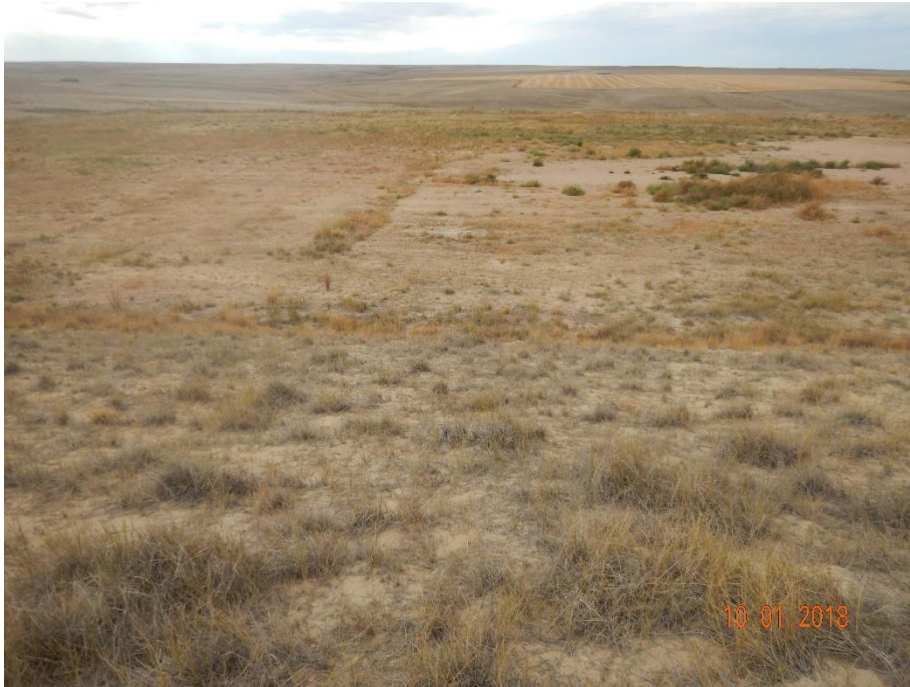
Photo 15:

Photo 14: Photo from the east end of the location, facing south. Photos 14-16 provide an overview of the location from south, to west, and north. Photos also show that large areas of the pad is predominantly undesirable weedy plant species, or bare and exposed soil, and is not graveled/stabilized.

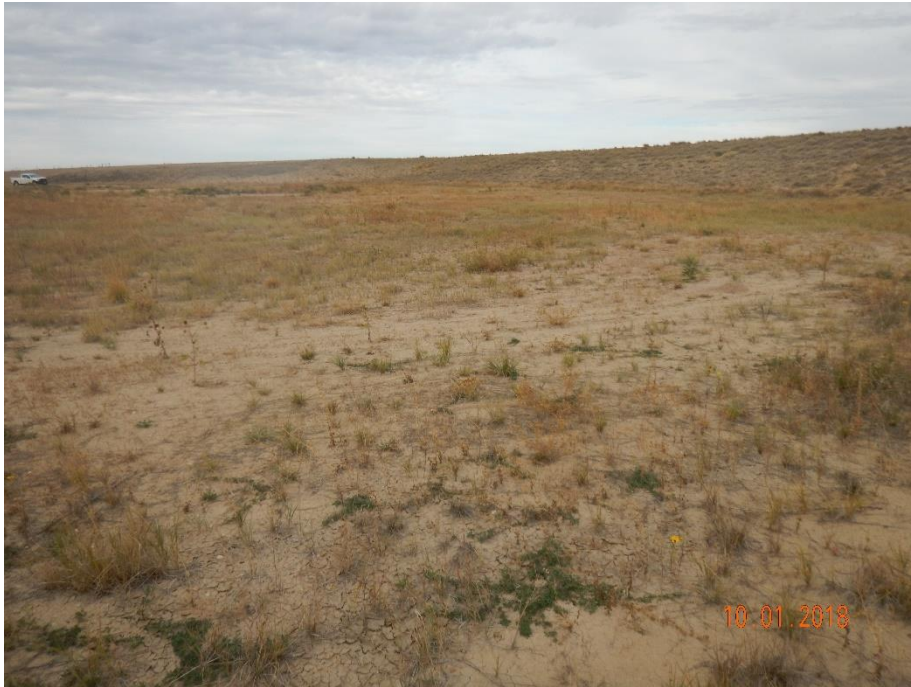
Photo 23:

Photo 22: Photo from the south end of the location, facing northwest. Photos 22-24 provide an overview of the location from northwest, northeast, to east. Photos also show that large areas of the pad is predominantly undesirable weedy plant species, or bare and exposed soil, and is not graveled/stabilized.

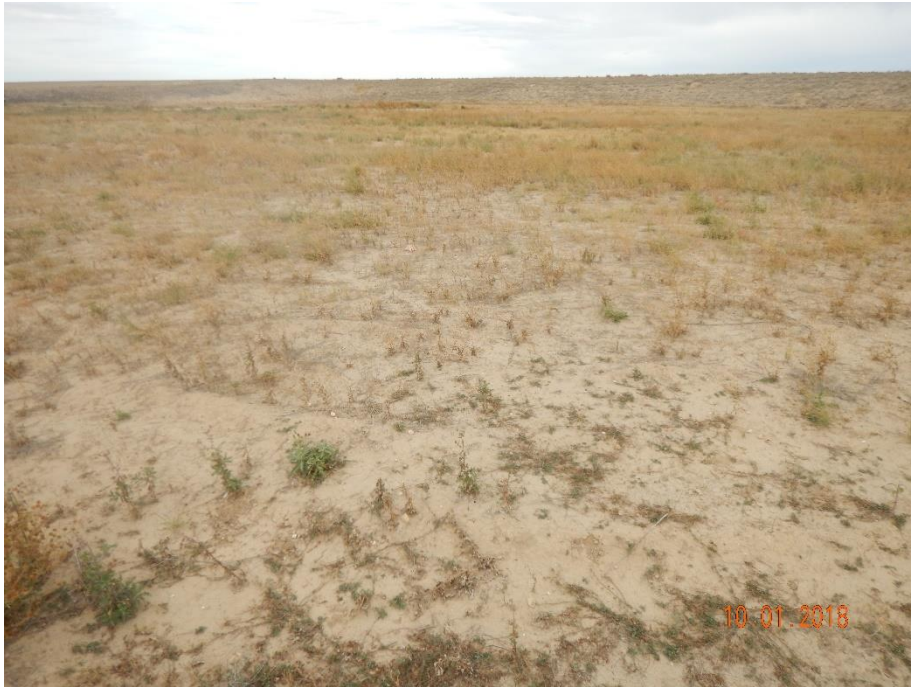
Photo 27:

Photo 26: Photo from the southwest end of the location, facing north. Photos 22-24 provide an overview of the location from north, northeast, to east. Photos also show that large areas of the pad is predominantly undesirable weedy plant species, or bare and exposed soil, and is not graveled/stabilized.

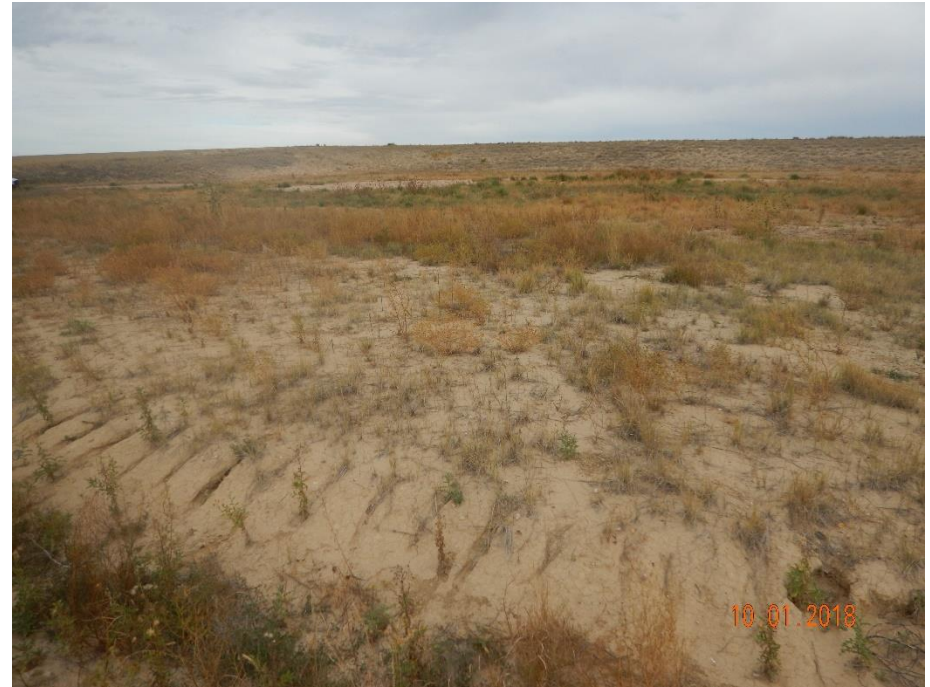
Photo 38:

Photo 37: Photo taken from the west end of the pad, facing north. Photos 37-40 provide an overview of the location from north, east, so south. Photos also show stormwater runoff from the pad into the ditch has created rill formations on the slopes of the ditch.

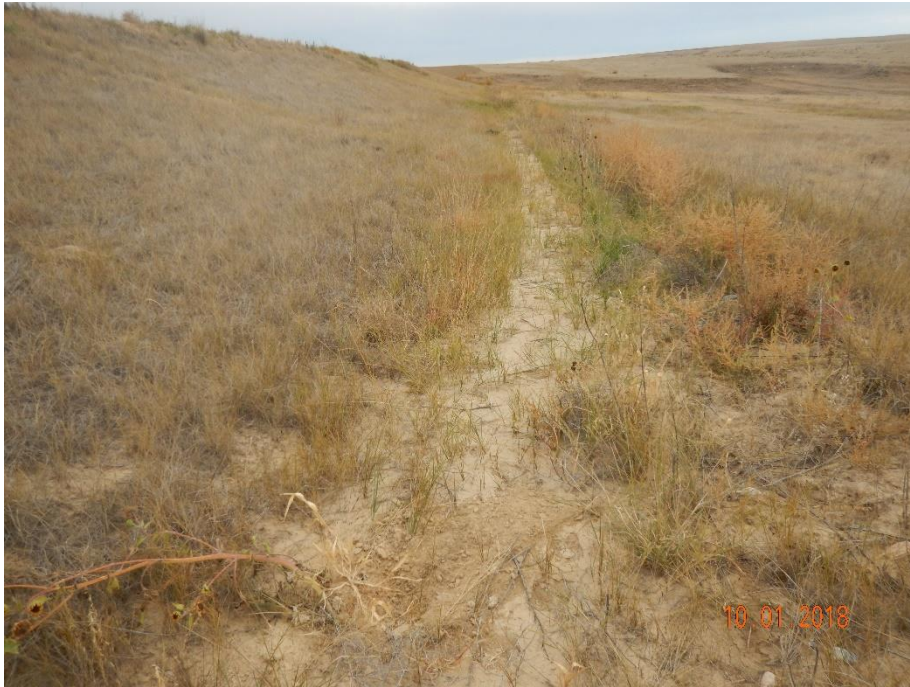
Photo 53: Photo taken from the northwest corner of the location, facing south. Photo shows stormwater ditch along the western perimeter of the location.
