**RE: Corrective Action Response to Field Inspection Forms, COGCC Doc. Nos. 67490239; 674902482**

**February 7, 2019**

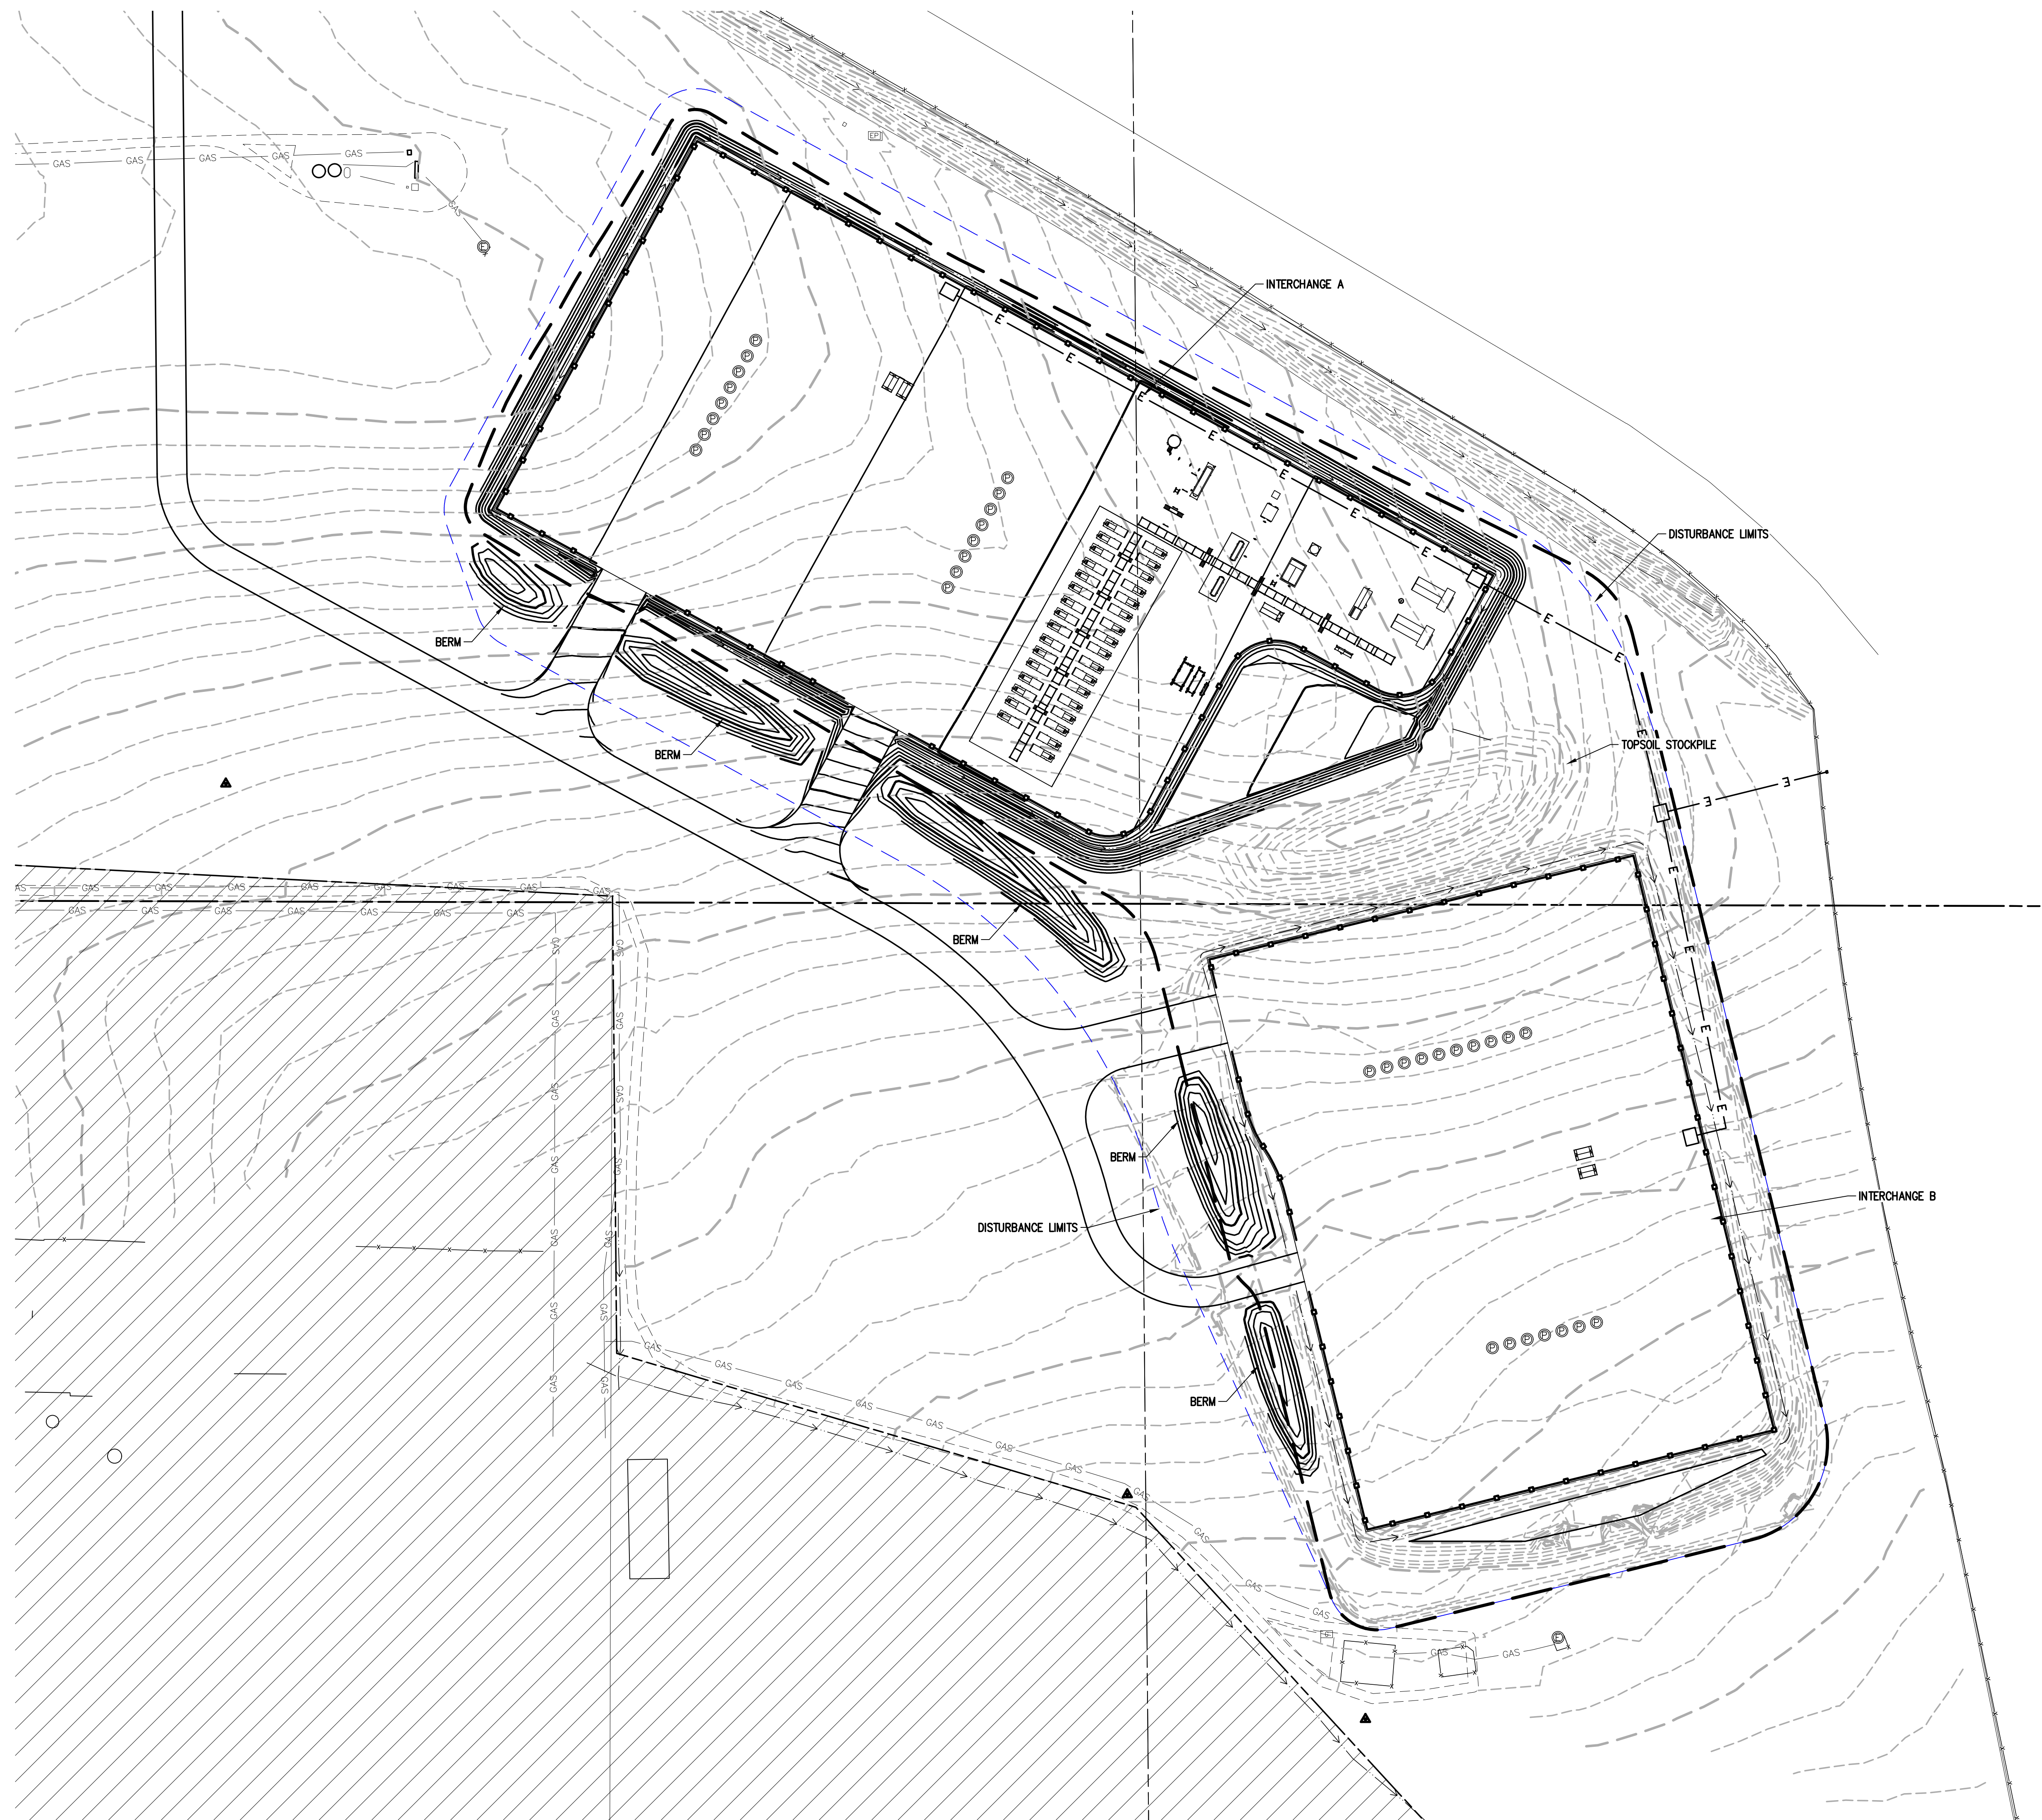
● Topsoil test hole

Extraction's assessment that 6-8" of topsoil was the appropriate amount for it to salvage in accordance with Rule 1002.b. has been corroborated by a recent investigation. Specifically, on February 5, 2019, Extraction personnel conducted a soil profile investigation at the Interchange A&B Pad by using a shovel to dig three test holes along the northern boundary of the site to an approximate depth of 12 inches (photos below demonstrating onsite soil depths along with corresponding latitude and longitude for each test hole). Soil horizons were estimated by noting changes in organic content, color, texture, density, and consistency as outlined in Rule 1002.b.

~2- 7": Moderate organic content. Brown. Clay with ~10-20% sand content. Root structures prevalent. Moderate density (shovel easily penetrates with minimal effort). Moist.

~7" to total depth. Sparse to no organic content. Brown. Clay and sand mix ~ 50%-50%. Very dense (shovel rejection without heavy effort, not frozen, possible disk pan). Root structures were not observed. Moist but drier than above layer.

Therefore, based on observed changes in organic content, color, texture, density and consistency, topsoil is estimated to be approximately 7" thick in the Interchange A&B Pad area.
