Inspection Photos

Location Name: CC 0629-01 Pad & Central Water Handling Facility

Location ID: #323887 & Facility ID: #417559

Inspection Date: April 17, 2019 & May 10, 2019

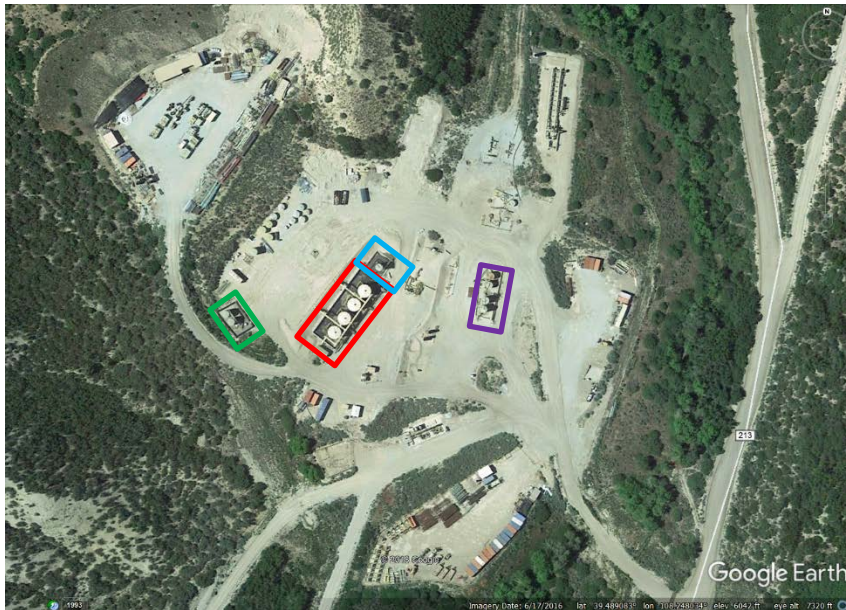
Photo #1 – Google Earth aerial photo dated 6/17/2016 depicting the location of tank batteries (condensate, central, 500 bbl AST, and loadout) included in this inspection report.
