Inspection Photos

08/20/2019

Operator: BISON OIL & GAS II LLC # 10661

Location ID: 454166

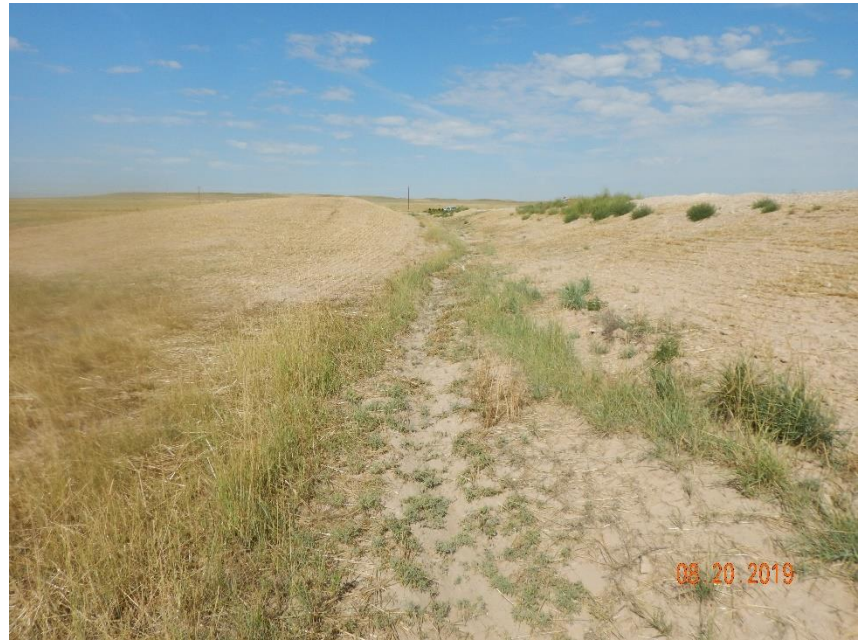
Photo 10: Photo taken from the southeast end of the location, facing north. Photo shows topsoil stockpile to the left, and pad to the right.

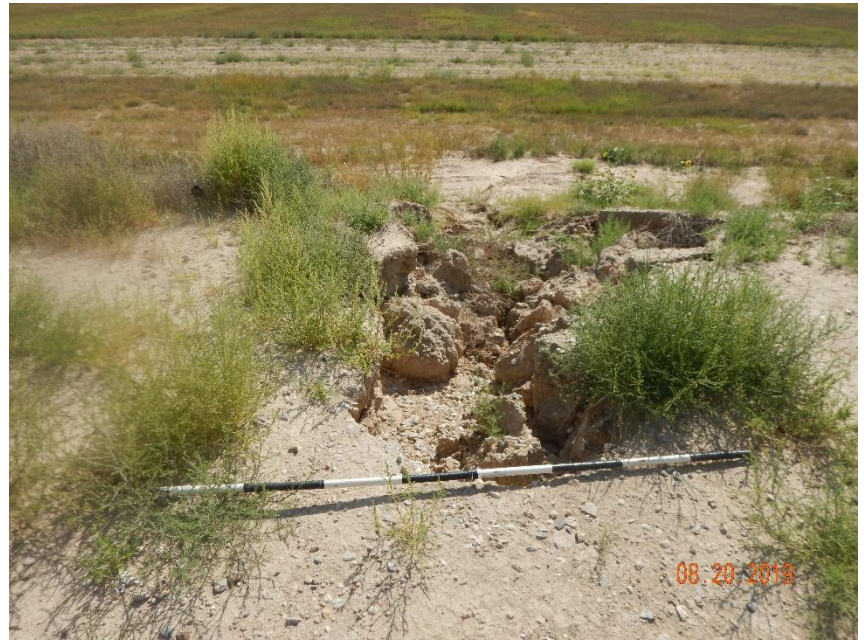
Photo 19: Photo taken from the east end of the pad, facing east. Photo shows erosion degradation on the slopes of the pad.

Photo 20: Continued from photo 19. Two (2) meter Robel-pole in photo used for reference.
