Inspection Photos
Operator: BP America
Location/API #: 067-09938
Date: 12-13-2019

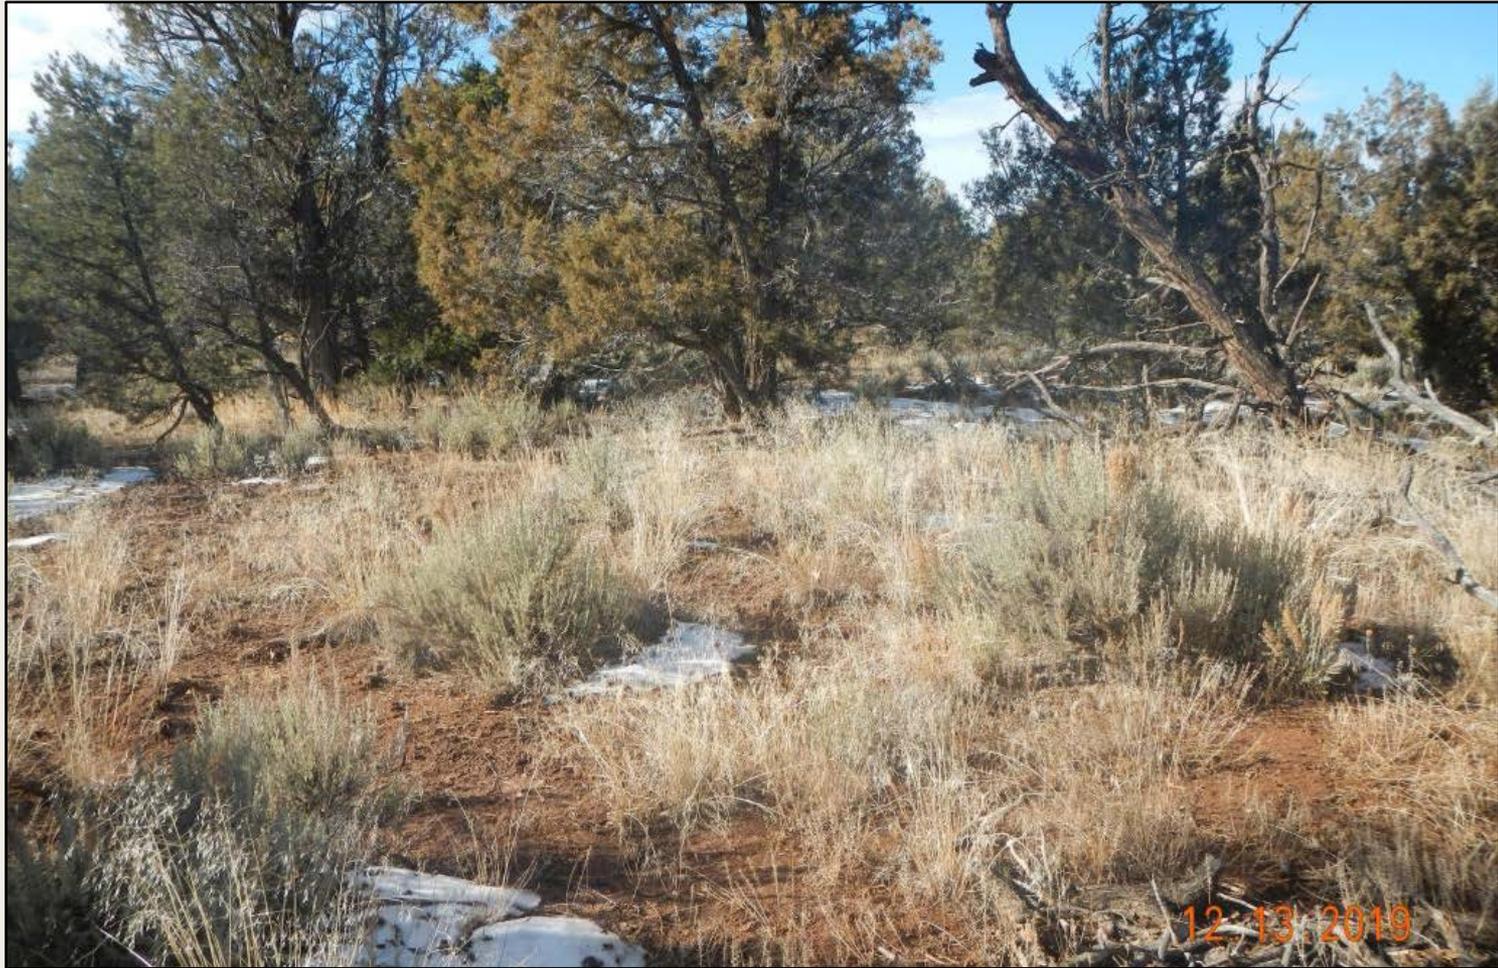
Photo 5. View of reference area, comprised of pinyon juniper woodland with understory dominated by sagebrush and Indian ricegrass.
