## Inspection Photos

Location Name: Starkey 14-28-969

Facility ID: CE&P 454686

Inspection Date: February 27, 2020

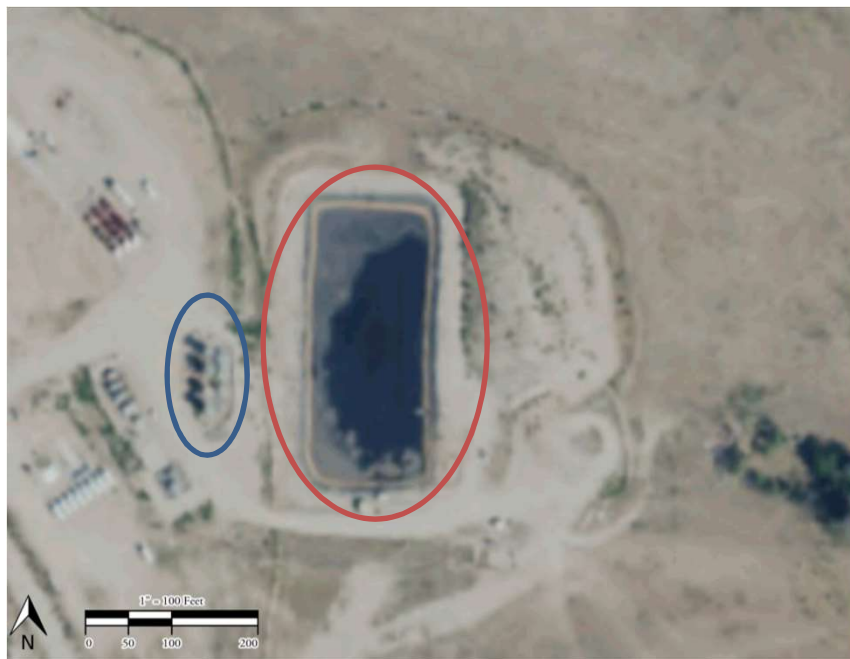
**Aerial view of the location. The blue oval is around the tank battery and the red oval is around pit ID 414554 (GISOnline Maps).**

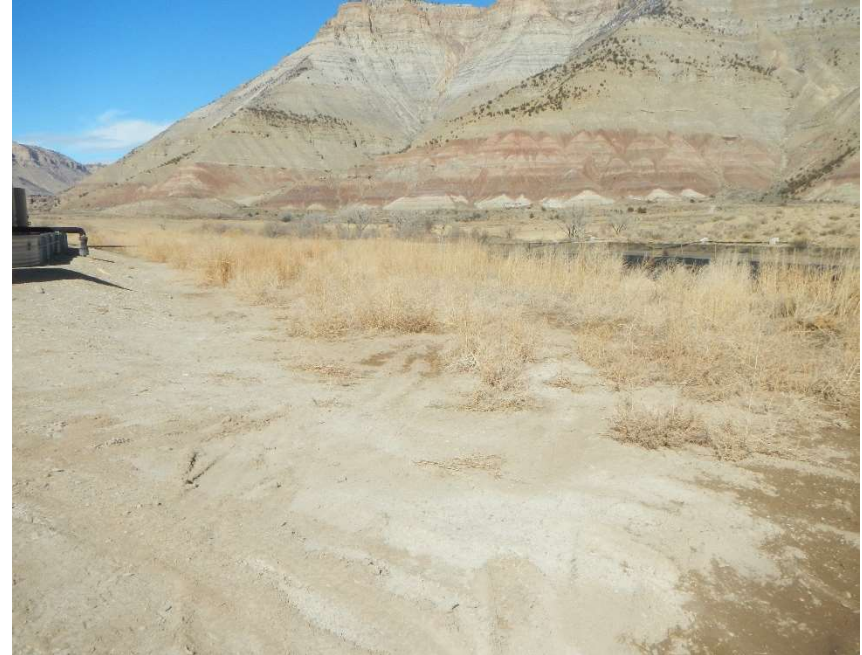
**Sitewide vegetation.**
