Inspection Photos

4/22/2020

Operator: CAERUS PICEANCE LLC - 10456

Facility ID: 419752

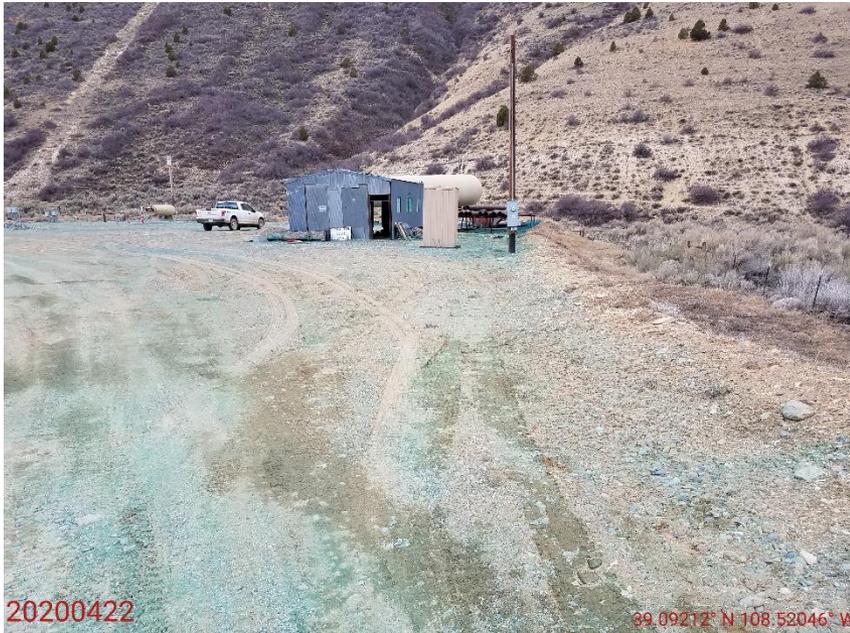
Photo 3: Photo taken from the northeast end of the Location, facing west. Photo provides an overview of the location.

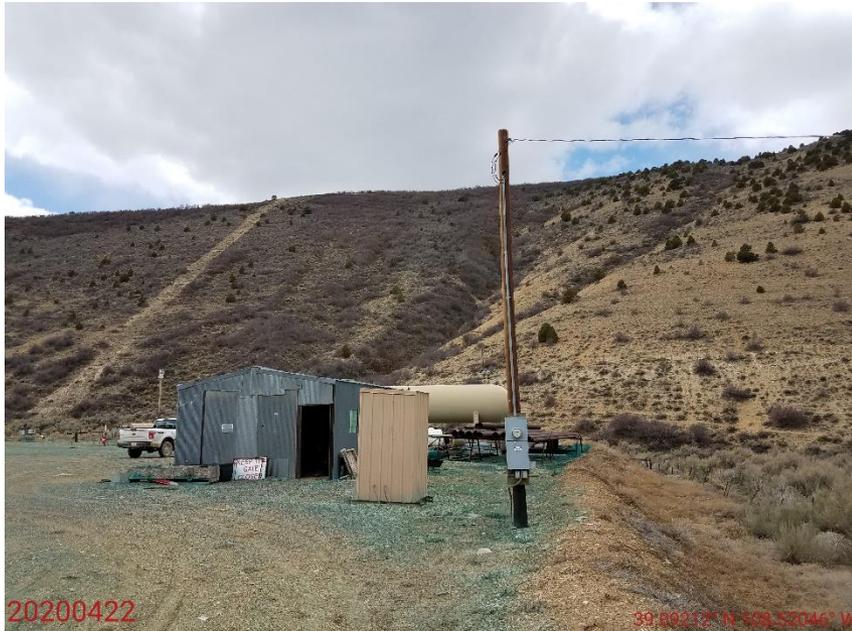
Photo 5: Photo taken from the north end of the Location, facing west. Photo shows storage of unused equipment/materials/trash. All stored/unused equipment and trash debris requires removal in accordance with Rule 603.f

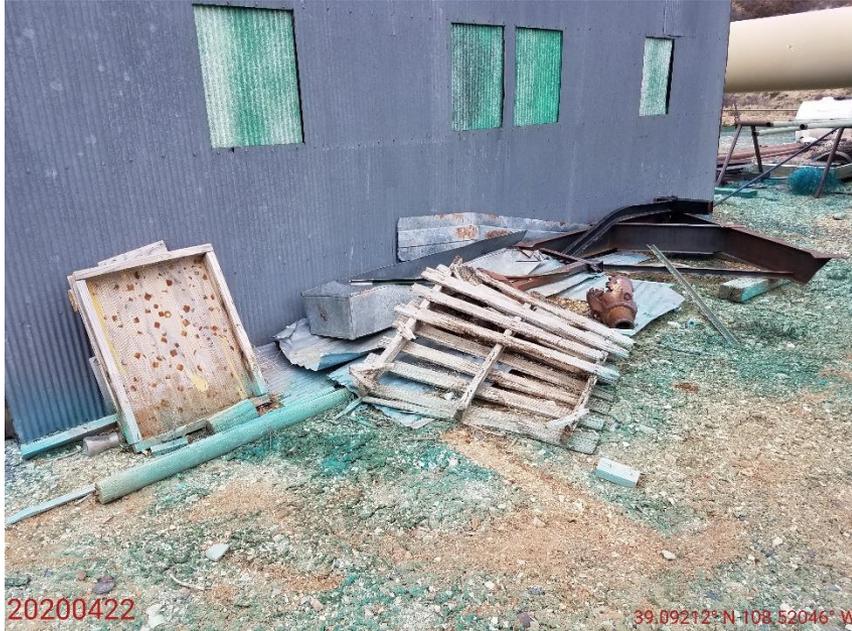
Photo 7: Photo taken from the north end of the Location. Photo shows trash debris stored on Location. All stored/unused equipment and trash debris requires removal in accordance with Rule 603.f

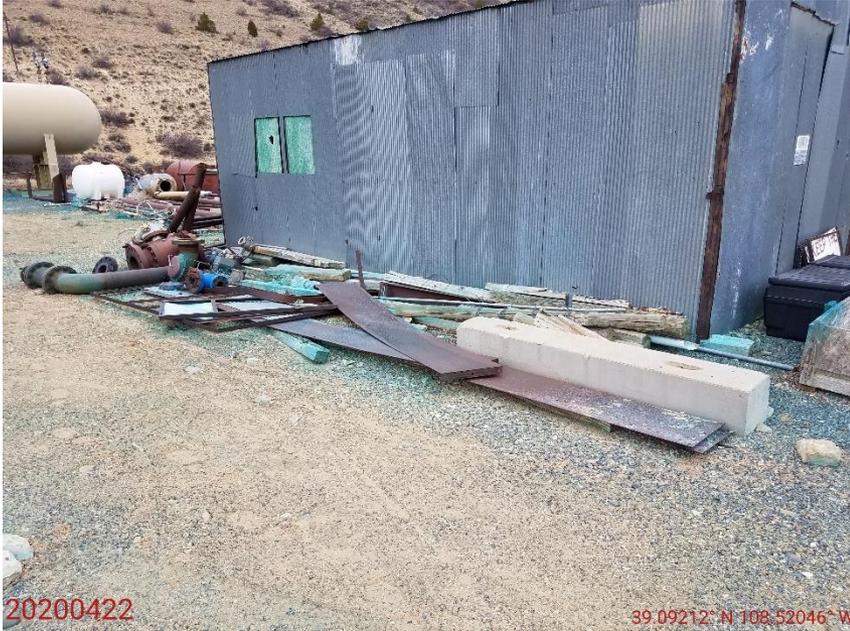
Photo 9: Photo taken from the north end of the Location. Photo shows unused equipment (shed, etc...) and trash debris stored on Location. All stored/unused equipment and trash debris requires removal in accordance with Rule 603.f

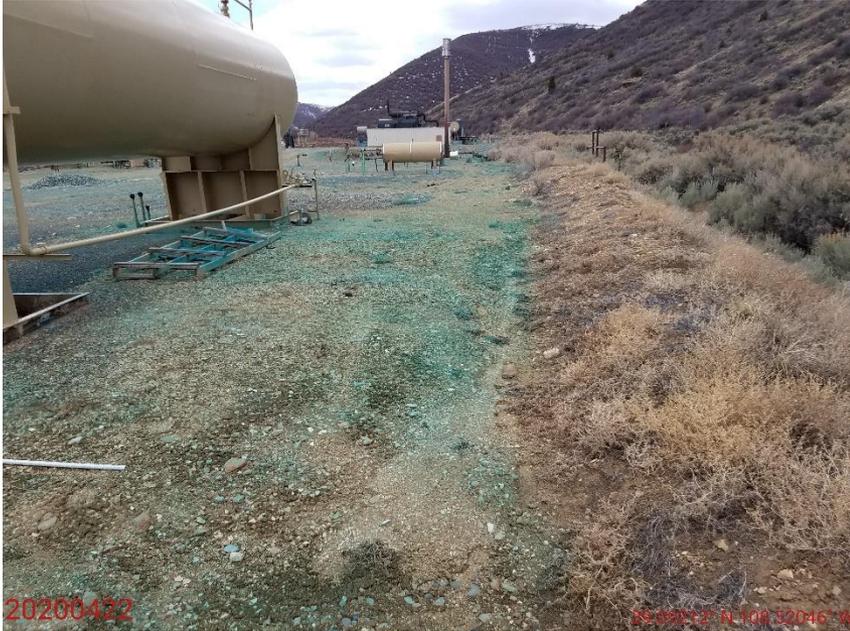
Photo 17: Photo taken from the northwest end of the Location, facing south. Photo shows weed debris has established/accumulated on the perimeter slopes/berms of the Location.

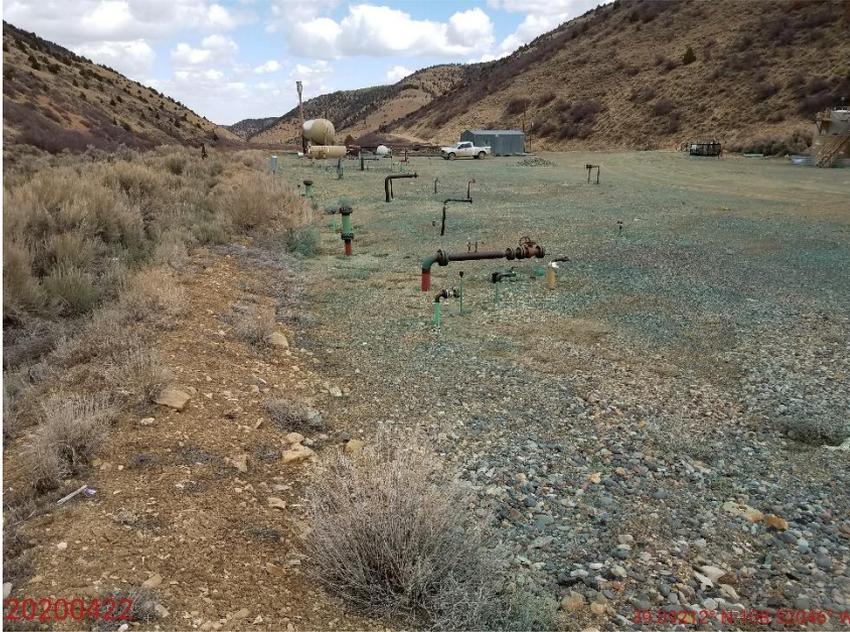
Photo 37: Photo taken from the west end of the Location, facing north. Photos 37-40 provide an overview of the Location from north, northeast, southeast to south. Photos also show unused/abandoned equipment on Location.

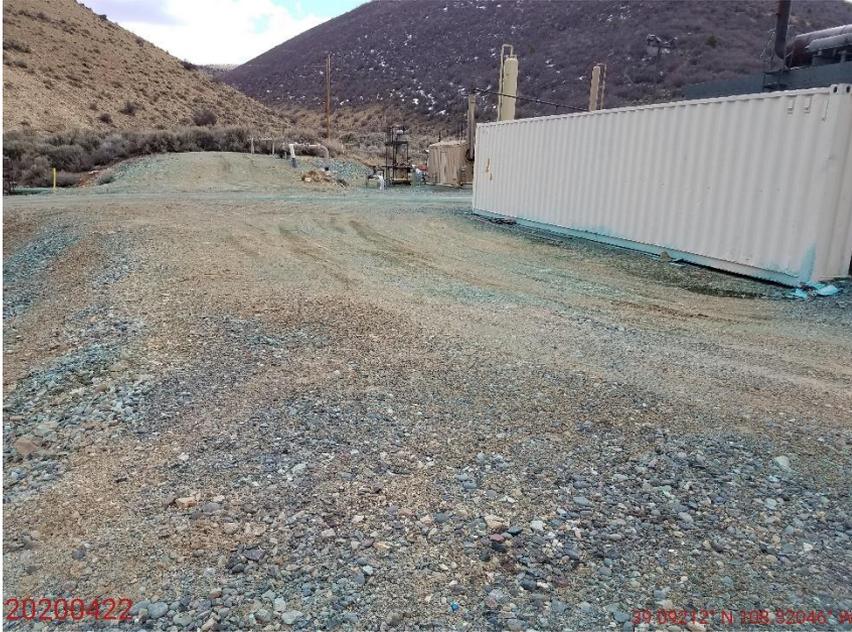
Photo 39: See comments under photo 37.

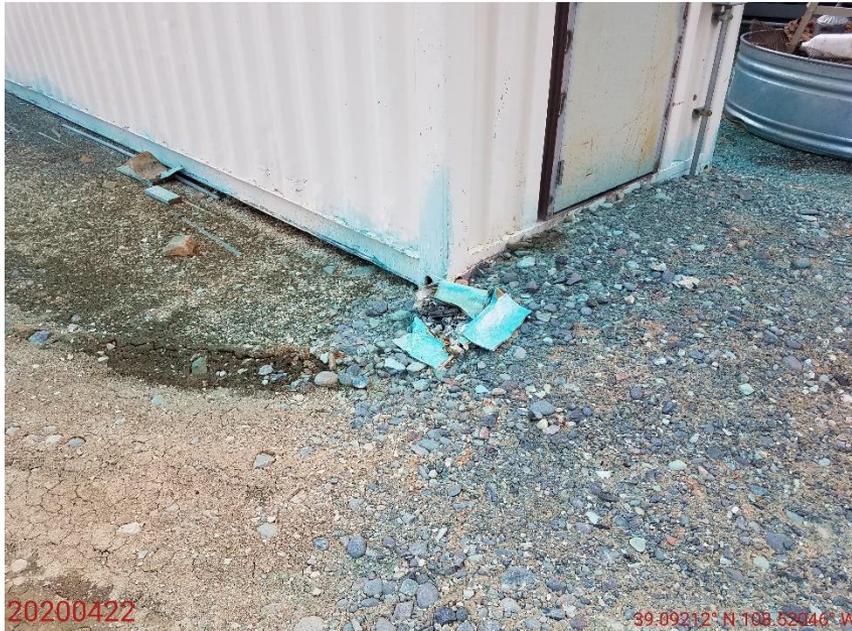
Photo 41: Photo taken from the storage container on the west end of the Location. Photo shows trash debris.

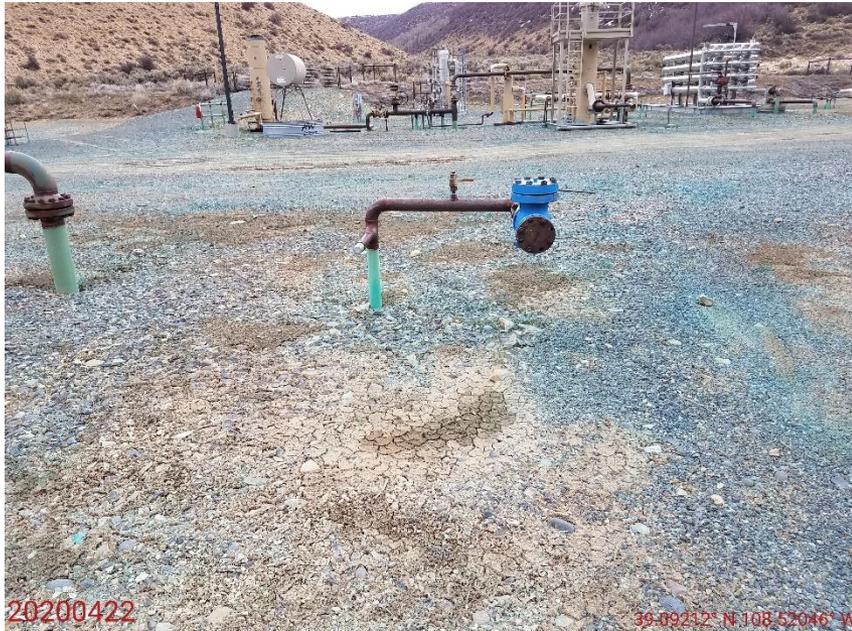
Photo 47: Photo taken from the southwest area of the Location. Photo shows unused/abandoned equipment (risers) on Location. Equipment appears to have been associated with a compressor, that has since been removed. All unused/abandoned equipment requires removal in accordance with Rule 603.f. Photo also shows stained soils.

Photo 51: See comments under photo 47.

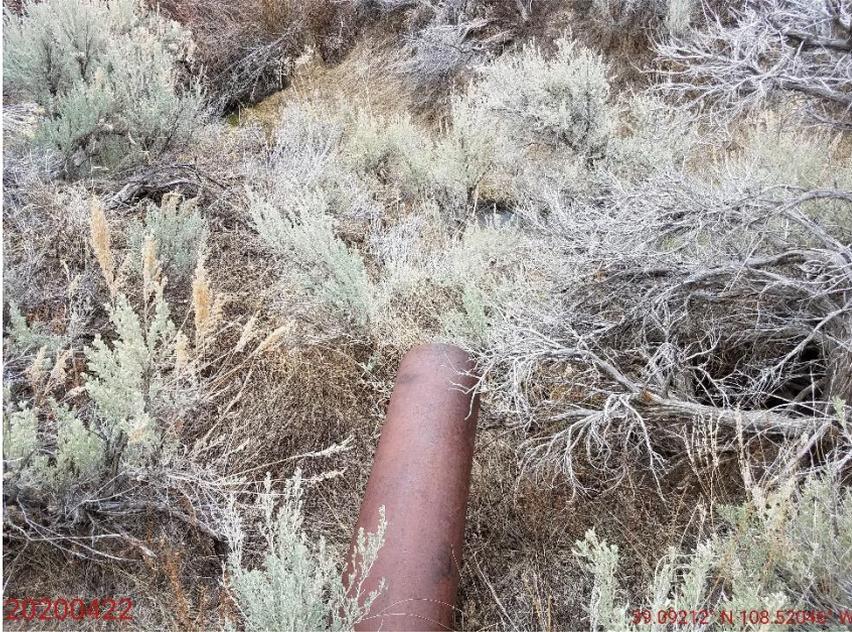
Photo 52: Photo taken from the southwest end of the Location, facing north. Photo shows stormwater containment pond. Pipe with gate installed to allow flow/discharge. Outlet of BMP appears to discharge directly into a creek adjacent to the Location.

Photo 53: See comments under photo 52.

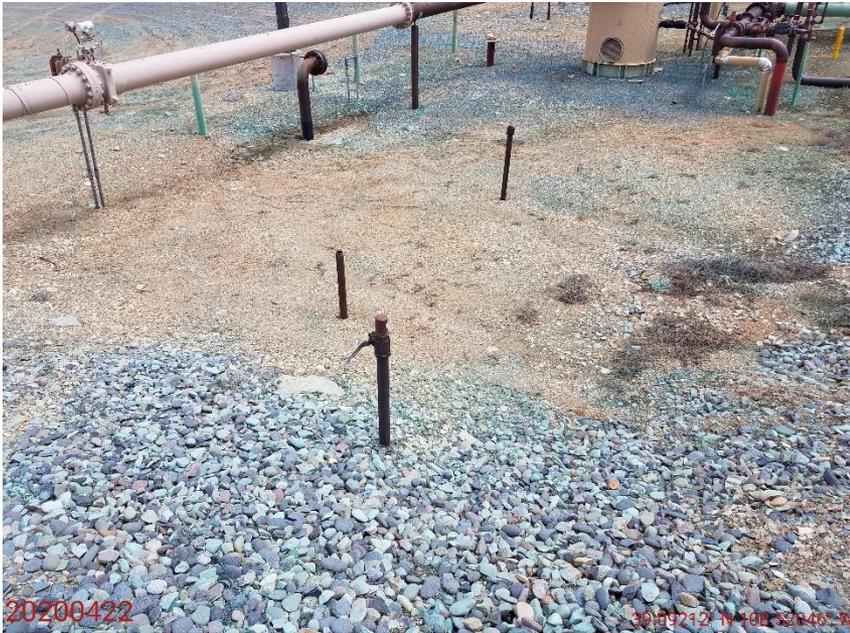
Photo 67: Photo taken from the west end of the vertical separator. Photo shows unused/abandoned equipment (risers) on Location. All unused/abandoned equipment requires removal in accordance with Rule 603.f.

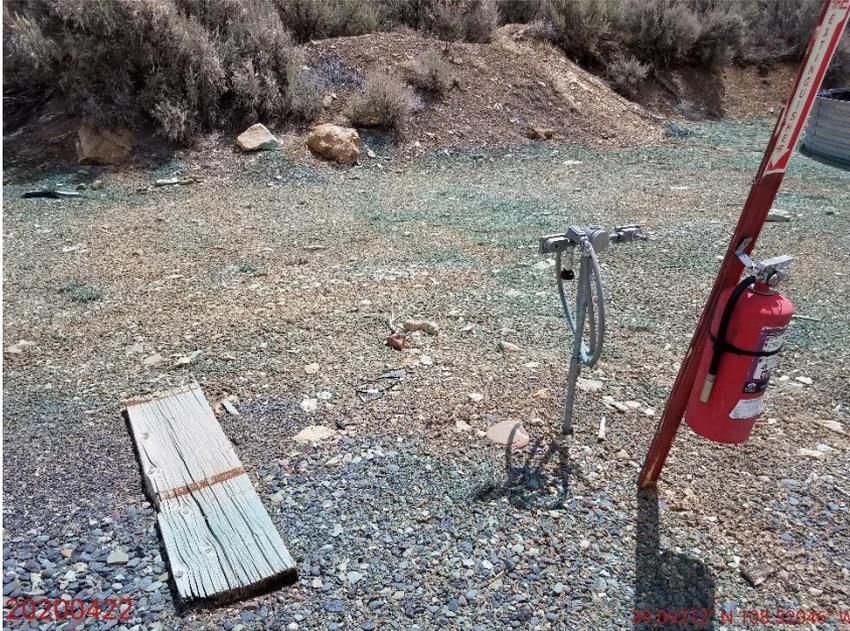
Photo 73: Photo taken from northeast end of the Location. Photo shows unused equipment and trash debris on Location. All stored/unused equipment and trash debris requires removal in accordance with Rule 603.f
