Inspection Photos

6/03/2020

Operator: WINDSOR ENERGY GROUP LLC -
10081

Location ID: 315696

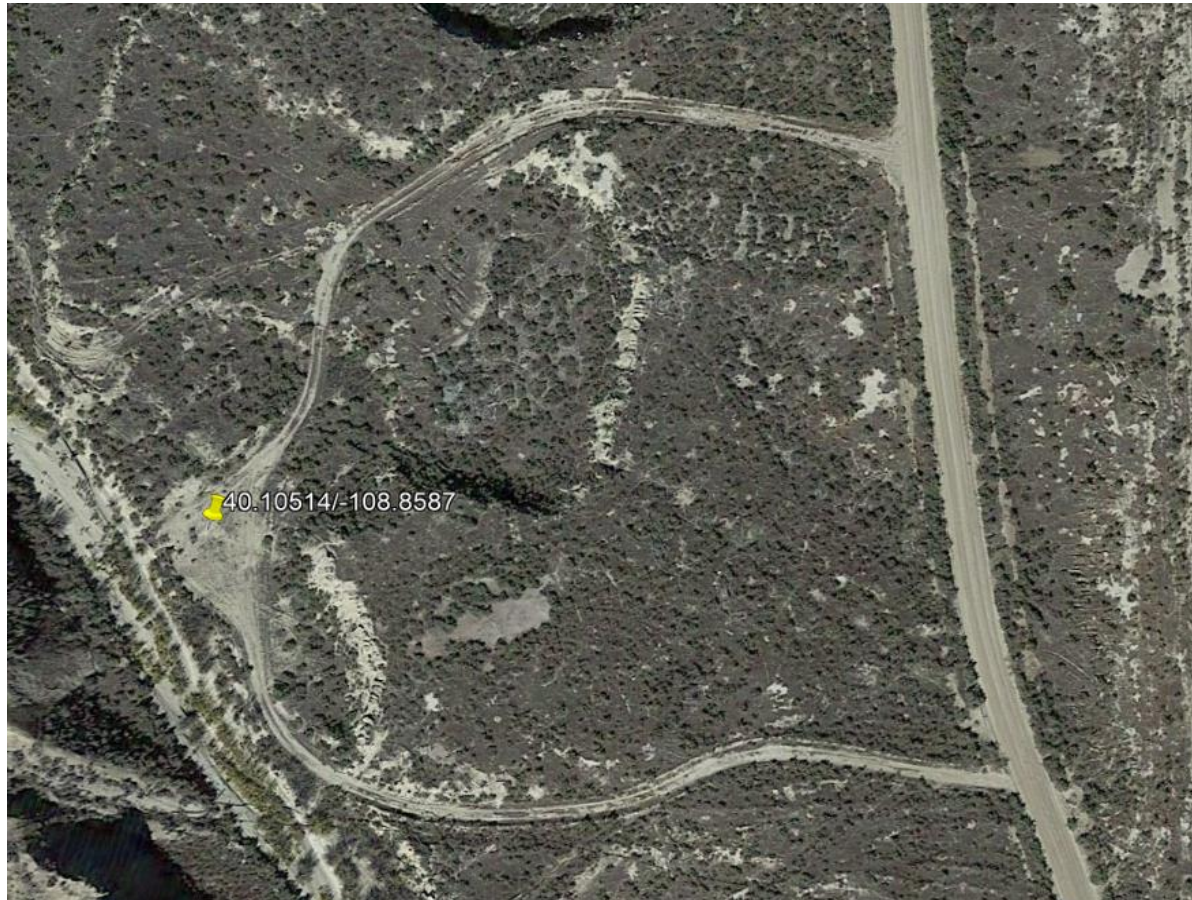
Photo 1: Current available Google Earth aerial imagery (2015). Photo shows aerial overview of the Location and access roads leading north and south of the Location.
