Inspection Photos  
Operator: ConocoPhillips  
API: 067-08199  
Date: 7/28/2020

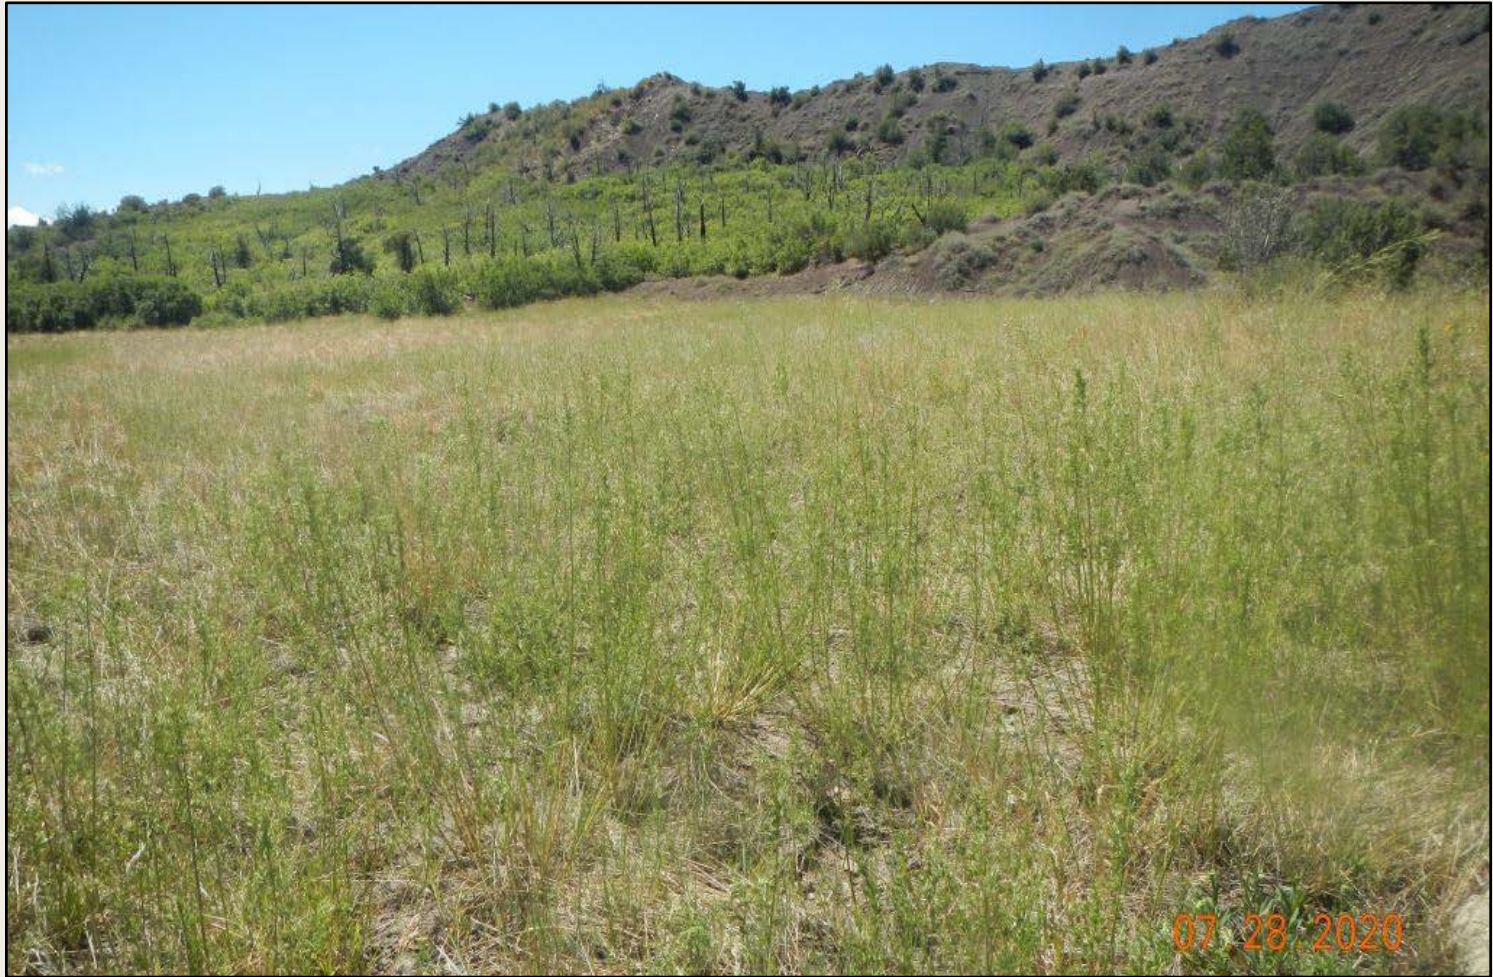
Photo 6. View of the southern project area from the southwestern corner facing eastward.

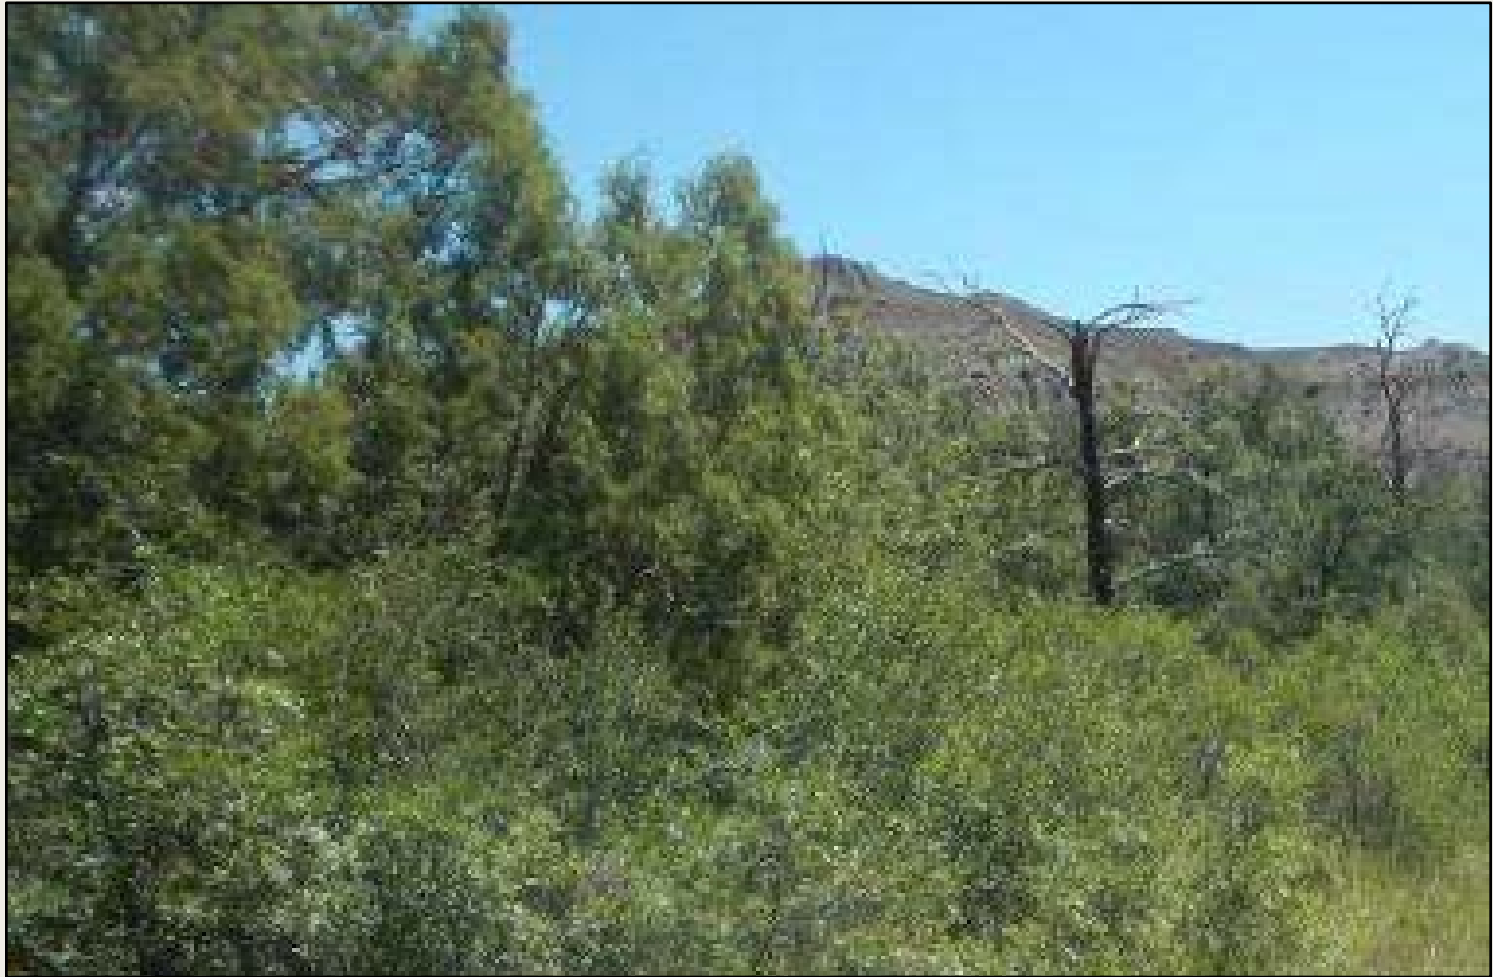
Photo 9. View of reference area vegetation comprised of ponderosa pine woodland in post-fire recovery vegetative condition, with dense gambel oak and scattered junipers in the understory.
